Pennsylvania Coal Association

Bituminous Coal Mine Safety Act

Section 334 Industry Studies

Final Report

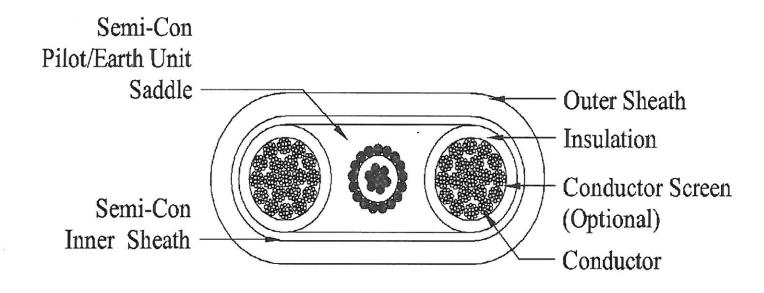
Flat DC Shuttle Car Cable for Republic of South Africa DC Shuttle Cars Pilot is the small central conductor and the earth (grounding conductor) is stranded around the insulated pilot wire.

South African Type RSA 41.5

This cable had two 35mm² conductors in a Flat Type GGC construction a Hypalon rubber jacket. It was a brand new style of semi-conductive shielded flat DC shuttle car cable designed by AmerCable for coal mines in the Republic of South Africa.

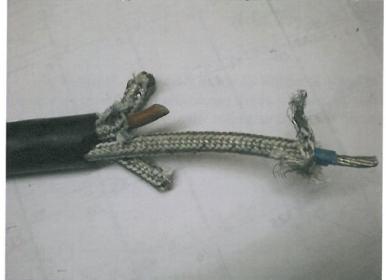
British BS 6708Type 11: 3 screened power conductor, 1 screened pilot

Description: 3-phase 4-core. Three power cores and one pilot core having the same nominal cross-sectional area, each having a protective metallic screen, laid around an elastomeric centre, sheathed overall. The combined screens shall function as the cable earth conductor

• British Standard BS 6708 Type 11.

This cable had three copper/nylon individually braided shielded power conductors, and one individually shielded pilot (ground check) conductor equal in size to the power conductors. This cable had no bare copper grounding conductors in the interstices. The copper braid shielding over all four conductors is made to the British requirement and has enough mass to carry any fault current that might occur during a failure. The specification BS 6708 contains dc resistance requirements for the braid shields in parallel.

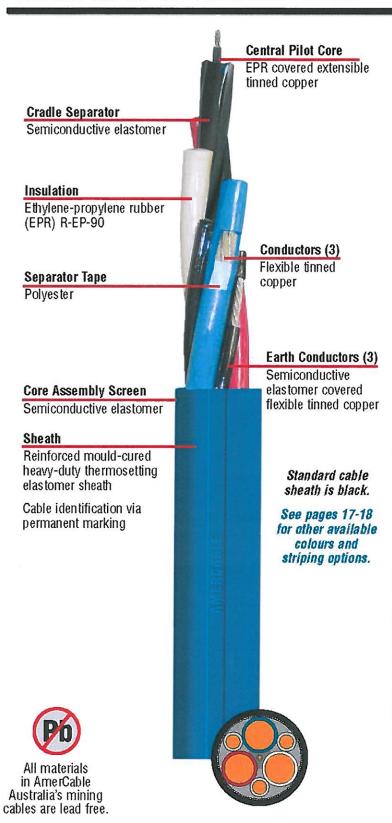
Type 275 Mould-cured CPE Sheath • 1.1kV

Used for shuttle cars or other equipment with cable reels.

Highly flexible construction with abrasion resistant CPE sheath. Available in colours and stripes.

Australian Type 275 CPE

This sample was labeled TR1069 and uses the standard #2 3/C Round GGC assembly, but with semi-conductive rubber insulated grounds and a semi-conductive rubber inner jacket layer. It had an AmerCable standard Extra-Heavy-Duty (EHD) Chlorinated Polyethylene Rubber (CPE) outer jacket layer.

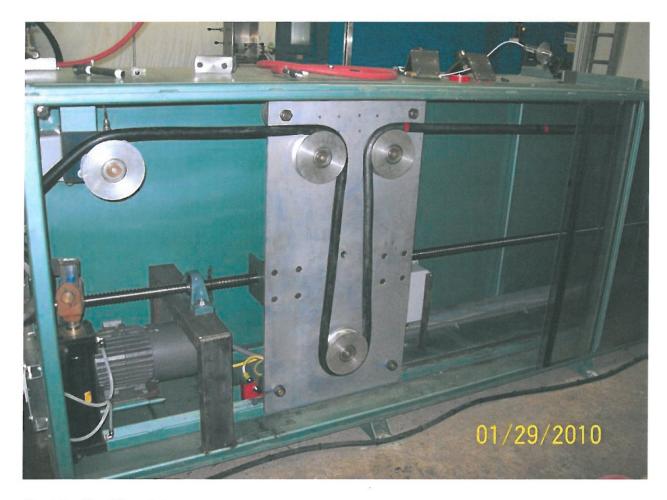
Shuttle Car Simulator

Cable must be capable of withstanding approximately 25,000 cycles on a machine designed to represent reeling and de-reeling of cables on shuttle cars (Shuttle Car Simulator). This was estimated to be approximately equal to 3 months of flexure in the mine.

The sheaves were 8" outside diameter and the tension was maintained at 100 lbs +/- 10%. These values were based on the practical experiences of the PCA committee members and AmerCable technical staff. The conductor temperature was approximately 75°C in a 25°C ambient. Seventy-five degrees Celsius was used instead of 90°C since this is the approximate temperature of shuttle car cable in free air, as opposed to temperatures down in the reel. The power conductors were wired in series to apply current. The machine was set to shut down when a power conductor experienced fatigue failure, or when the ground check or a grounding conductor broke. Also, a ground fault monitor was used to determine if/when a braid shield wire broke and penetrated the insulation. This too was set to shut down the machine at that moment.

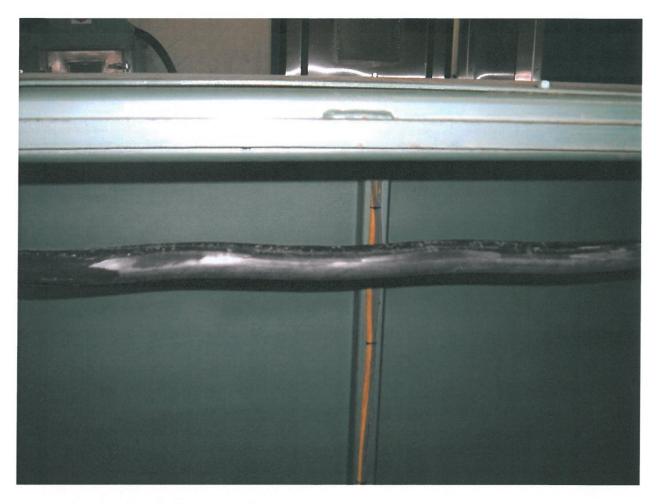
Australian Type 275, first sample kinked

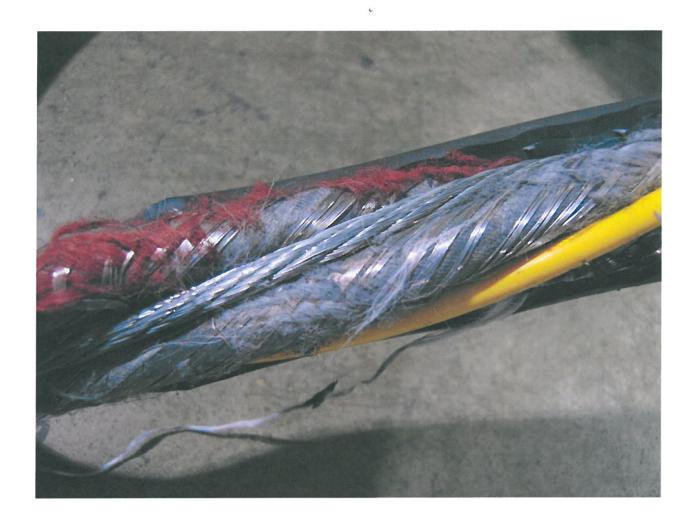
Standard SHDGC with broken shield wires. Also, note the wide spacing of the braid wires after only 3,512 cycles.

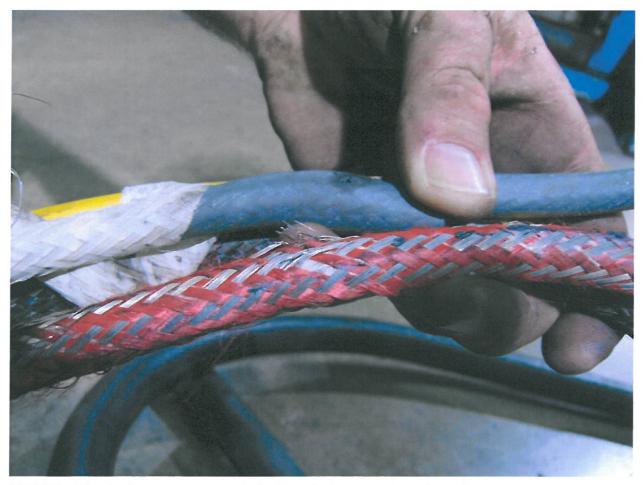
SHDGC shield wires penetrated the insulation causing the trip.

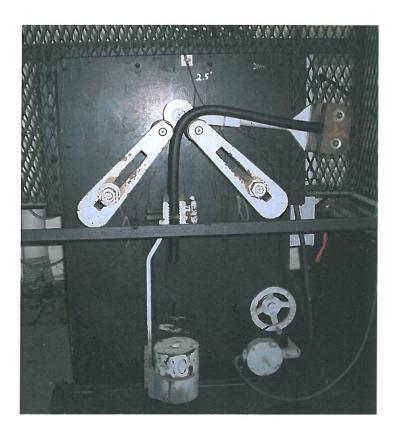
Flex Testing

- Cable is flexed under tension through an angle of 180°
- 10,000 cycles for round cables
- 20,000 cycles for flat cables
- Samples periodically checked for shorts & opens
- Dissection for the examination of wire breaks

The testing equipment consisted of two apparatus to test cables – each subjecting the cables to different forces. The first tester, the "Flex Testing" apparatus, held a cable sample under tension and flexed the cable through an angle of 180°. Cables are periodically checked for shorts and opens in the various conductors. The test is performed for 10,000 cycles on round cables and for 20,000 cycles on flat cables. After the test is completed the test cable is dissected and the cores and shields are examined for individual wire breakage.

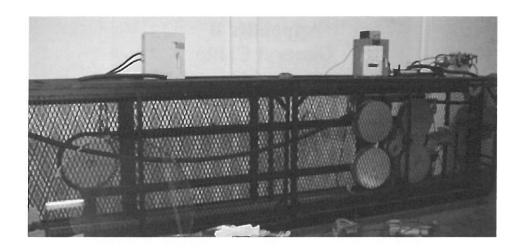
Shuttle Car Simulator Testing

- 7,500 cycles for round cable and 8,000 cycles for flat cables
- Samples periodically checked for shorts and opens
- Dissection for the examination of wire breaks
- Test utilizes a stationary piece of cable on a traversing carriage
- Four sheaves create a double "S" bend of the cable as it cycles over a 15' distance
- Cable tension air pressure:100 PSI ±10PSI

The second test simulated the operation of a mine shuttle car. This test used a stationary piece of cable on a traversing carriage. Four sheaves create a double "S" bend in the cable as it cycles over a 15 foot distance and the cable is tensioned with air pressure of 100psi (±10 psi). Round cables are cycled to a count of 7,500 and flat cables to 8,000. Again the samples are periodically checked for shorts and opens and upon test completion, the test cable is dissected and the cores and shields are examined for individual wire breakage.

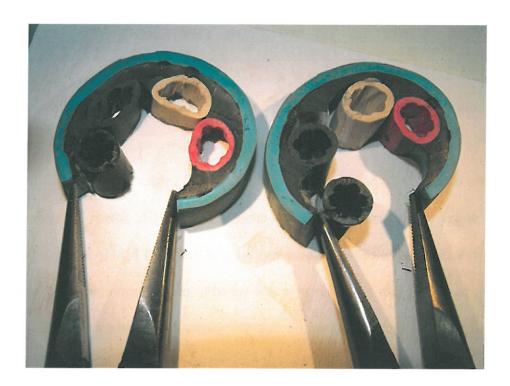
From the photo it can be seen that the cut cross sections of two cable samples behave very differently when they are spread apart with the pliers. The "without talc" section on the left, shows that the phase insulation is bonded to the semi-conductive jacket

Investigation by General Cable revealed that the stripping problem was caused by inconsistent application of talc between the conductor insulation and the inner semi-conductive jacket.

Sections of the cable that had adequate talc applied were significantly easier to strip then sections lacking enough talc. Without a proper amount of talc applied to the core, the inner jacket bonds to the phase insulation during the curing process making the cable difficult to strip.
