Exhibit A: Monitoring well and surface water sampling locations.

Exhibit B: EQT Phoenix Pad S site overview. Photo taken 5/31/13.

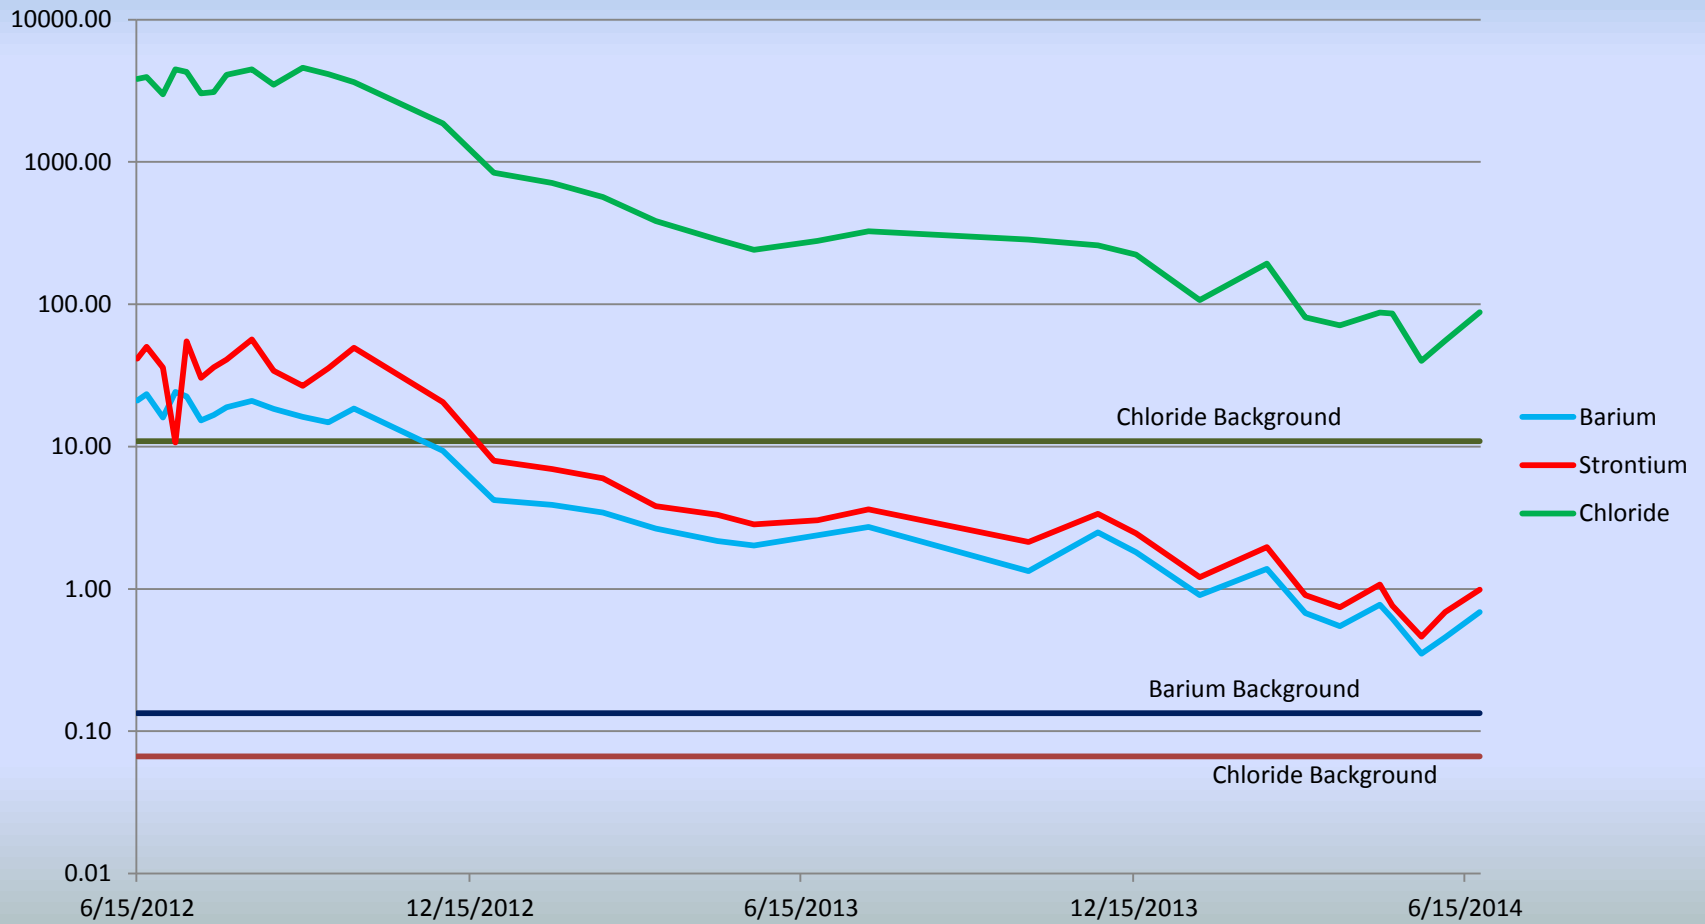
Exhibit D: Water quality Danzer 1 spring.

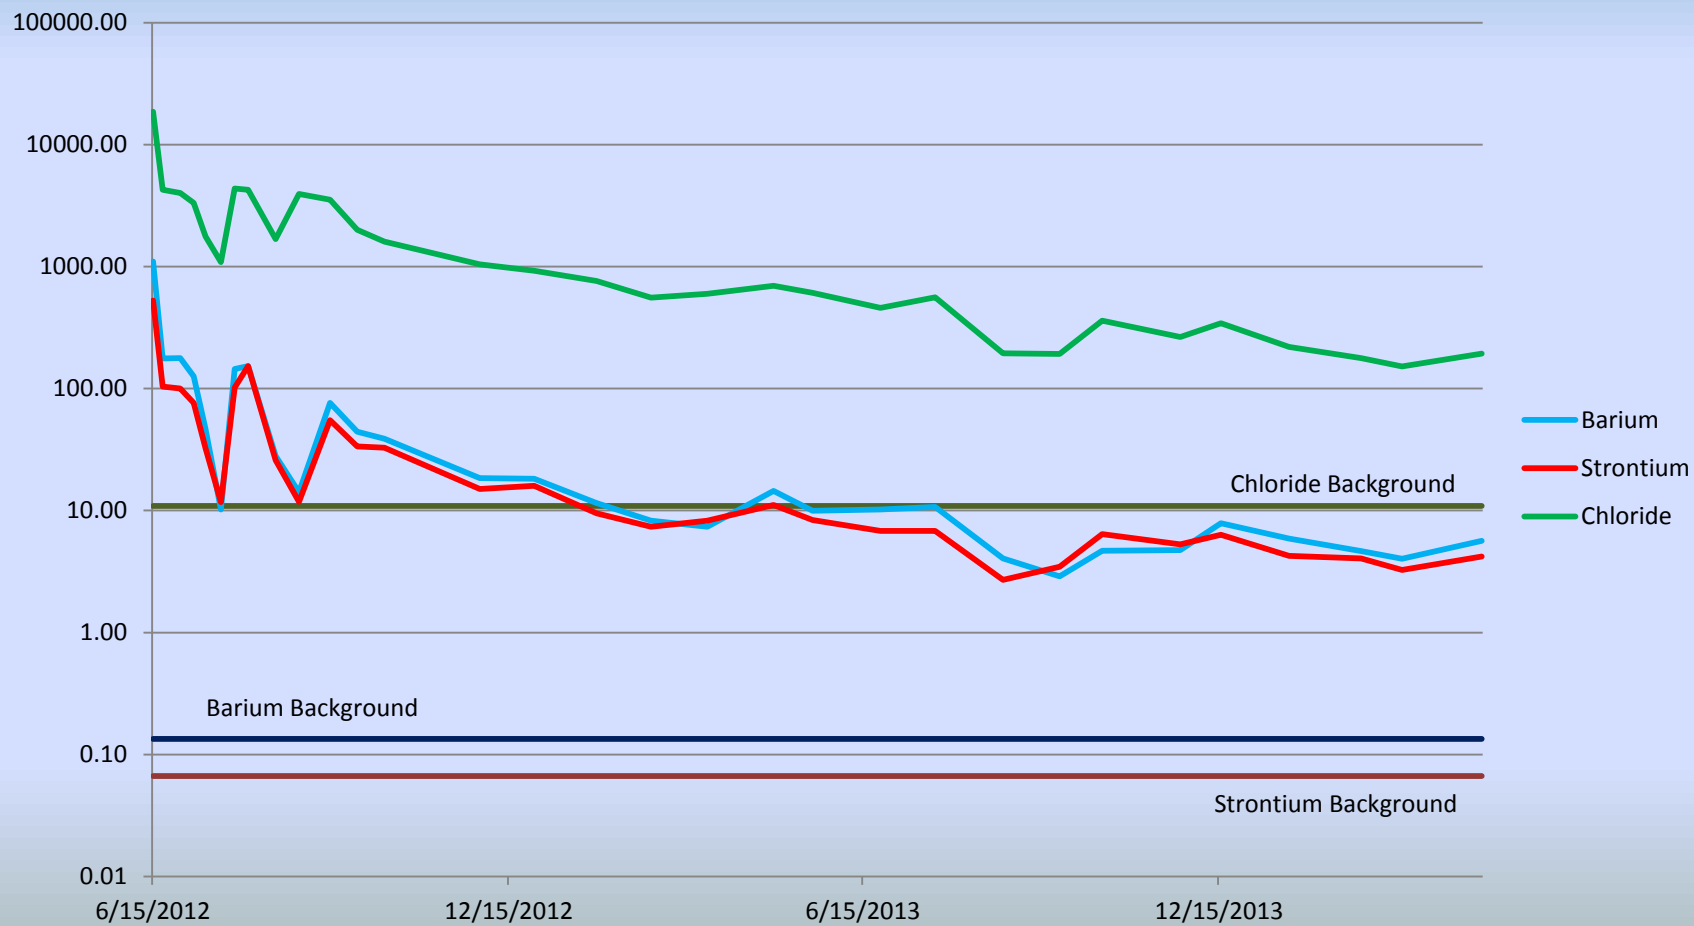
Exhibit E: Water quality lower west seeps.

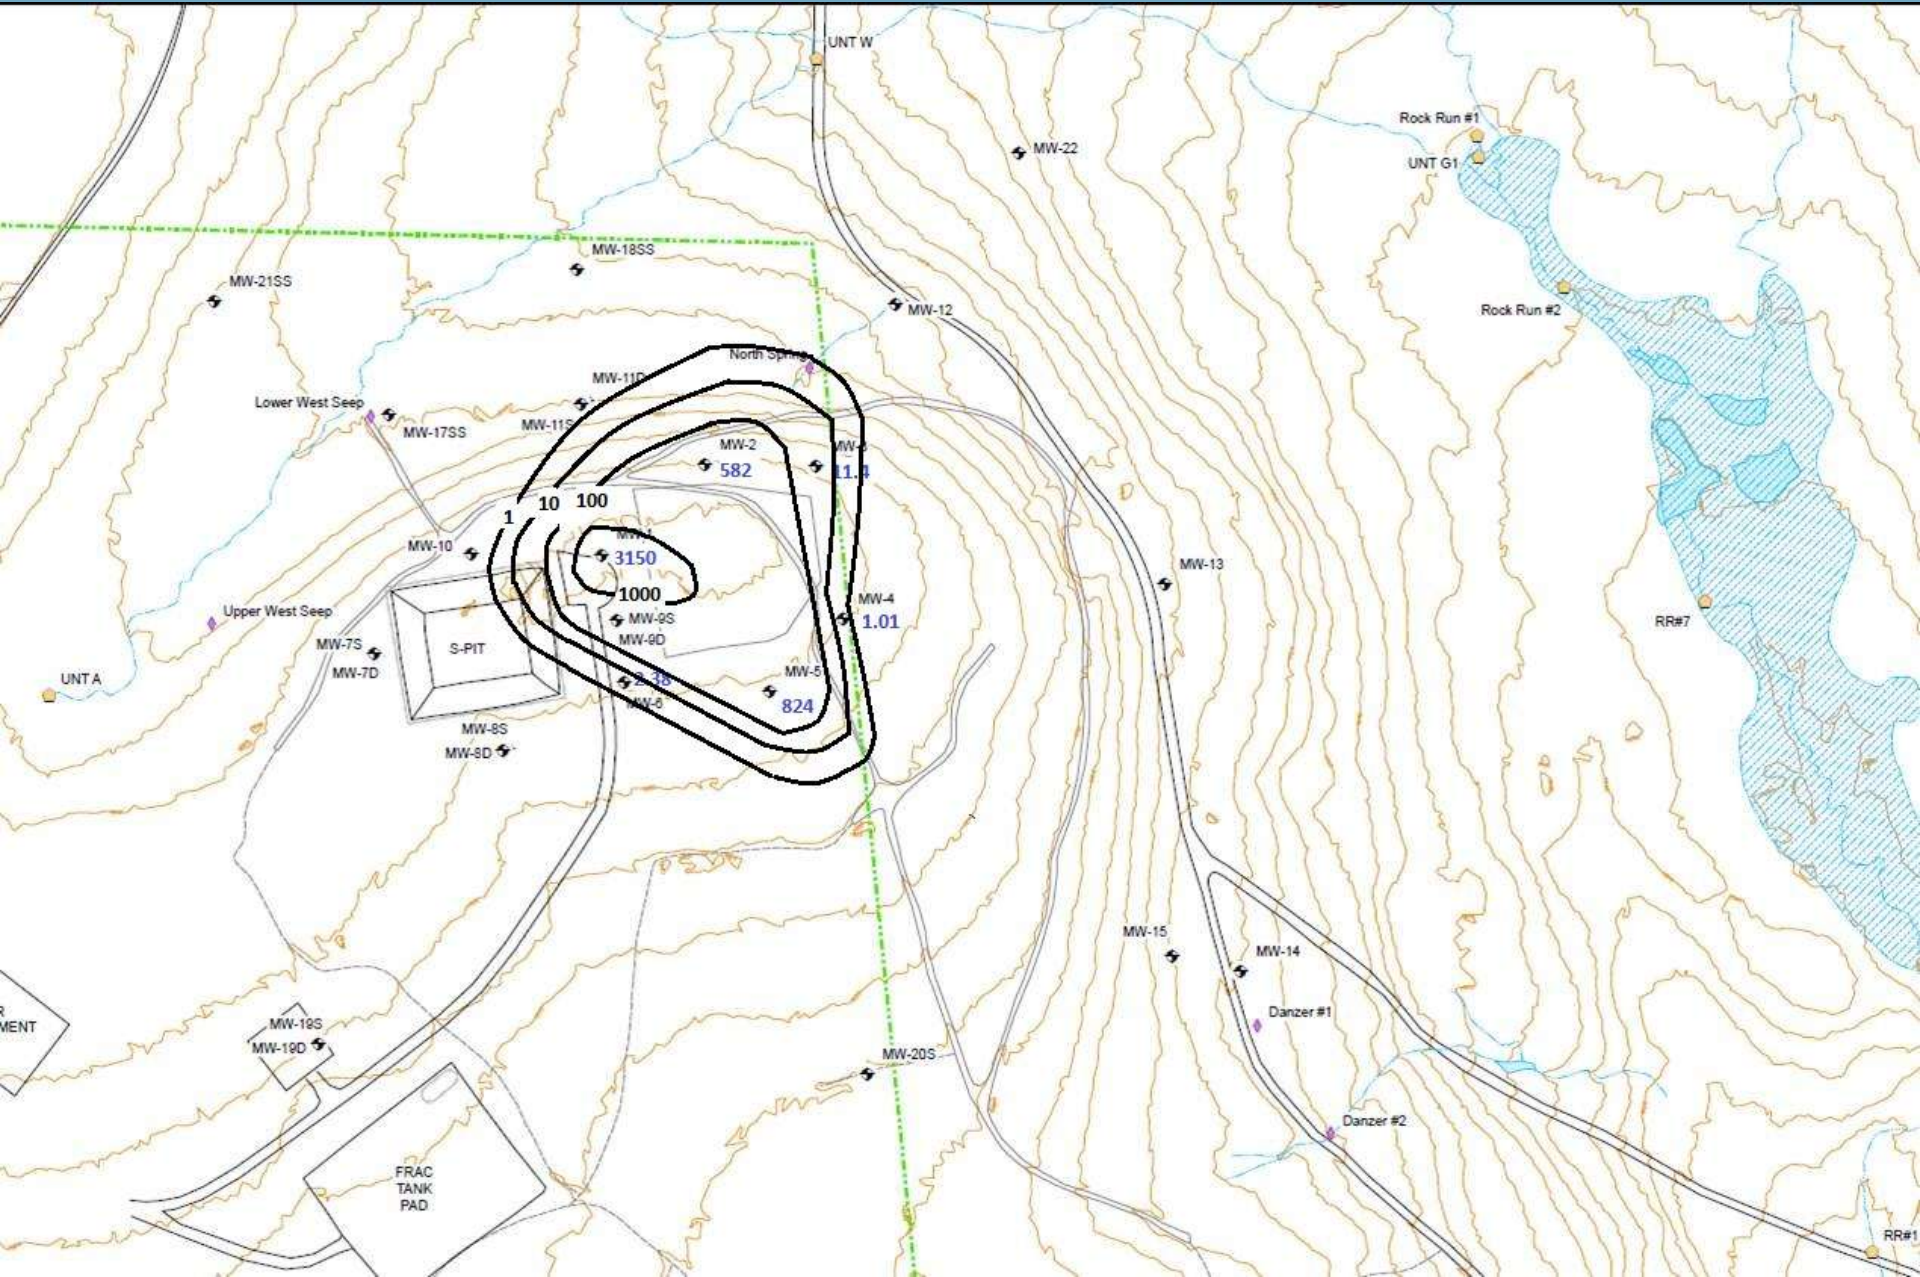
Exhibit F: Groundwater chloride concentrations in mg/L- May 30, 2012.

Secondary Maximum Contaminant Level (SMCL) is 250 mg/L.

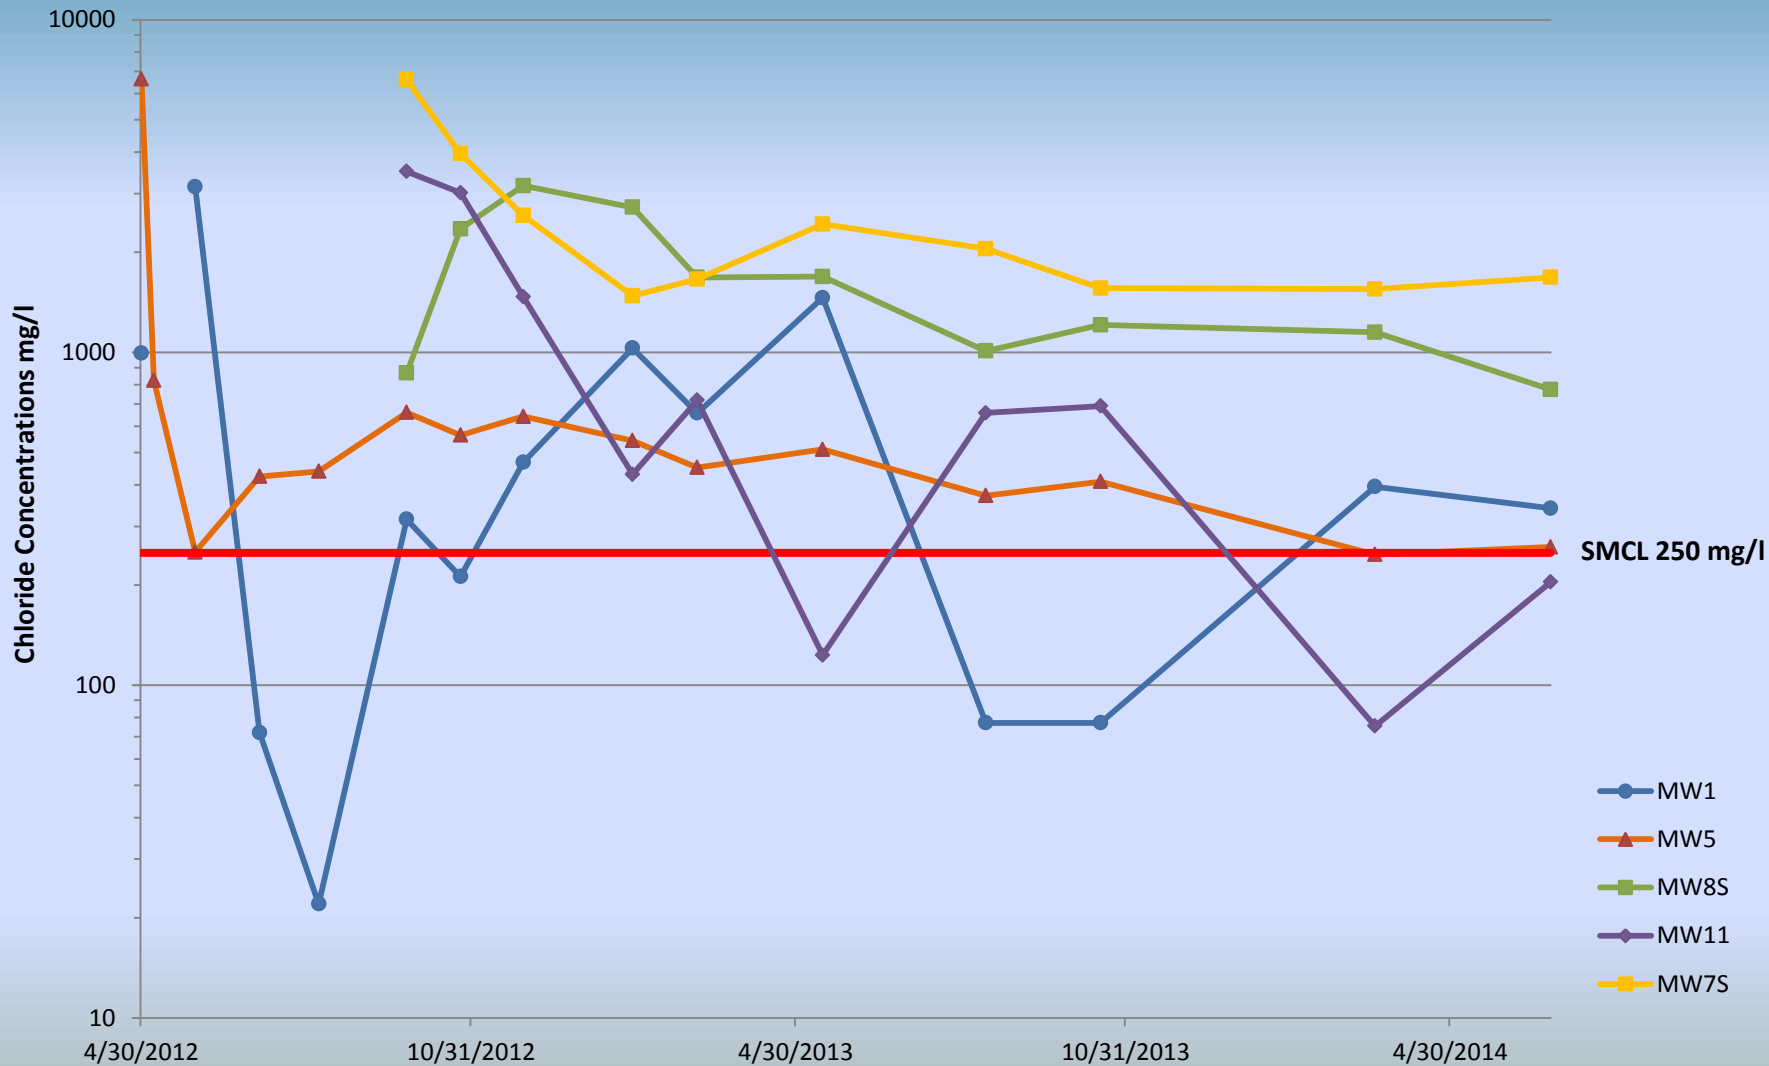
Exhibit H: Chloride concentrations versus time in select wells.
