A Successful HSCA Funded Cleanup:

Mt. Laurel Road Battery Casing Site

Alsace Township, Berks County, PA

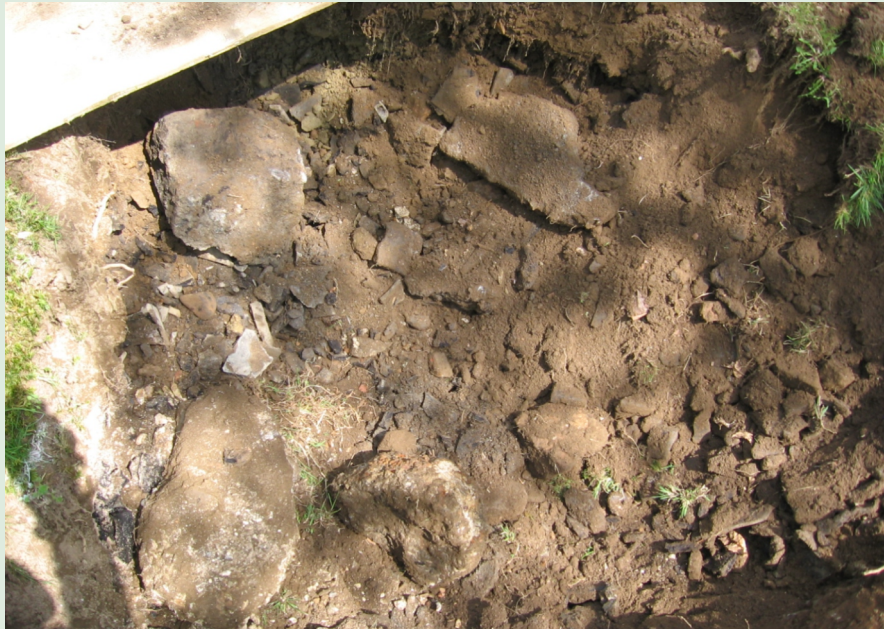
Battery casing material intermingled with soil, cobbles and other fill material that was used pre-1990 to raise and level residential yards at the Mt. Laurel Battery Casing Site, Alsace Township, Berks County, Pennsylvania.

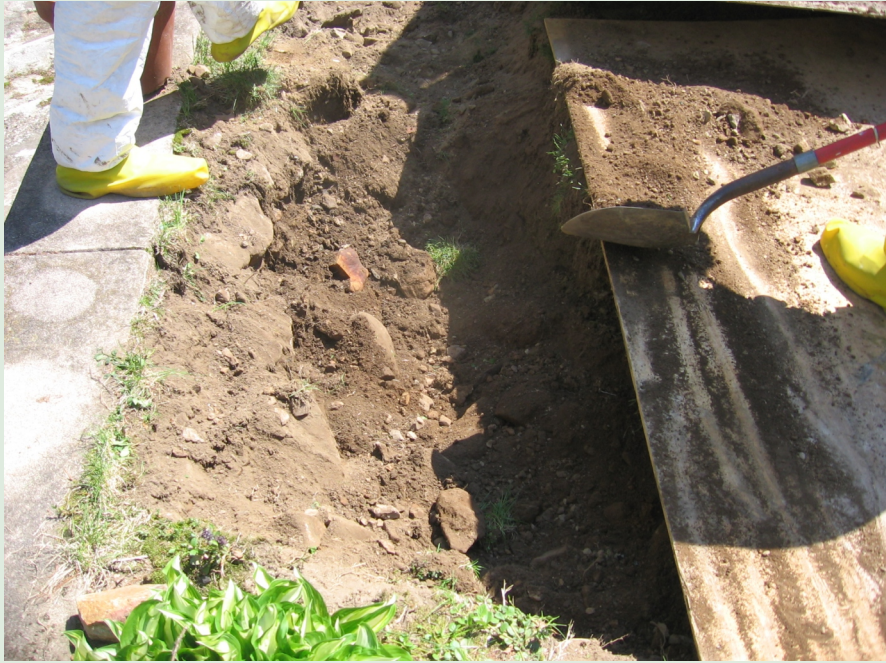
Personal protective outerwear was required to remediate battery casing material intermingled with soil, cobbles and other fill material at the Mt. Laurel Battery Casing Site, Alsace Township, Berks County, Pennsylvania.

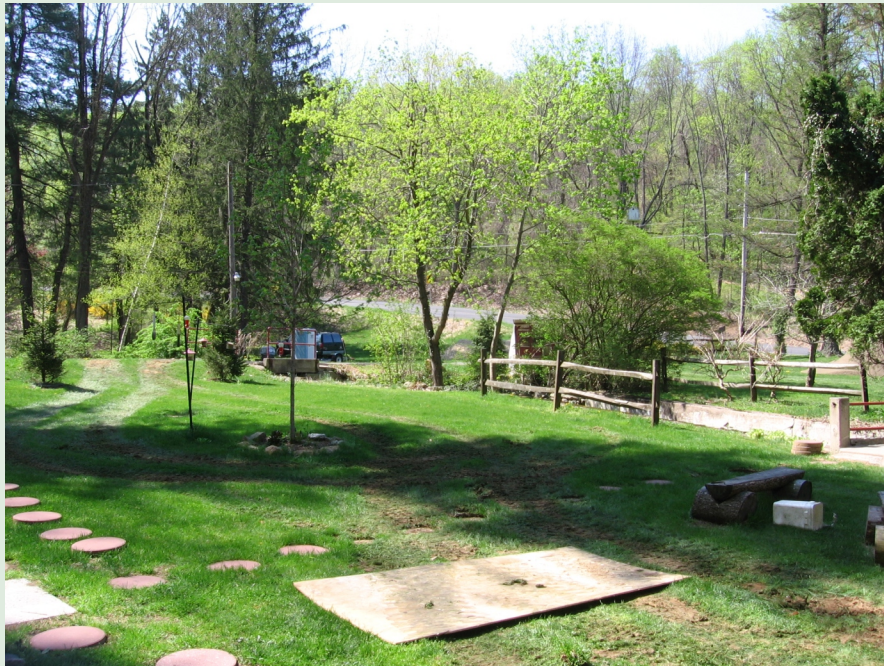
Restoration is almost complete in 2015 at the Mt. Laurel Road Battery Casing Site, Alsace Township, Berks County, Pennsylvania.

Excavation of contaminated soil and Site restoration were completed in June 2015. Restoration activities included backfilling, repairing of cracked concrete, replanting of trees/shrubs, seeding, stabilization, replanting of flowers and trees, adding and compacting gravel to a driveway, and replacing pavers. The Site clean-up effort concluded in 2017 with the approval of the final report. Institutional controls consisted of environmental covenants and these were signed and presented to Alsace Township in December 2018.
