# PIKE RUN SUBSIDENCE ABANDONED MINE RECLAMATION PROJECT

Office of Active and Abandoned Mine Operations

The Pike Run Subsidence project involved reclamation of one (1) pre-act Abandoned Mine Land Feature (AMLF).

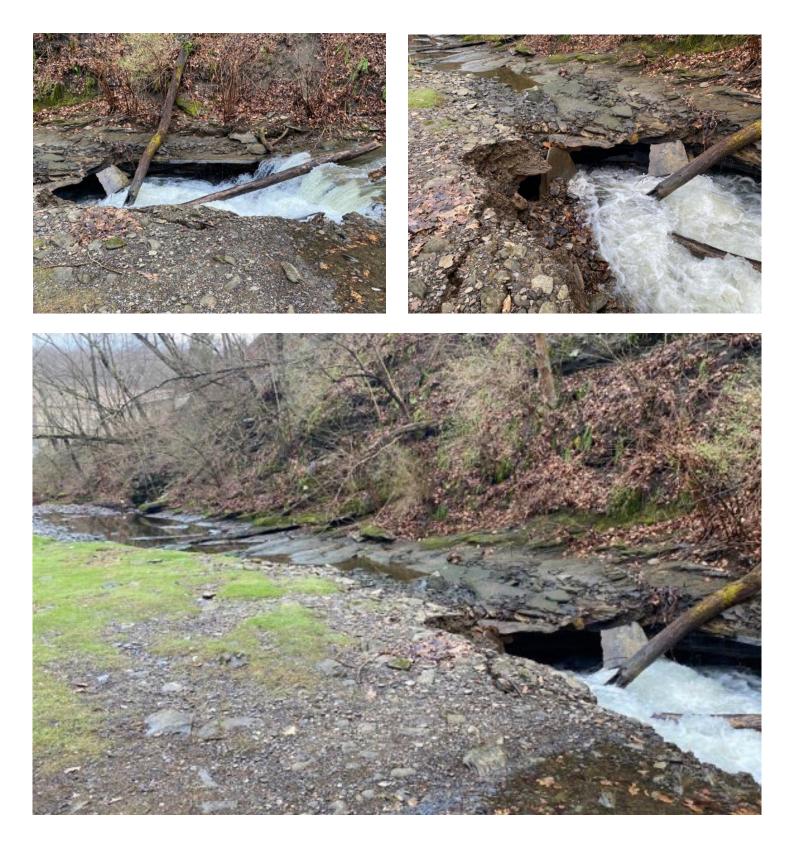
# **Pre-Construction**

The abandoned feature is a direct result of the Vesta #4 Mine prior to 1925. AMLF No. 4769–07 VO consisted of a 10–foot by 20–foot by 10–foot vertical subsidence cave hole that exposed the mine workings in a perennial stream course.

This opening diverted the stream into the mine workings. The project eliminated AMLF No. 4769–07 VO by filling the opening with a pumped concrete cement grout mixture.

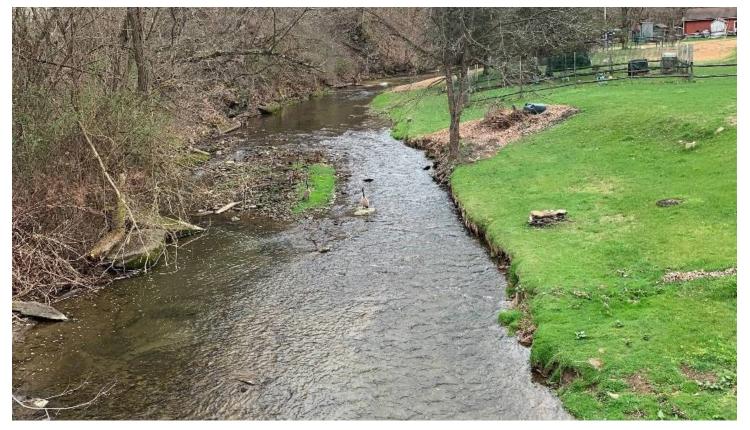
# **Post-Construction**

Accomplishments for this project include the reclamation of AMLF No. 4769–07, a Priority 1 VO, which subsequently restored the diverted stream flow caused by the subsidence.
