# THE ENGINEER

## Blasting Vibrations and Building Damage

By T. D. NORTHWOOD,\* R. CRAWFORD\* and A. T. EDWARDS†

Building vibration and building damage resulting from blasting operations were studied in a series of experiments on expendable buildings. Sixty charges ranging from 0.3 lb to 1 600 lb were set off at distances of 3ft to 300ft from the buildings under study. For this range the primary evidence of damage was in basement walls. Observations were made of vibration displacement, velocity, acceleration and strain of the building structures. The results supported previous conclusions that particle velocity is the most useful indicator of the onset of damage.

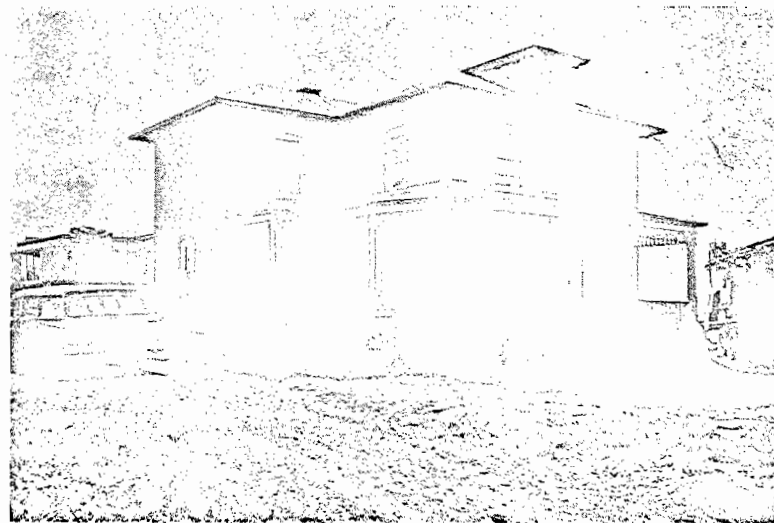
Fig. 1—One of six buildings used in Carillon studies

The new project was carried out in a region being levelled for use as a head pond for a hydro-electric plant at Carillon Falls on the Ottawa River. Several buildings earmarked for demolition were made available by the Quebec-Hydro Power Commission and the Hydro-Electric Power Commission of Ontario. The buildings selected were houses between thirty and seventy years old. The older houses were founded on glacial till consisting of sand with a large proportion of fair sized boulders; the newer buildings were founded on or very close to hard limestone bedrock overlain by a similar glacial till. The type of construction, particularly of the basements, varied with the age of the building. For all except one house of frame construction and one of stone masonry, the superstructure was 9in to 12in brickwork. The newer houses had solid concrete basements, whereas the older ones had basements constructed of uncut stones and mortar up to a thickness of 28in in some places. Apart from minor cracks, which were carefully documented prior to blasting, the houses selected were in fairly good condition with regard to masonry, brickwork, concrete and plaster. Foundations and footings, chimneys and roofs also were in good condition. Fig. 1 shows one of the houses studied.

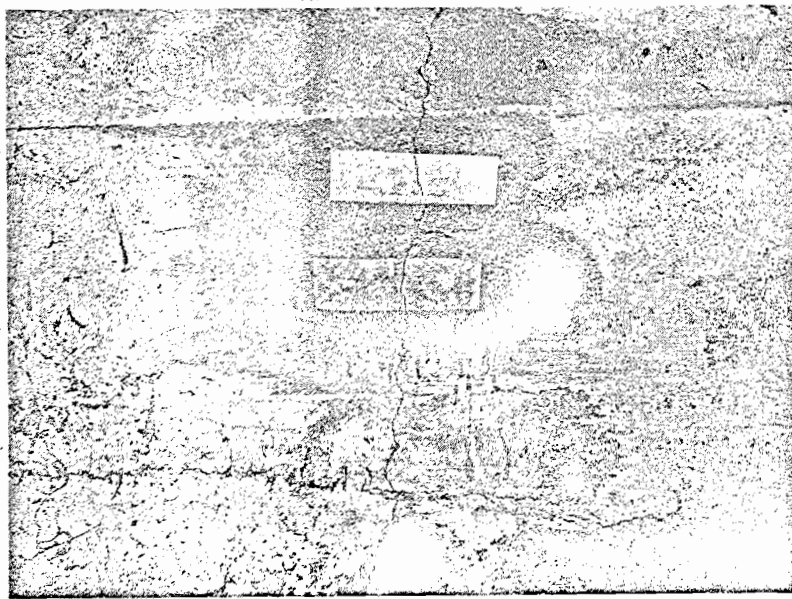
Fig. 2—Paper "telltale" used for indicating movement of old cracks. Second "telltale" was applied after first was partially torn.

Several types of observation were used to detect and assess damage. A close visual inspection for existing damage was made and photographs were taken before and after test shots to record damage. Strips of paper cemented over old cracks were used as indicators or "telltale" of movement (Fig. 2) and the lengths of cracks were noted. Plumb bobs and precise level measurements were employed in some of the buildings for indicating permanent deformation or settlement.

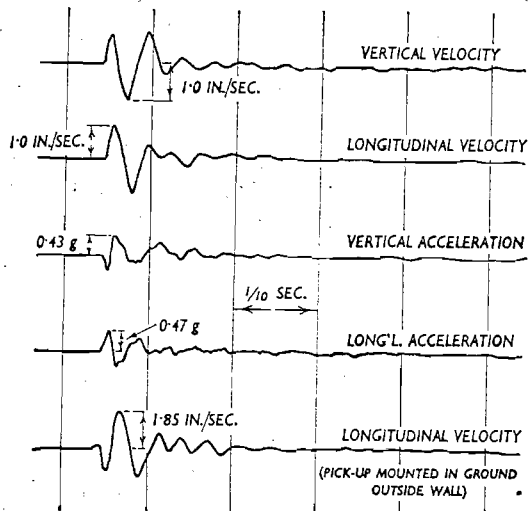
Fig. 4—Typical velocities and accelerations from a 100 lb charge at 300ft fired in rock. Transducers mounted on a concrete basement wall

The form of typical disturbances is illustrated in Figs. 4 to 6. The first of these shows longitudinal and vertical components of velocity and acceleration for the same blast, all observed on a basement wall, together with a velocity measurement from a stake driven into the ground beside the building. Generally the acceleration and velocity records were quite different, as in this case, although point-to-point differentiation of the velocity curves demonstrates that the corresponding records are consistent. Velocity curves are usually the simplest, consisting of a well-defined initial pulse followed by a quickly damped wave-train. Acceleration records are frequently complicated by sharp pulses of short duration followed by a slower wave-train. Velocity records obtained from stakes in the ground generally agreed reasonably well in waveform with the basement records, but amplitudes were usually larger.

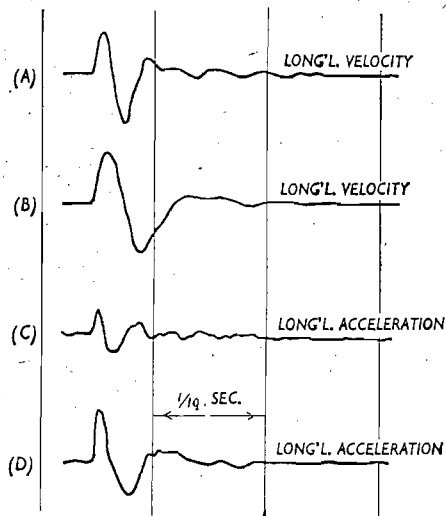
Fig. 5—Comparison of waveshape for different charges at same distance. Traces A and C, 100 lb at 300ft. Traces B and D, 600 lb at 300ft

Fig. 5 shows records for two different

charges at the same distance. This illustrates the general observation that the duration of the initial pulse (and usually of the whole disturbance) is longer for increased charge. This is further illustrated by Fig. 6, which shows the brief disturbance produced by a very small charge (at short distance).
