Subject: **Revised PNDI Review**

Map of Proposed ATWS and
Access Road

Adelphia Gateway Project
Quakertown ATWS and Access Road
Quakertown, PA

Re: Wetland Delineation
Quakertown Compressor Station Area Site
West Rockhill Township
Bucks County, Pennsylvania

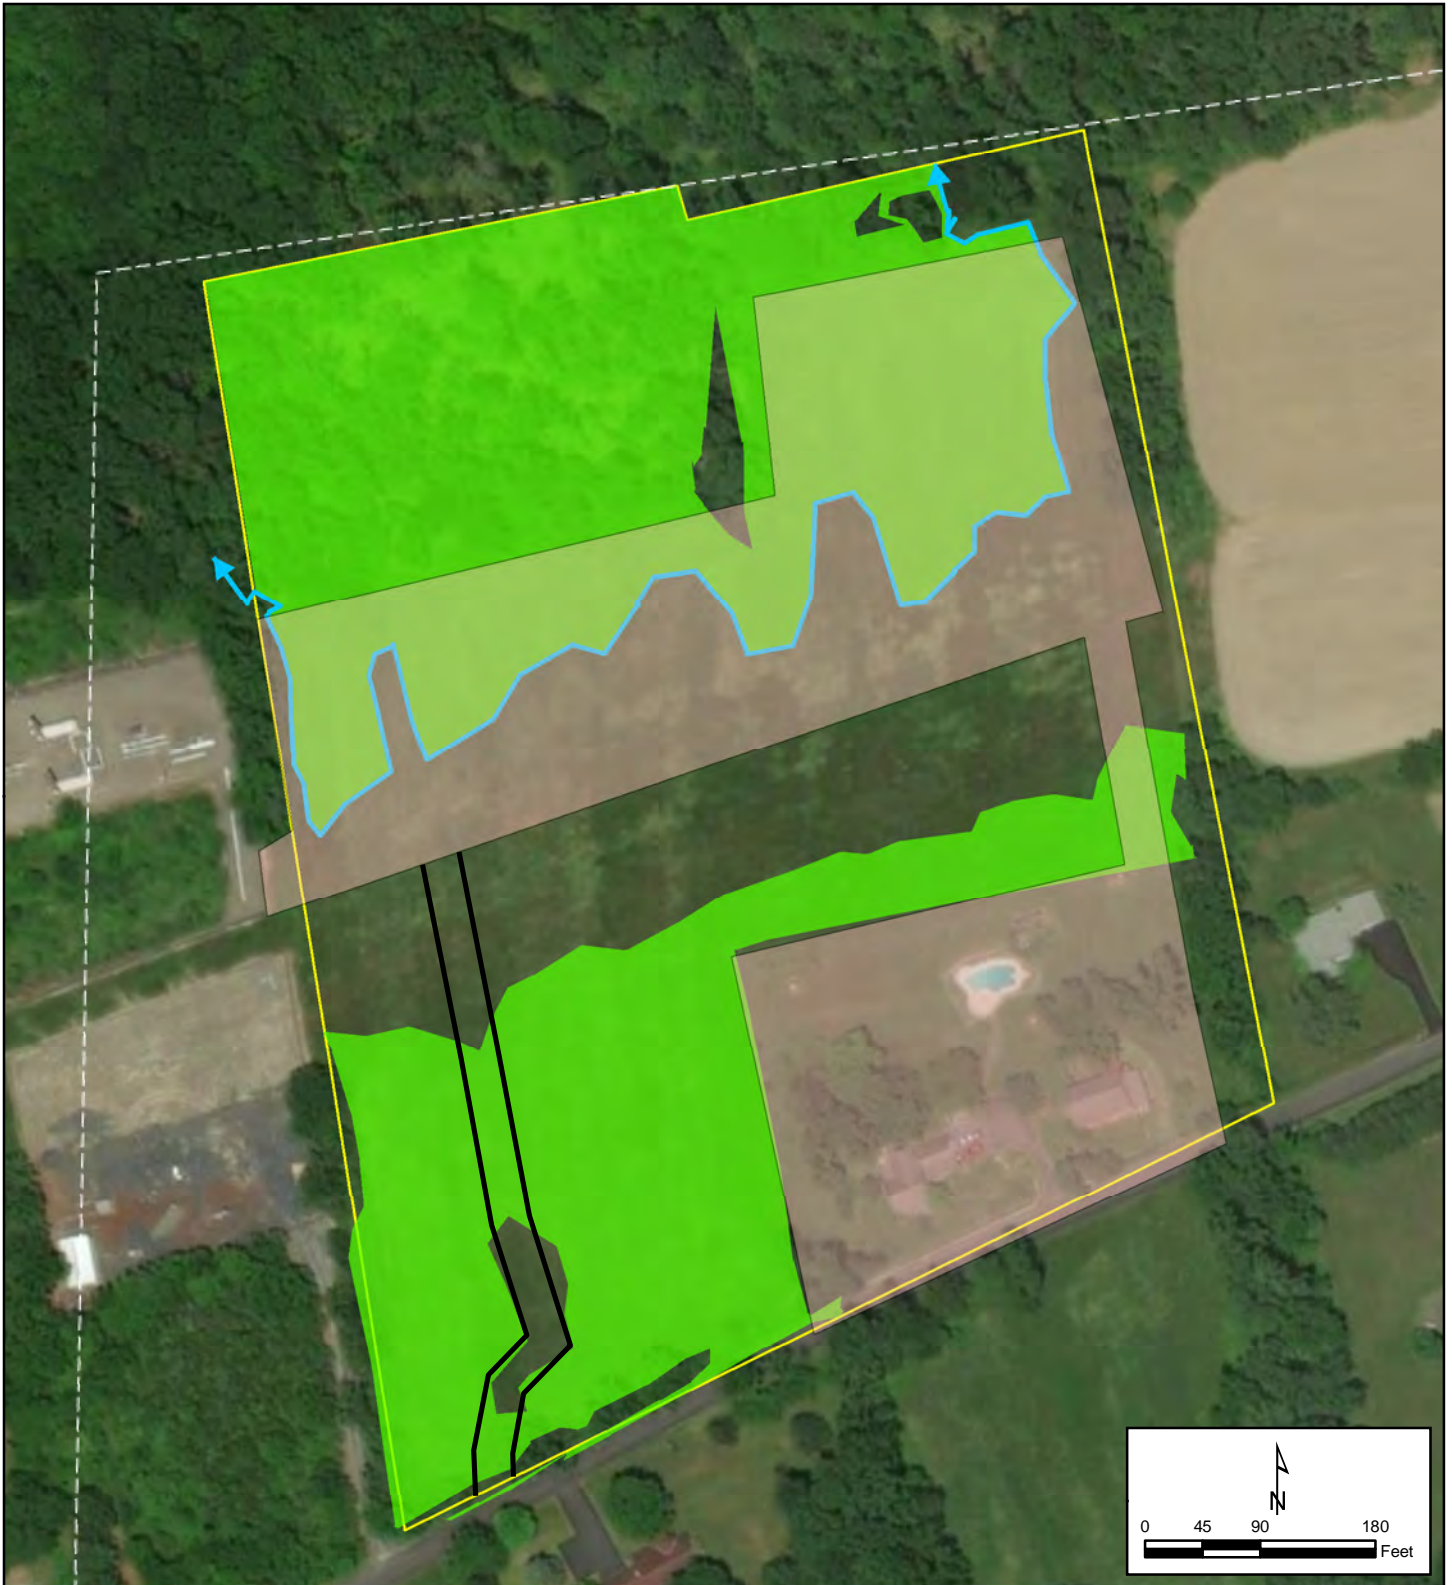
- Open Ended Wetland
- Proposed Additional Temporary Workspace
- Wetland
- Proposed Access Road

NV5, LLC conducted wetland and waterbody surveys at the site in July 2019 and identified two wetlands that would be crossed by the ATWS and access road. The ATWS would temporarily affect 2.1 acres of wetlands, and the access road would temporarily affect 0.2 acre of wetlands. There are no waterbodies at the site. NV5, LLC (on behalf of Adelpia) is requesting an additional Large Project PNDI review to confirm that your earlier determination is not affected. Appendix A contains a PNDI Review Form. Appendix B contains a map of the proposed ATWS and access road. Appendix C contains a summary of the wetland surveys conducted at the site.

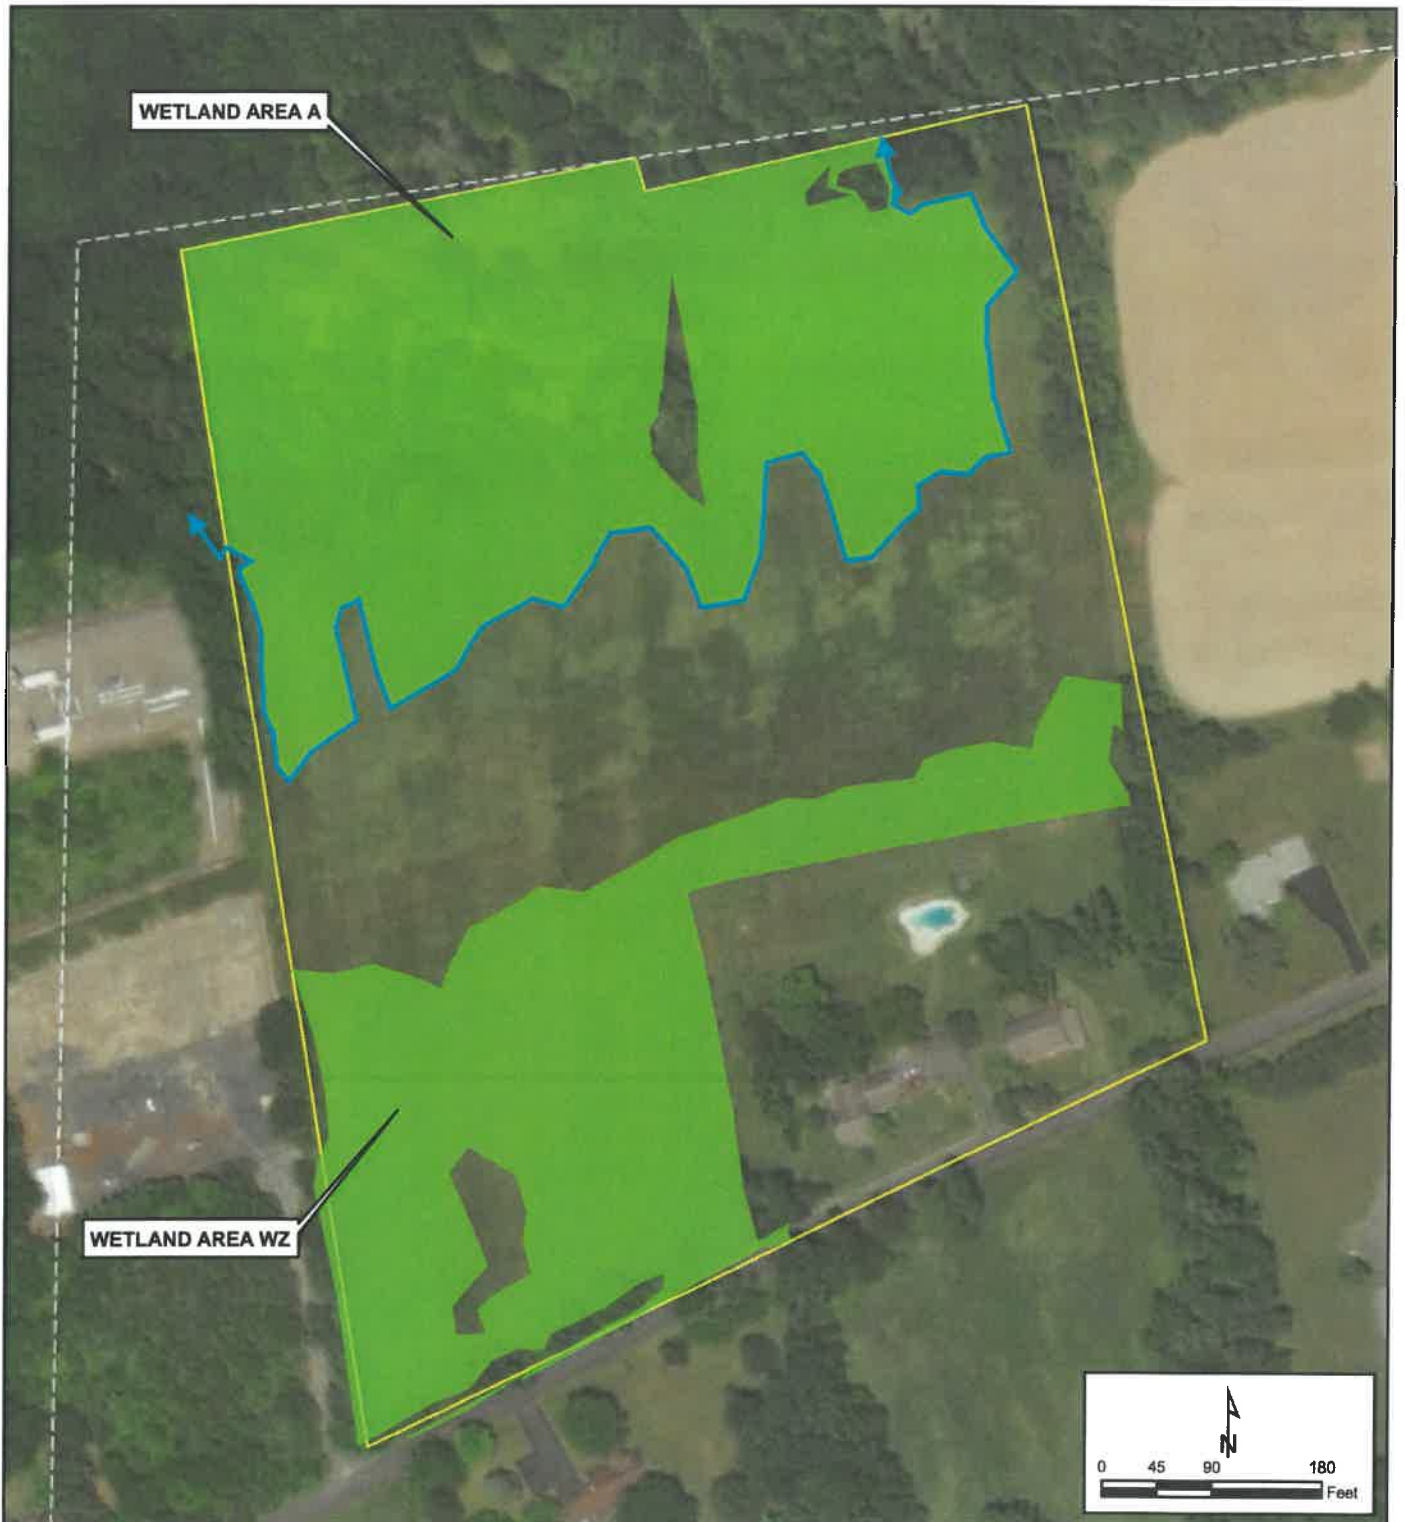
Site Map

LEGEND
 Open Ended Wetland Site Boundary
 Wetland

**Adelphia Gateway Project
 Environmental Survey Area
 Quakertown, PA**

Mr. Angus delineated two separate wetland areas:

- Wetland Area A (4.6 acres); and
- Wetland Area WZ (3.1 acres).

The wetlands are characterized by a dominance of hydrophytic vegetation, hydric soils, and presence of wetland hydrologic indicators. Upland areas lacked these characteristics. Attachment 1 includes a Map showing the wetland areas and upland inclusions at the Site.
