Re: NPDES Permit Modification Application (Permit No. PA0594121)

**Heidelberg Materials Northeast LLC**

Rock Hill Quarry Operation – SMP No. 7974SM1

East Rockhill Township, Bucks County EARTHRES Project No. 061003.052

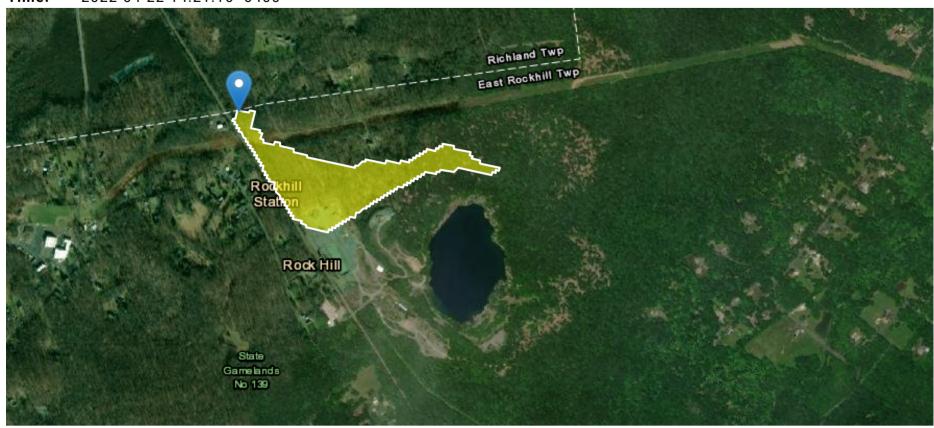
Clicked Point (Latitude, Longitude): 40.40944, -75.30806

#### **Basin Characteristics**

Parameter Code	Parameter Description	Value	Unit
BSLOPD	Mean basin slope measured in degrees	4.2196	degrees
CARBON	Percentage of area of carbonate rock	0	percent
DRNAREA	Area that drains to a point on a stream	0.0458	square miles
ELEV	Mean Basin Elevation	585	feet
FOREST	Percentage of area covered by forest	78.4148	percent
PRECIP	Mean Annual Precipitation	45	inches
ROCKDEP	Depth to rock	4	feet
URBAN	Percentage of basin with urban development	2.1079	percent

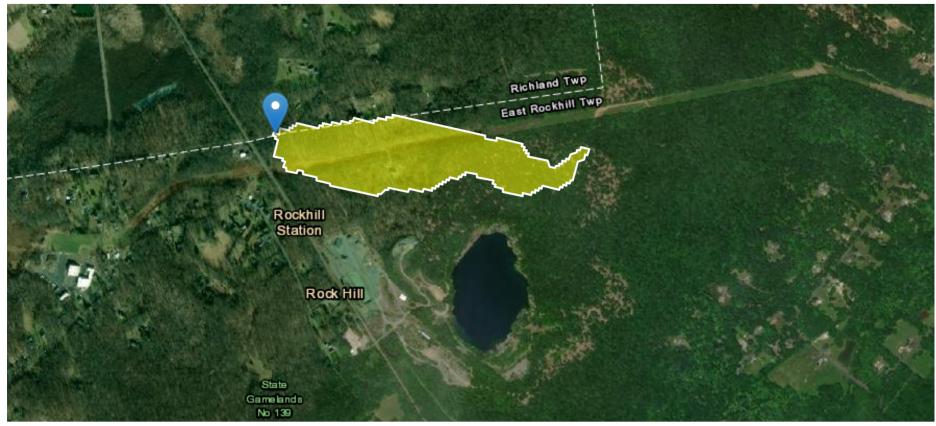
Clicked Point (Latitude, Longitude): 40.40964, -75.30751

#### **Basin Characteristics**

Parameter Code	Parameter Description	Value	Unit
BSLOPD	Mean basin slope measured in degrees	5.4081	degrees
CARBON	Percentage of area of carbonate rock	0	percent
DRNAREA	Area that drains to a point on a stream	0.0741	square miles
ELEV	Mean Basin Elevation	642	feet
FOREST	Percentage of area covered by forest	99.3747	percent
PRECIP	Mean Annual Precipitation	45	inches
ROCKDEP	Depth to rock	4	feet
URBAN	Percentage of basin with urban development	0	percent

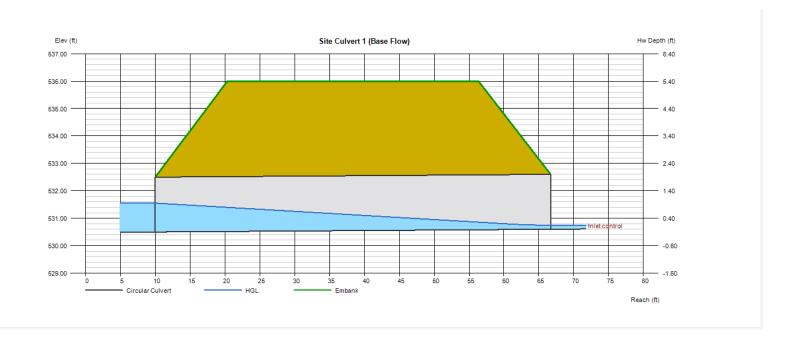
### Site Culvert 1 (Base Flow)

Invert Elev Dn (ft)	= 530.50	Calculations	
Pipe Length (ft)	= 56.70	Qmin (cfs)	= 0.09
Slope (%)	= 0.18	Qmax (cfs)	= 0.09
Invert Elev Up (ft)	= 530.60	Tailwater Elev (ft)	= (dc+D)/2
Rise (in)	= 24.0		
Shape	= Circular	Highlighted	
Span (in)	= 24.0	Qtotal (cfs)	= 0.09
No. Barrels	= 1	Qpipe (cfs)	= 0.09
n-Value	= 0.013	Qovertop (cfs)	= 0.00
Culvert Type	<ul><li>Circular Concrete</li></ul>	Veloc Dn (ft/s)	= 0.05
Culvert Entrance	<ul><li>= Groove end projecting (C)</li></ul>	Veloc Up (ft/s)	= 1.49
Coeff. K,M,c,Y,k	= 0.0045, 2, 0.0317, 0.69, 0.2	HGL Dn (ft)	= 531.55
		HGL Up (ft)	= 530.70
Embankment		Hw Elev (ft)	= 530.73
Top Elevation (ft)	= 536.00	Hw/D (ft)	= 0.07
Top Width (ft)	= 36.00	Flow Regime	= Inlet Control
Crest Width (ft)	= 100.00

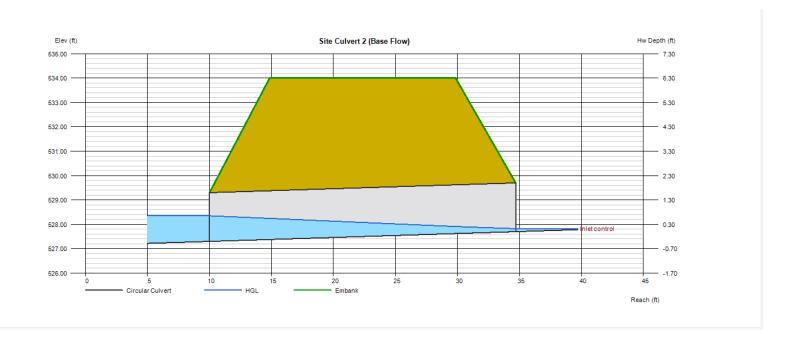
### Site Culvert 2 (Base Flow)

Invert Elev Dn (ft)	= 527.30	Calculations	
Pipe Length (ft)	= 24.70	Qmin (cfs)	= 0.09
Slope (%)	= 1.62	Qmax (cfs)	= 0.09
Invert Elev Up (ft)	= 527.70	Tailwater Elev (ft)	= (dc+D)/2
Rise (in)	= 24.0		
Shape	= Circular	Highlighted	
Span (in)	= 24.0	Qtotal (cfs)	= 0.09
No. Barrels	= 1	Qpipe (cfs)	= 0.09
n-Value	= 0.012	Qovertop (cfs)	= 0.00
Culvert Type	<ul><li>= Circular Culvert</li></ul>	Veloc Dn (ft/s)	= 0.05
Culvert Entrance	= Smooth tapered inlet throat	Veloc Up (ft/s)	= 1.49
Coeff. K,M,c,Y,k	= 0.534, 0.555, 0.0196, 0.9, 0.2	HGL Dn (ft)	= 528.35
		HGL Up (ft)	= 527.80
Embankment		Hw Elev (ft)	= 527.82
Top Elevation (ft)	= 534.00	Hw/D (ft)	= 0.06
Top Width (ft)	= 15.00	Flow Regime	= Inlet Control
Crest Width (ft)	= 100.00

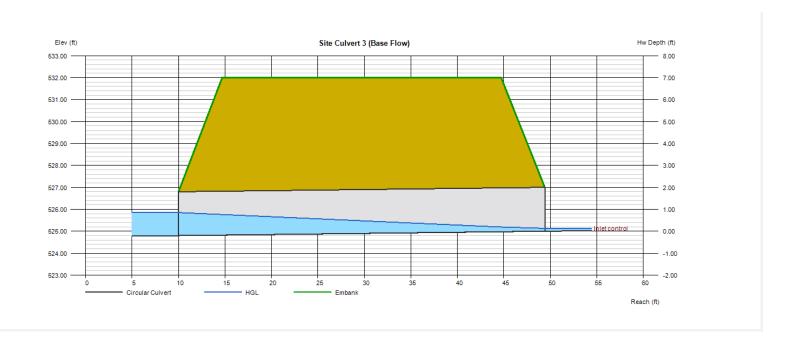
### Site Culvert 3 (Base Flow)

Invert Elev Dn (ft)	= 524.80	Calculations	
Pipe Length (ft)	= 39.40	Qmin (cfs)	= 0.09
Slope (%)	= 0.51	Qmax (cfs)	= 0.09
Invert Elev Up (ft)	= 525.00	Tailwater Elev (ft)	= (dc+D)/2
Rise (in)	= 24.0		
Shape	= Circular	Highlighted	
Span (in)	= 24.0	Qtotal (cfs)	= 0.09
No. Barrels	= 1	Qpipe (cfs)	= 0.09
n-Value	= 0.012	Qovertop (cfs)	= 0.00
Culvert Type	<ul><li>Circular Concrete</li></ul>	Veloc Dn (ft/s)	= 0.05
Culvert Entrance	<ul><li>= Groove end projecting (C)</li></ul>	Veloc Up (ft/s)	= 1.49
Coeff. K,M,c,Y,k	= 0.0045, 2, 0.0317, 0.69, 0.2	HGL Dn (ft)	= 525.85
		HGL Up (ft)	= 525.10
Embankment		Hw Elev (ft)	= 525.13
Top Elevation (ft)	= 532.00	Hw/D (ft)	= 0.07
Top Width (ft)	= 30.00	Flow Regime	= Inlet Control
Crest Width (ft)	= 100.00

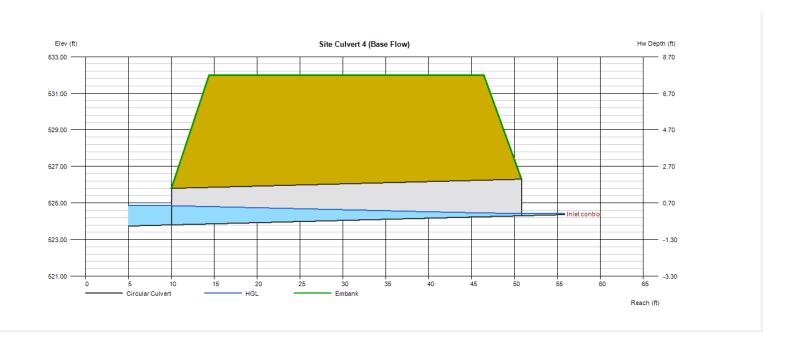
### Site Culvert 4 (Base Flow)

Invert Elev Dn (ft)	= 523.80	Calculations	
Pipe Length (ft)	= 40.80	Qmin (cfs)	= 0.09
Slope (%)	= 1.23	Qmax (cfs)	= 0.09
Invert Elev Up (ft)	= 524.30	Tailwater Elev (ft)	= (dc+D)/2
Rise (in)	= 24.0		
Shape	= Circular	Highlighted	
Span (in)	= 24.0	Qtotal (cfs)	= 0.09
No. Barrels	= 1	Qpipe (cfs)	= 0.09
n-Value	= 0.012	Qovertop (cfs)	= 0.00
Culvert Type	<ul><li>= Circular Culvert</li></ul>	Veloc Dn (ft/s)	= 0.05
Culvert Entrance	= Smooth tapered inlet throat	Veloc Up (ft/s)	= 1.49
Coeff. K,M,c,Y,k	= 0.534, 0.555, 0.0196, 0.9, 0.2	HGL Dn (ft)	= 524.85
		HGL Up (ft)	= 524.40
Embankment		Hw Elev (ft)	= 524.42
Top Elevation (ft)	= 532.00	Hw/D (ft)	= 0.06
Top Width (ft)	= 32.00	Flow Regime	= Inlet Control
Crest Width (ft)	= 100.00

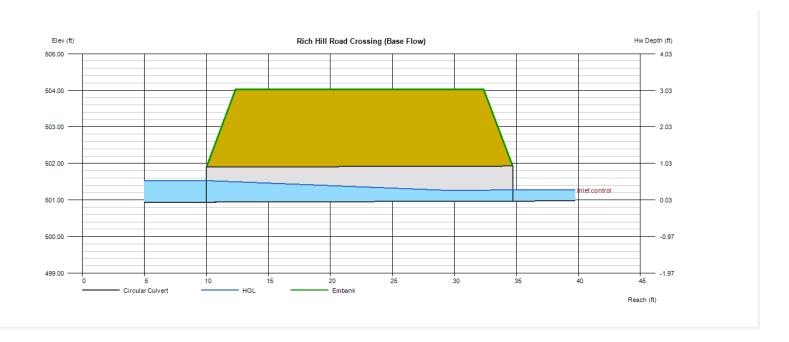
## Rich Hill Road Crossing (Base Flow)

Invert Elev Dn (ft)	= 500.94	Calculations	
Pipe Length (ft)	= 24.70	Qmin (cfs)	= 0.28
Slope (%)	= 0.12	Qmax (cfs)	= 0.28
Invert Elev Up (ft)	= 500.97	Tailwater Elev (ft)	= (dc+D)/2
Rise (in)	= 11.5		
Shape	= Circular	Highlighted	
Span (in)	= 11.5	Qtotal (cfs)	= 0.28
No. Barrels	= 1	Qpipe (cfs)	= 0.28
n-Value	= 0.012	Qovertop (cfs)	= 0.00
Culvert Type	<ul> <li>Circular Corrugate Metal Pipe</li> </ul>	Veloc Dn (ft/s)	= 0.60
Culvert Entrance	= Projecting	Veloc Up (ft/s)	= 2.24
Coeff. K,M,c,Y,k	= 0.034, 1.5, 0.0553, 0.54, 0.9	HGL Dn (ft)	= 501.53
		HGL Up (ft)	= 501.19
Embankment		Hw Elev (ft)	= 501.28
Top Elevation (ft)	= 504.03	Hw/D (ft)	= 0.32
Top Width (ft)	= 20.00	Flow Regime	= Inlet Control
Crest Width (ft)	= 100.00

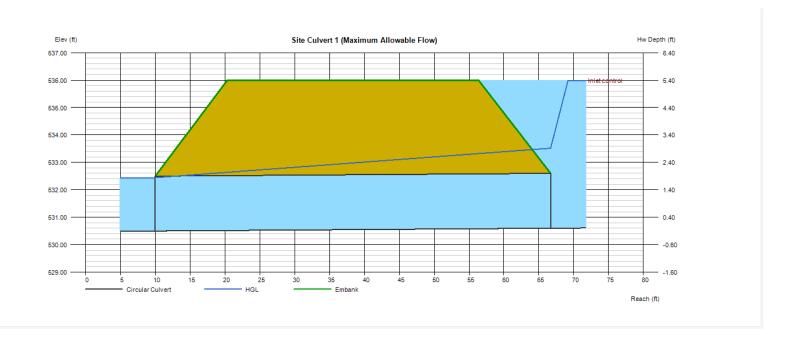
## Site Culvert 1 (Maximum Allowable Flow)

Invert Elev Dn (ft)	= 530.50	Calculations	
Pipe Length (ft)	= 56.70	Qmin (cfs)	= 31.70
Slope (%)	= 0.18	Qmax (cfs)	= 31.70
Invert Elev Up (ft)	= 530.60	Tailwater Elev (ft)	= (dc+D)/2
Rise (in)	= 24.0		
Shape	= Circular	Highlighted	
Span (in)	= 24.0	Qtotal (cfs)	= 31.70
No. Barrels	= 1	Qpipe (cfs)	= 31.70
n-Value	= 0.013	Qovertop (cfs)	= 0.00
Culvert Type	<ul><li>Circular Concrete</li></ul>	Veloc Dn (ft/s)	= 10.17
Culvert Entrance	<ul><li>Square edge w/headwall (C)</li></ul>	Veloc Up (ft/s)	= 10.09
Coeff. K,M,c,Y,k	= 0.0098, 2, 0.0398, 0.67, 0.5	HGL Dn (ft)	= 532.44
		HGL Up (ft)	= 533.52
Embankment		Hw Elev (ft)	= 535.99
Top Elevation (ft)	= 536.00	Hw/D (ft)	= 2.70
Top Width (ft)	= 36.00	Flow Regime	= Inlet Control
Crest Width (ft)	= 100.00

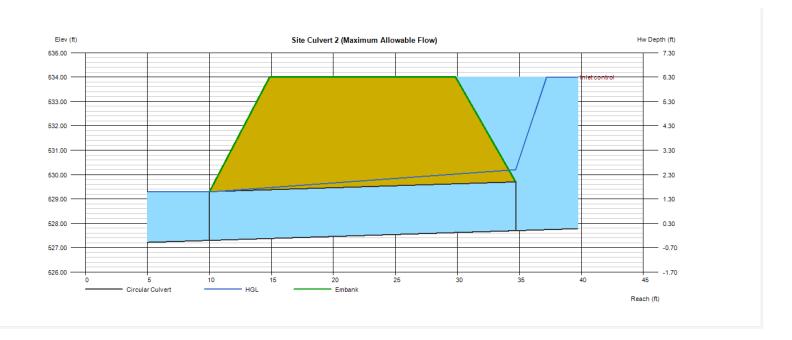
## Site Culvert 2 (Maximum Allowable Flow)

Invert Elev Dn (ft)	= 527.30	Calculations	
Pipe Length (ft)	= 24.70	Qmin (cfs)	= 47.70
Slope (%)	= 1.62	Qmax (cfs)	= 47.70
Invert Elev Up (ft)	= 527.70	Tailwater Elev (ft)	= (dc+D)/2
Rise (in)	= 24.0		
Shape	= Circular	Highlighted	
Span (in)	= 24.0	Qtotal (cfs)	= 47.70
No. Barrels	= 1	Qpipe (cfs)	= 47.70
n-Value	= 0.012	Qovertop (cfs)	= 0.00
Culvert Type	<ul><li>= Circular Culvert</li></ul>	Veloc Dn (ft/s)	= 15.20
Culvert Entrance	= Smooth tapered inlet throat	Veloc Up (ft/s)	= 15.18
Coeff. K,M,c,Y,k	= 0.534, 0.555, 0.0196, 0.9, 0.2	HGL Dn (ft)	= 529.29
		HGL Up (ft)	= 530.20
Embankment		Hw Elev (ft)	= 534.00
Top Elevation (ft)	= 534.00	Hw/D (ft)	= 3.15
Top Width (ft)	= 15.00	Flow Regime	= Inlet Control
Crest Width (ft)	= 100.00

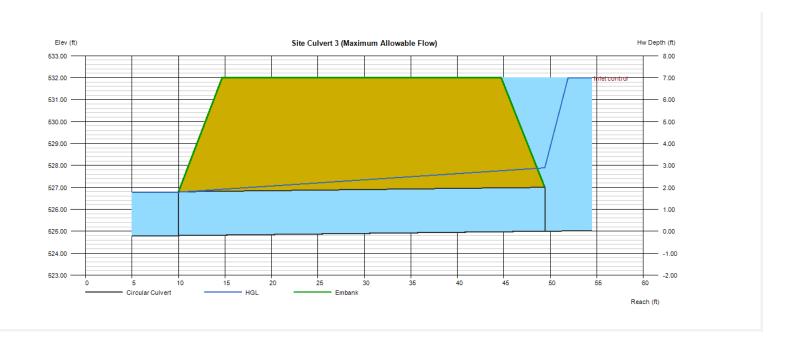
## Site Culvert 3 (Maximum Allowable Flow)

Invert Elev Dn (ft)	= 524.80	Calculations	
Pipe Length (ft)	= 39.40	Qmin (cfs)	= 41.80
Slope (%)	= 0.51	Qmax (cfs)	= 41.80
Invert Elev Up (ft)	= 525.00	Tailwater Elev (ft)	= (dc+D)/2
Rise (in)	= 24.0		
Shape	= Circular	Highlighted	
Span (in)	= 24.0	Qtotal (cfs)	= 41.80
No. Barrels	= 1	Qpipe (cfs)	= 41.80
n-Value	= 0.012	Qovertop (cfs)	= 0.00
Culvert Type	= Circular Concrete	Veloc Dn (ft/s)	= 13.33
Culvert Entrance	= Groove end projecting (C)	Veloc Up (ft/s)	= 13.31
Coeff. K,M,c,Y,k	= 0.0045, 2, 0.0317, 0.69, 0.2	HGL Dn (ft)	= 526.78
		HGL Up (ft)	= 527.89
Embankment		Hw Elev (ft)	= 531.99
Top Elevation (ft)	= 532.00	Hw/D (ft)	= 3.49
Top Width (ft)	= 30.00	Flow Regime	= Inlet Control
Crest Width (ft)	= 100.00

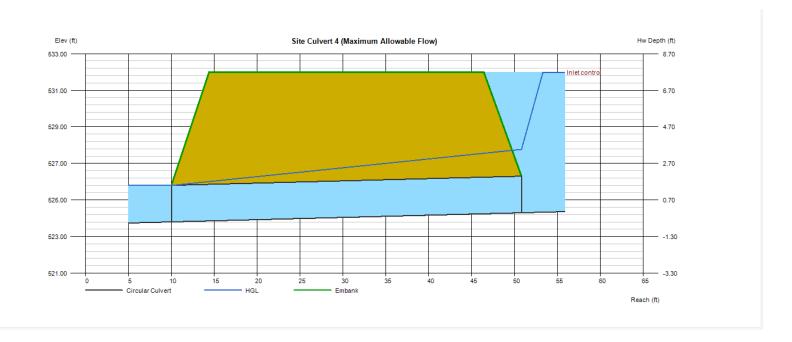
## Site Culvert 4 (Maximum Allowable Flow)

= 523.80	Calculations	
= 40.80	Qmin (cfs)	= 54.50
= 1.23	Qmax (cfs)	= 54.50
= 524.30	Tailwater Elev (ft)	= (dc+D)/2
= 24.0		
= Circular	Highlighted	
= 24.0	Qtotal (cfs)	= 54.50
= 1	Qpipe (cfs)	= 54.50
= 0.012	Qovertop (cfs)	= 0.00
<ul><li>Circular Culvert</li></ul>	Veloc Dn (ft/s)	= 17.35
= Smooth tapered inlet throat	Veloc Up (ft/s)	= 17.35
= 0.534, 0.555, 0.0196, 0.9, 0.2	HGL Dn (ft)	= 525.79
	HGL Up (ft)	= 527.77
	Hw Elev (ft)	= 531.99
= 532.00	Hw/D (ft)	= 3.84
= 32.00	Flow Regime	= Inlet Control
= 100.00		
	= 40.80 = 1.23 = 524.30 = 24.0 = Circular = 24.0 = 1 = 0.012 = Circular Culvert = Smooth tapered inlet throat = 0.534, 0.555, 0.0196, 0.9, 0.2 = 532.00 = 32.00	= 40.80 Qmin (cfs) = 1.23 Qmax (cfs) = 524.30 Tailwater Elev (ft) = 24.0 = Circular Highlighted = 24.0 Qtotal (cfs) = 1 Qpipe (cfs) = 0.012 Qovertop (cfs) = Circular Culvert Veloc Dn (ft/s) = Smooth tapered inlet throat Veloc Up (ft/s) = 0.534, 0.555, 0.0196, 0.9, 0.2 HGL Dn (ft) HGL Up (ft) HW Elev (ft)  = 532.00 Hw/D (ft) Flow Regime

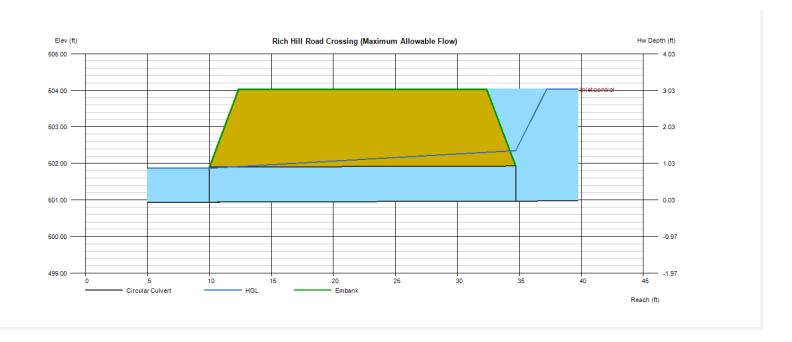
## Rich Hill Road Crossing (Maximum Allowable Flow)

Invert Elev Dn (ft)	= 500.94	Calculations	
Pipe Length (ft)	= 24.70	Qmin (cfs)	= 4.89
Slope (%)	= 0.12	Qmax (cfs)	= 4.89
Invert Elev Up (ft)	= 500.97	Tailwater Elev (ft)	= (dc+D)/2
Rise (in)	= 11.5		
Shape	= Circular	Highlighted	
Span (in)	= 11.5	Qtotal (cfs)	= 4.89
No. Barrels	= 1	Qpipe (cfs)	= 4.89
n-Value	= 0.012	Qovertop (cfs)	= 0.00
Culvert Type	<ul> <li>Circular Corrugate Metal Pipe</li> </ul>	Veloc Dn (ft/s)	= 6.84
Culvert Entrance	= Projecting	Veloc Up (ft/s)	= 6.78
Coeff. K,M,c,Y,k	= 0.034, 1.5, 0.0553, 0.54, 0.9	HGL Dn (ft)	= 501.87
		HGL Up (ft)	= 502.35
Embankment		Hw Elev (ft)	= 504.03
Top Elevation (ft)	= 504.03	Hw/D (ft)	= 3.19
Top Width (ft)	= 20.00	Flow Regime	= Inlet Control
Crest Width (ft)	= 100.00
