NARRATIVE REPORT FORM

Facility Name: Glenwood Drive and Walker Road

Primary Facility ID: 881609 _____

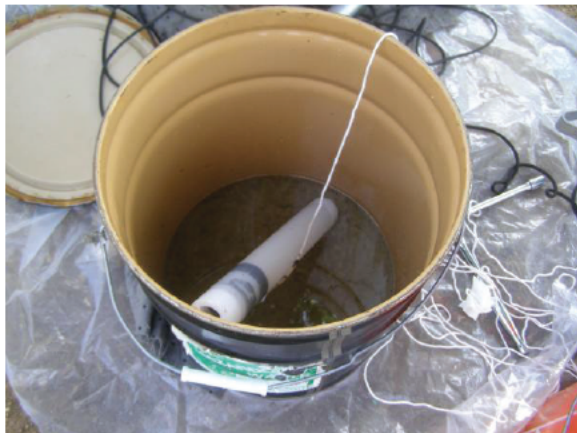
- I arrived after the gauging and bailing occurred.
- Was informed that the residence was gauged and bailed on Sunday June 29, 2025.
- A LNAPL sample was collected to be analyzed.
- There was a new riser and well pump installed on Friday June 27, 2025.
- RETTEW was at the residence to get the GPS readings of the new riser of the well.

LNAPL in bailed water from well at [REDACTED]
 6-30-25

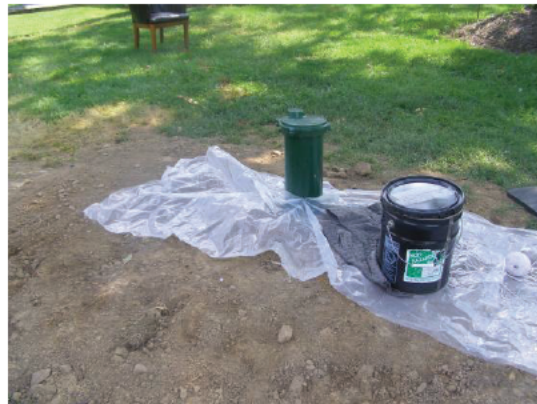
New potable well riser at [REDACTED]
 6-30-25

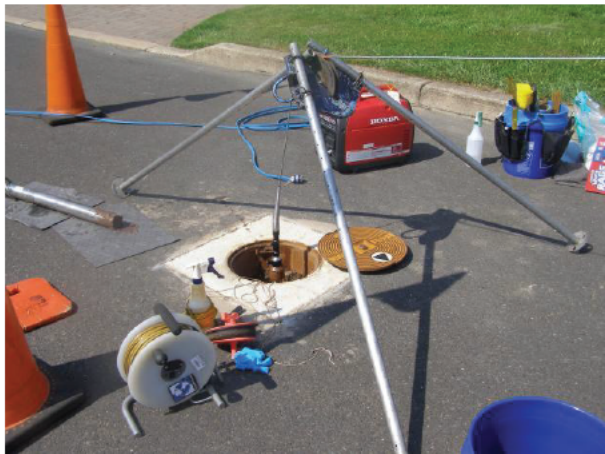
- He stated that seismic refraction was being conducted on profile #3 today and #4 tomorrow. Profiles 0-2 and 5-6 were previously conducted.
- UV Sonde was being performed on recovery wells RW-2, RW-3, and RW-4.

Probe with UV light being lowered into Recovery Well RW-4 on
 Glenwood Drive
 6-30-25

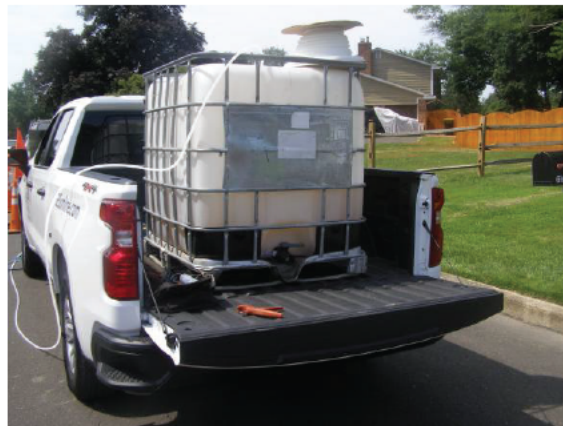
Tote where water from recovery wells was pumped prior to using UV
 light
 6-30-25
