NARRATIVE REPORT FORM

Facility Name: Glenwood Drive & Walker Road Primary Facility ID: 881609

- Purpose of visit: Observe installation of monitoring wells along Glenwood Drive
- Weather: Overcast to Sunny; 80s to 90s
- Crews onsite: Energy Transfer/Sunoco; GES; Stantec; Environmental Noise Control; Summit Drilling; Anson Construction

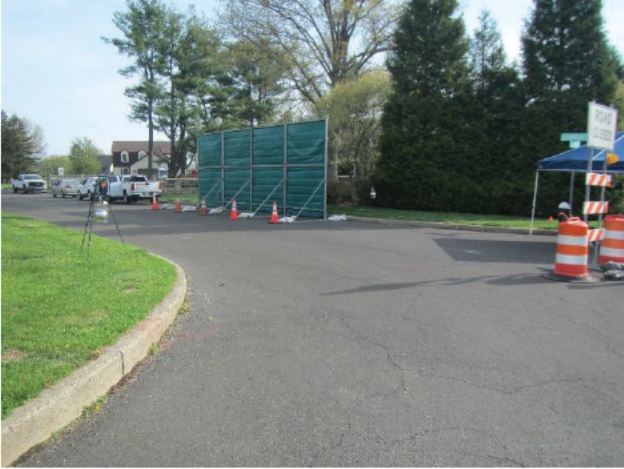
- 8:45 – DEP onsite at intersection of Glenwood Drive and Walker Road; road closure setup on Glenwood Drive with sound barriers setup. No drill crew visible.

Sound barrier and road closure at intersection of Glenwood Drive and Walker Road.

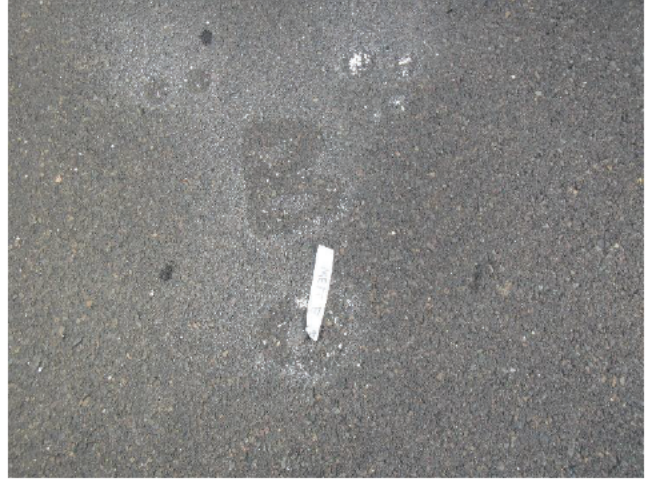
Proposed well locations marked with paint and flagging.

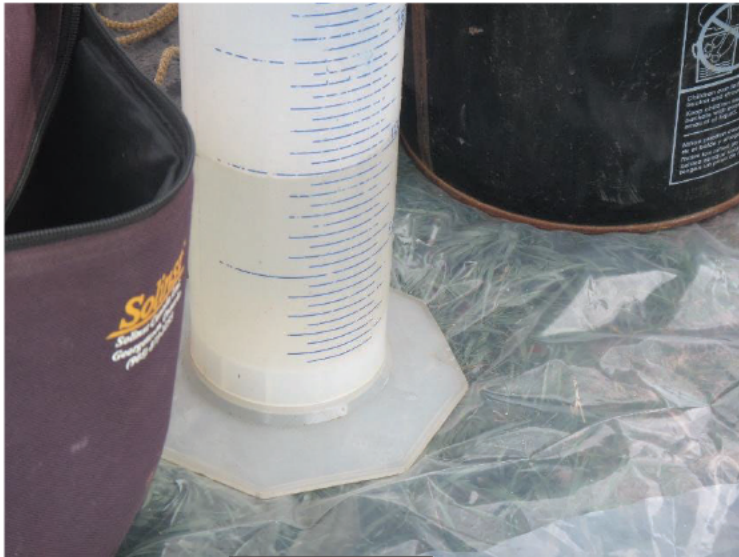
- 9:19 – The second GES crew gauges the [REDACTED] potable well. 145.8ppm PID reading, Depth to water – 28.72ft, and no LNAPL detected. They still bailed the well to check for product. Approximately 1000mL of water bailed with no product visible. Depth to water after bailing is 29.05ft.

Bailed water from [redacted] potable well gauging. No product seen.

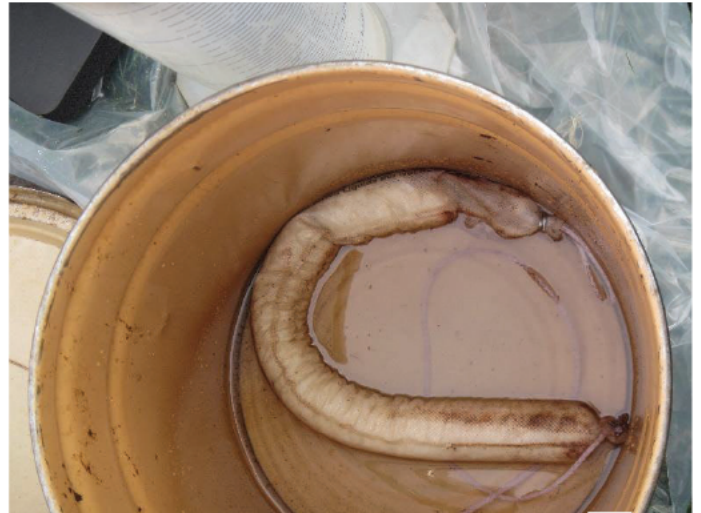
- 9:30 – The second GES crew gauges the potable well at [REDACTED]. 33.8ppm PID reading, Depth to water – 29.61 ft, and no LNAPL detected. The absorbent sock was removed and replaced. Depth to water after sock removal was 29.06ft.

Absorbent sock removed during gauging of [redacted] potable well.

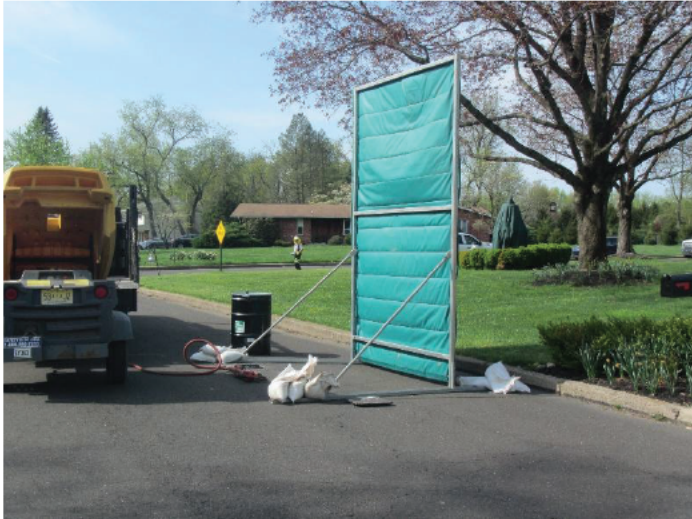
- 9:50 – The sound barrier is moved from Well C location to Well B location. There are issues with the utility markouts near the Well C locations. The mark out lines are faded and were not re-sprayed. GES/Summit are calling to have an emergency markout completed to confirm the location of utility lines near the Well C location. Hand clearing of Well B location will begin instead.

Sound barrier setup at Well B location prior to hand clearing.

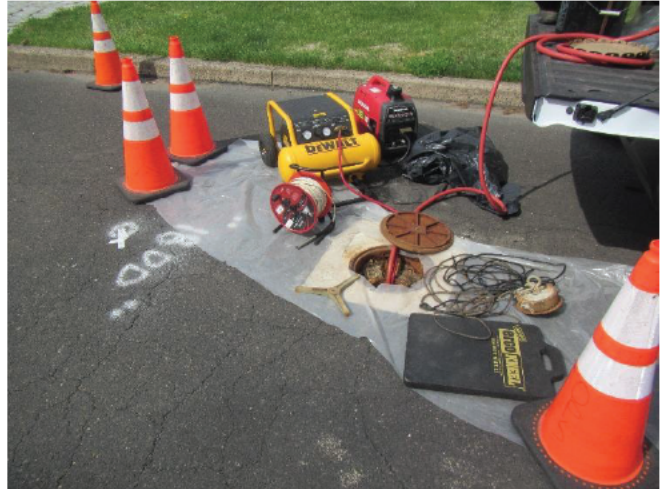
- 10:30 – Second GES crew begins setting up to pump RW-2.
- 10:35 – The second GES crew begins pumping RW-2. GES removed the sock in RW-2 prior to pumping. The sock was 100% saturated with product.

- 13:25 – The second GES crew finished pumping RW-2 and removed approximately 180 gallons of liquid. There was possible sheen/product in the tank from pumping. The crew is moving to pump RW-3.

Pumping setup at RW-2 with proposed MW-18DD visible.

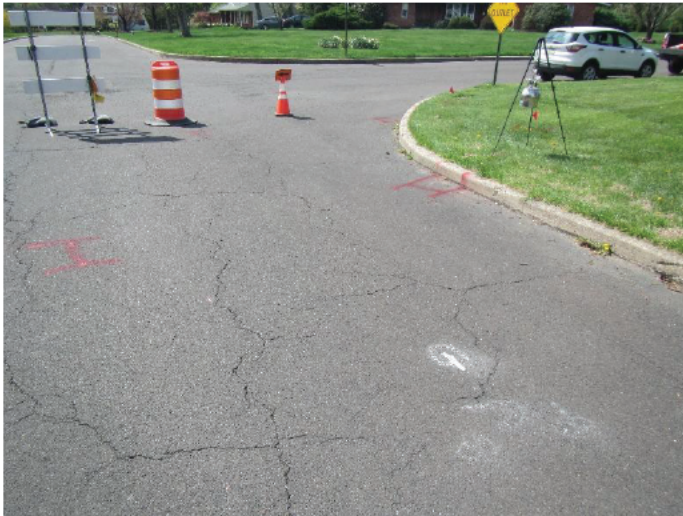
- 11:00 – Utility markout crew onsite to re-mark utilities in the vicinity of the Well C location.
- 11:50 – Summit reached approximately 3ft below ground surface at Well B location using a combination of air knifing, hand augur, post hole digger, and breaker bar.

Re-marked underground utilities in the vicinity of Well C.

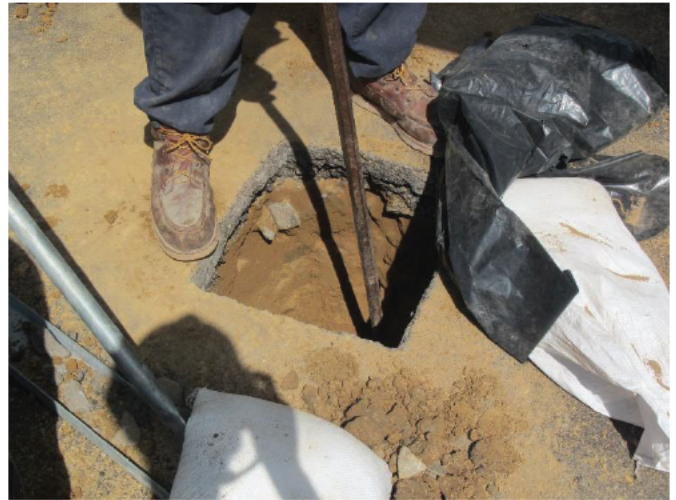
- 14:00 – GES grabs soil from around 2ft below grade at the Well C location. There were no PID detections from the soil.
- 15:10 – Summit hits rock in the Well C location at 44 inches below grade. GES grabs some of the soil and screened it with a PID. No PID readings were seen from the soil.

Hand clearing of Well C.

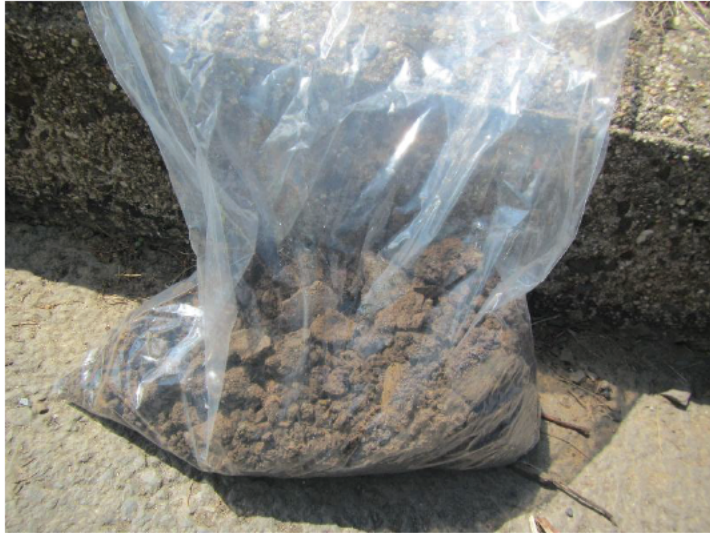
Soil from 2ft below grade from Well C.

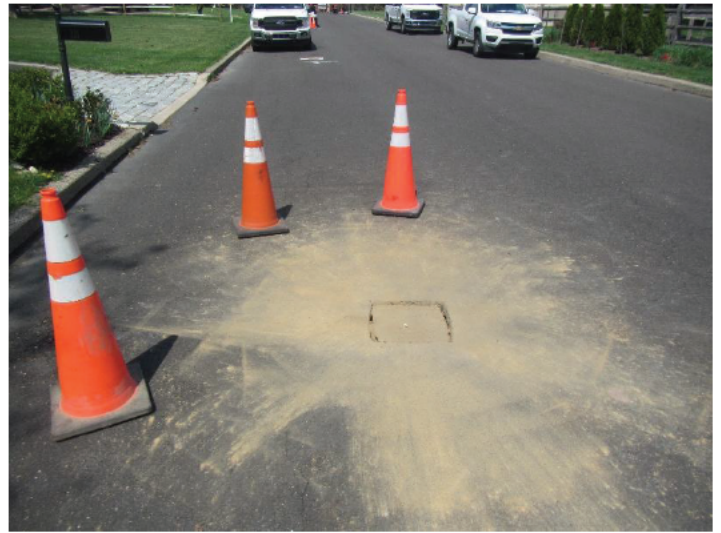
- 12:05 – DEP heads offsite while Summit is still clearing Well B location.
- 13:15 – DEP back onsite. Summit is now clearing the Well C location. Weathered rock was encountered at around 3ft below grade at the Well B location preventing further hand clearing. The hole was backfilled with the soil removed during the hand clearing and topped with the piece of asphalt that was removed initially. No other surface covering is being used for overnight according to GES.

Well B location after completion of hand clearing.
