NARRATIVE REPORT FORM

Facility Name: Glenwood Drive & Walker Road Primary Facility ID: 881609

- Purpose of visit: Observe installation of monitoring wells along Glenwood Drive
- Weather: Cloudy 50s to 60s
- Crews onsite: Energy Transfer/Sunoco; GES; Stantec; Environmental Noise Control; Summit Drilling; Anson Construction

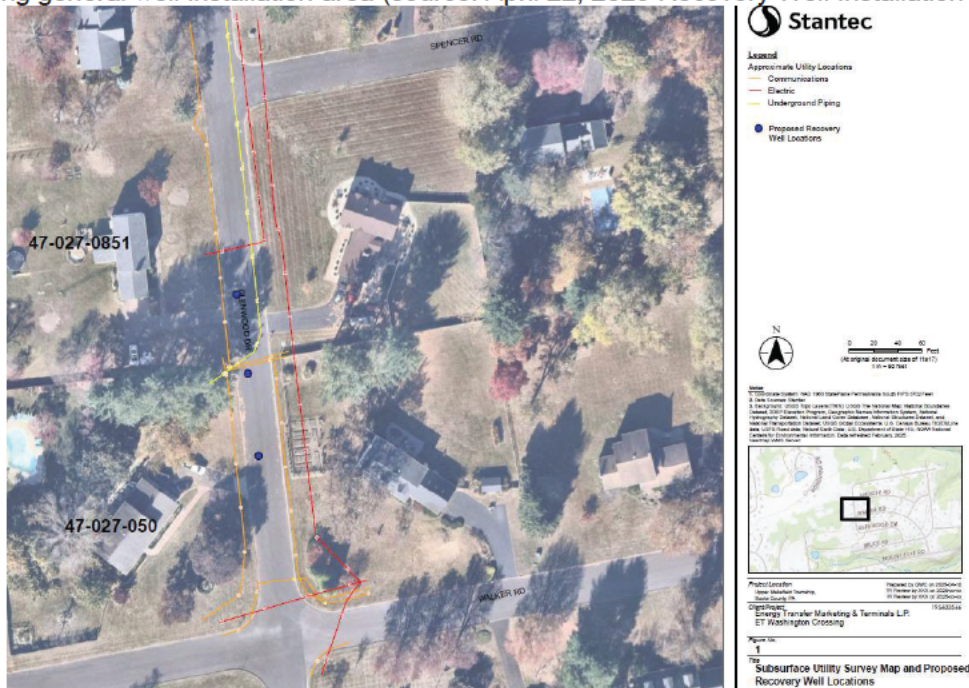
Map showing general well installation area (source: April 22, 2025 Recovery Well Installation Work Plan)

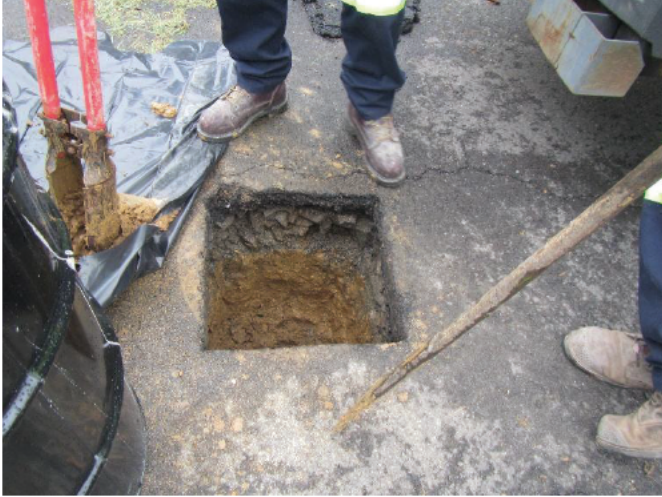
Hand clearing of MW-17DD prior to drilling.

- 9:35 – Summit finishes hand clearing MW-17DD to approximately 3.2ft before hitting weathered rock. Summit begins to prep for drilling.
- 9:40 – Nancy from ET let DEP know that they notified the township and bus company that drilling on Glenwood Drive will continue past May 1st.

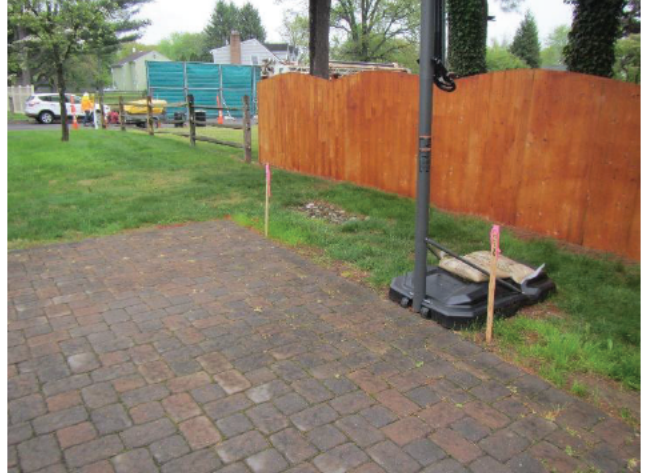
Proposed MW-15S and MW-15D well locations.

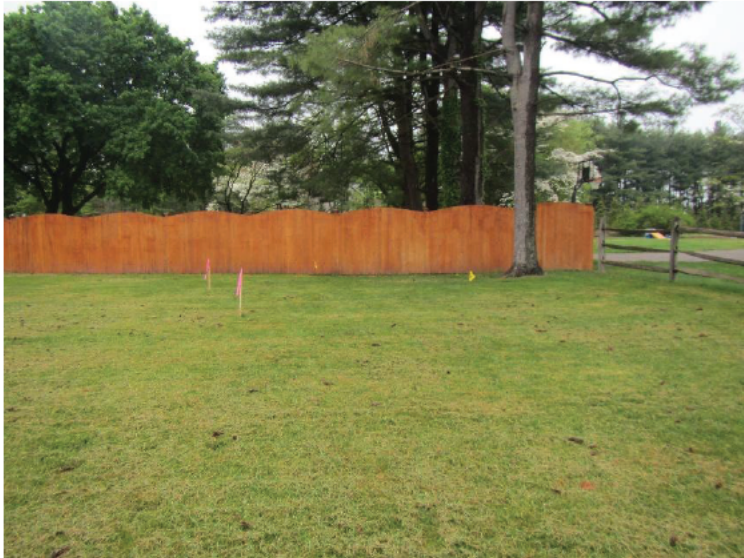
Proposed Well A and MW-16DD locations.

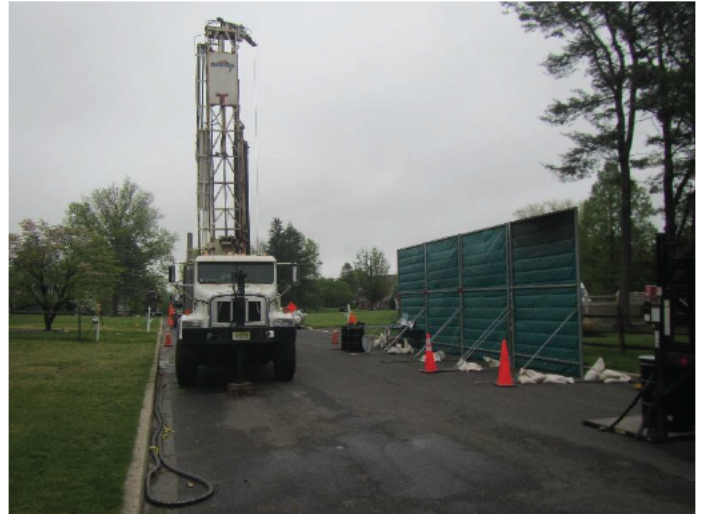
Drill rig set up on MW-17DD.

- 10:12 – Summit finishes getting the drill rig set up on MW-17DD.
- 10:15 – A second GES crew begins gauging wells along Glenwood Drive. Well C: depth to water is 24.35ft with no measurable LNAPL. The dedicated groundwater pump fell down the well while gauging and will need to be removed.

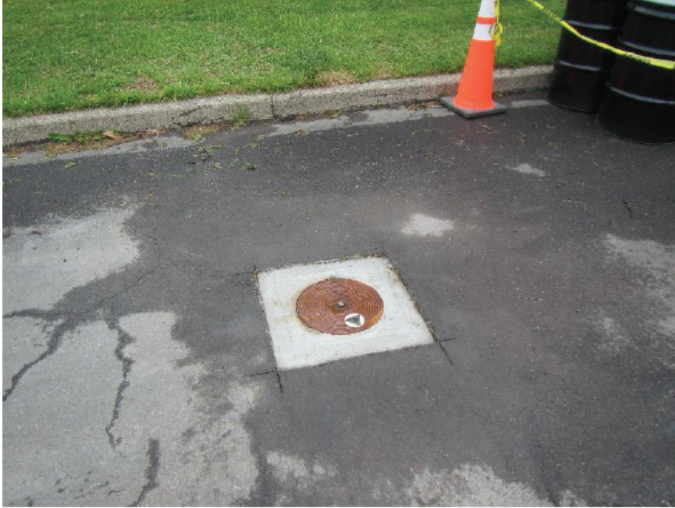
Completed flush mounted Well C.

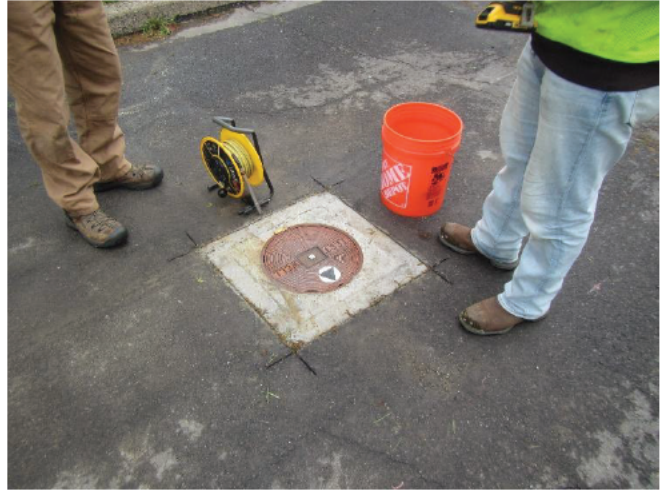
Completed flush mounted Well B.

- 10:18 – GES gauges Well B. Depth to water is 31.90ft with no measurable LNAPL.
- 10:19 – GES gauges RW-2. Depth to water is 24.70ft with no measurable LNAPL.

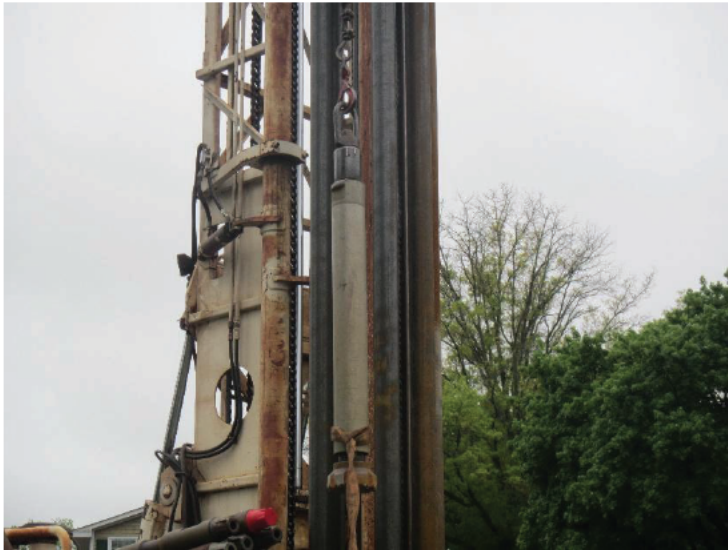
Drill head being connected to the drill rig.

- 11:40 – Summit finishes attaching the 10in cutting head onto the drill rig.
- 12:13 – Summit begins drilling MW-17DD after taking a break.
- 12:16 – Summit stops drilling to top off sand and bentonite in the annular space of the temporary casing.

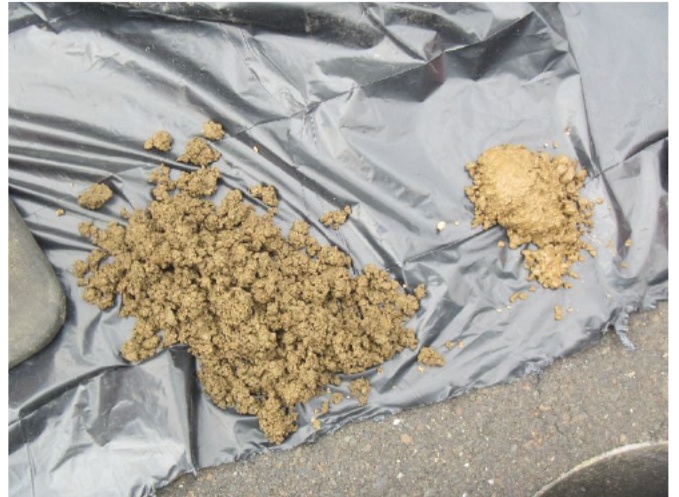
Rock chips from 5 feet (left) and 10 feet (right) collected while drilling MW-17DD.

- 12:53 – The drill rig shuts off while drilling for an unknown reason. However, the rig restarts with no issues.
- 12:54 – Petroleum like odor is noticeable while drilling. PID readings of up to 18ppm are also noted between 6 and 10 feet below ground surface.

- 12:58 – PID readings continue between 20 and 50ppm while drilling between 10 and 15 feet below ground surface. Summit begins adding water while drilling for dust suppression.
