NARRATIVE REPORT FORM

Facility Name: Glenwood Drive and Walker Road

Inspection Date: 5/26/26		Inspection Time: am		Lat/Long:																																											
Program: ECB		<input type="checkbox"/> Storage Tanks		<input type="checkbox"/> HSCA																																											
				<input checked="" type="checkbox"/> LRP																																											
Owner Name: Energy Transfer			Inspection ID:		Site ID:																																										
Facility Location (911) Address: Glenwood Drive and Walker Road Washington Crossing, PA 18977				Municipality: Upper Makefield Twp.																																											
				County: Bucks																																											
Responsible Official Name: Brad Fish				Responsible Official Address:																																											
Title: Senior Environmental Specialist Emergency Response & Remediation				100 Green Street Marcus Hook, PA 19061																																											
Responsible Official Telephone: 610-859-6297																																															
Email Address: bradford.fish@energytransfer.com																																															
Entities Present:

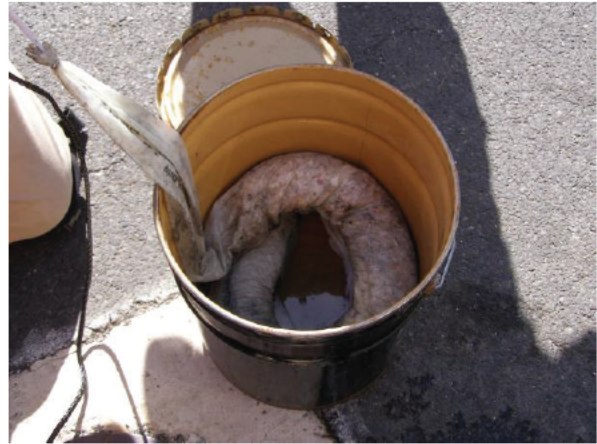
- Contained a sock.
- A LNAPL sample was collected at 10:30.
- A new sock was installed.

Absorbent sock from RW-3
 5-26-26 @ 9:47

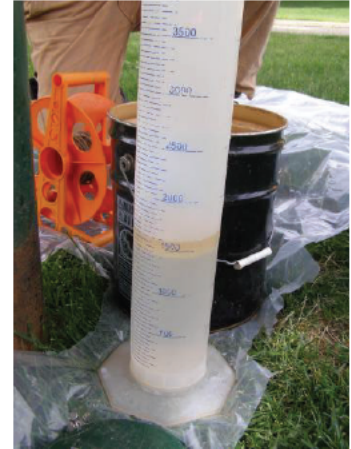
- The well was bailed. The water was placed in a graduated cylinder to measure volume of LNAPL, then poured into a metal bucket.
- Depth of the LNAPL was measured at 0.08'
- Approximately 150 mL of LNAPL was recovered.
- A LNAPL sample was collected at 10:30.

Recovered LNAPL from [REDACTED]
 5-26-26 @ 10:15

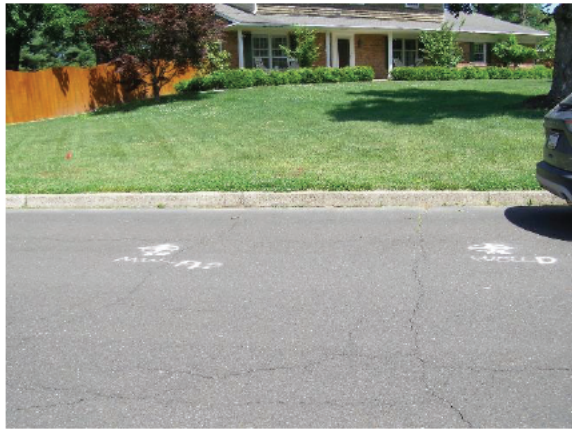
Location of wells Well D and MW-19D on Walker Road.
 5-26-26 @ 11:37

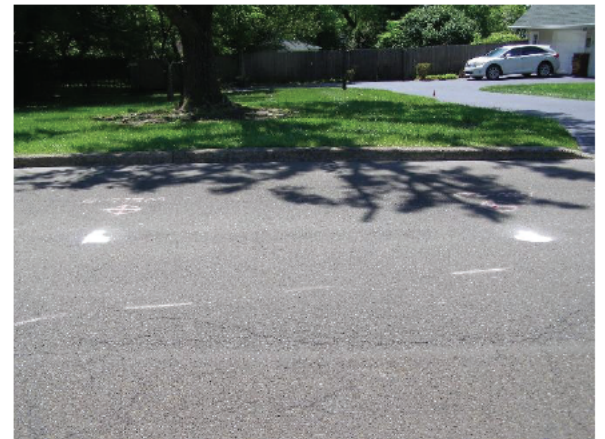
Well E and MW-20 on Walker Road
 5-29-26 @ 11:39
