The Poplar Run Repair and Maintenance Project
Growing Grant Program #C990002494
Sponsor: The Trust for Tomorrow

Project Description

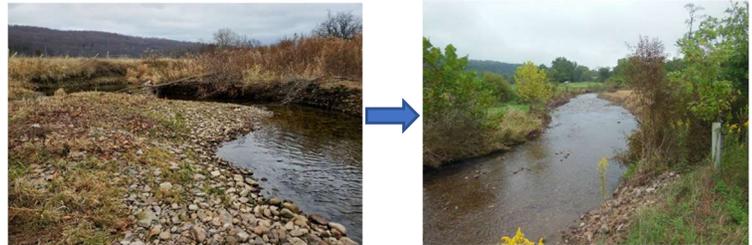
- At Area #4, in an area that is susceptible to backwater from the flooding of the Frankstown Branch of the Juniata, recurring flooding had resulted in extensive erosion and resultant sediment dropping out when flood waters receded, leaving large gravel bars throughout this reach. The excess gravel was moved back to the eroded bank, and an additional log vane was added to this section to improve the stream flow around the bend.

Each of these repaired areas will be planted with a mixed forest buffer to further stabilize the stream and bring additional habitat to the system.
