A Successful HSCA Funded Cleanup:

General Alloy Site

Rochester Township, Beaver County, PA

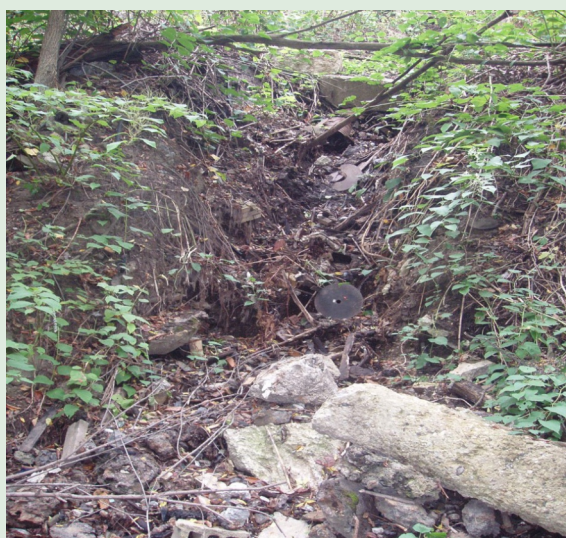
Foundry waste sand before the landslide and cleanup

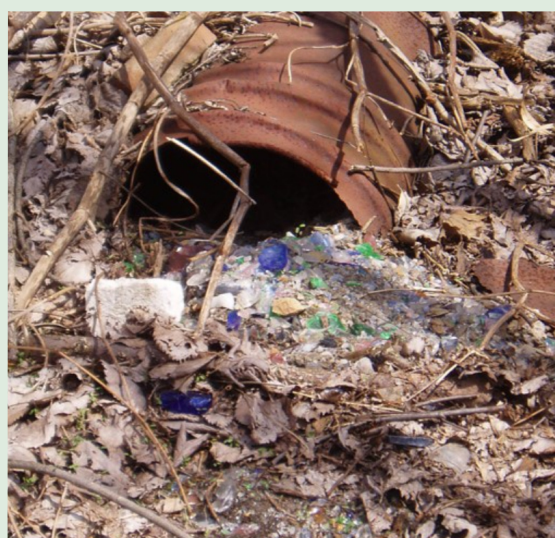
Frye Glass waste before the landslide and cleanup

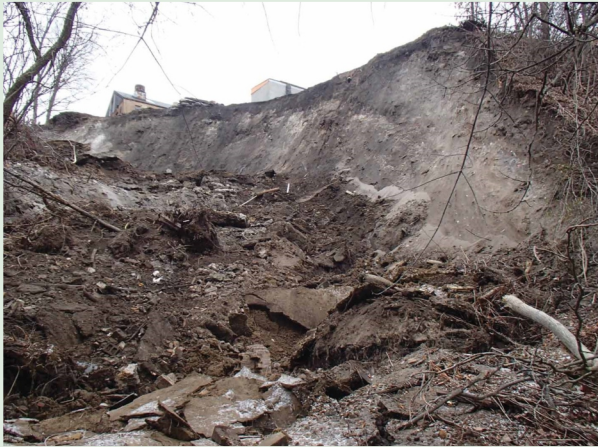
The slope after the landslide

Work began at the Site in July of 2016. However, in December of 2016, a landslide occurred at the Site and compromised a building on the property that was occupied by an active business, American Machining and Fabrication. The building was deemed unsafe by Rochester Township officials and the owner of the business was forced to move to an alternate location with assistance from DEP. The material from the Site dammed up McKinley Run and caused a mixing of the foundry sand and the glass. The landslide altered DEP's original remediation plans at the Site. DEP determined that a prompt response was necessary to be protective of public health and the environment, and part of that response was to raze the compromised building and properly stabilize the slope. Due to its proximity to the General Alloy Site, the Frye Glass Dump Site was cleaned up concurrently.

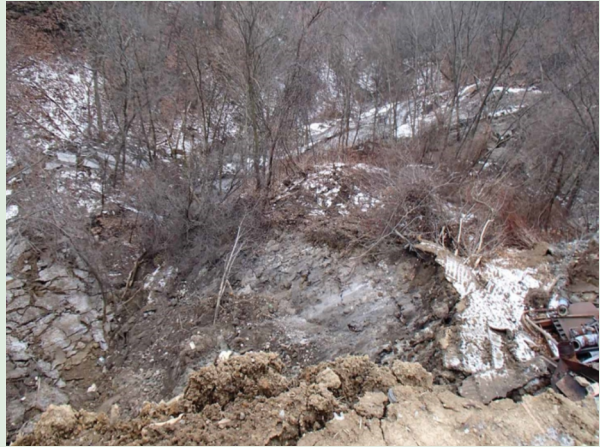
After the landslide (view from above)

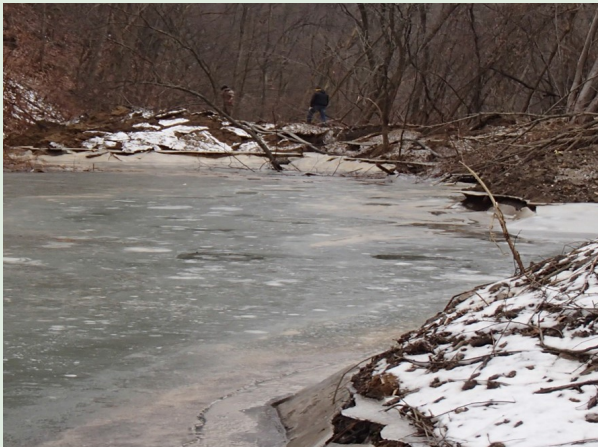
Blocked McKinley Run after the landslide and before the cleanup

Remediation was completed in 2019. A three-to-one slope was constructed in the area of the landslide. All new storm drains were installed at locations where the old, corroded drains existed. New storm drains and outfalls were installed on two streets to divert water away from the Site. Waste was removed from McKinley Run in the area of the landslide. The stream bank at the toe of the Site was lined with rip-rap to prevent further erosion from taking place.

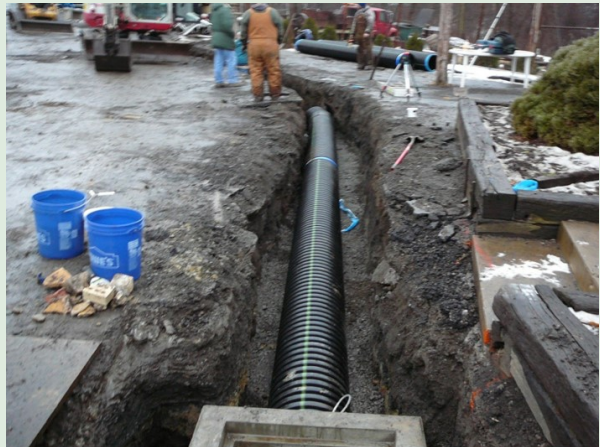
Storm water management during the cleanup

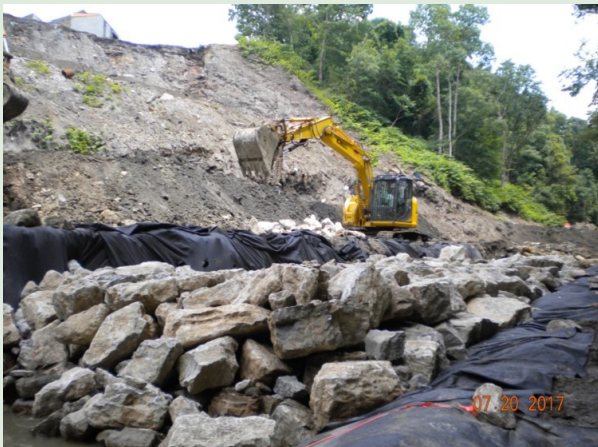
Slope stabilization during the cleanup

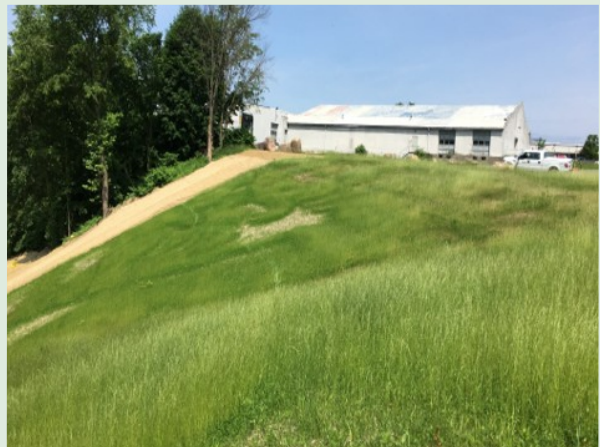
Vegetated slope after the cleanup
