**PENNEAST PIPELINE PROJECT**

**Susquehanna River Crossing**

**Alternatives Analysis**

**January 2018, Revised December 2018**

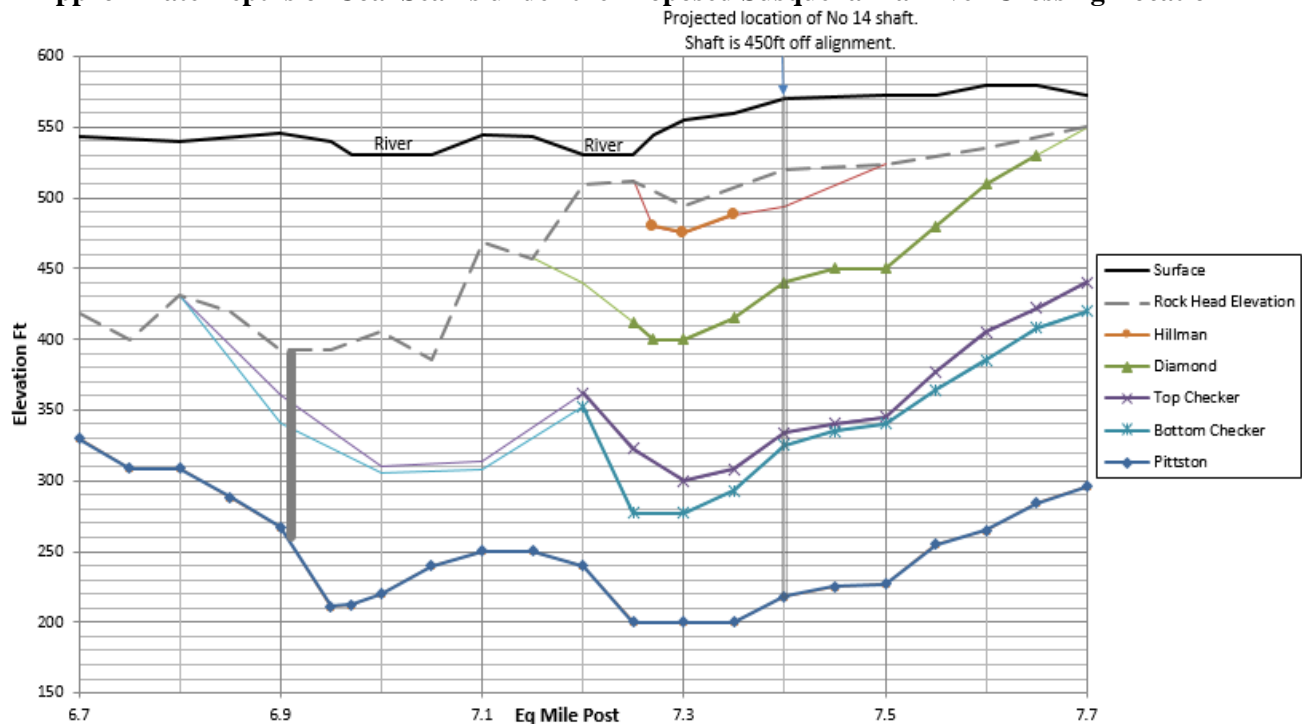
**Figure 2-1**  
**Approximate Depths of Coal Seams under the Proposed Susquehanna River Crossing Location**

Based on records which indicated extensive mining occurred beneath the river at depths greater than 130 feet, PennEast determined that crossing the river via horizontal directional drill (HDD) method was not a suitable pipeline construction method for this crossing. As crossing via HDD was not deemed feasible, PennEast focused additional studies on the coal seams nearer the surface, namely the two shallowest Hillman and Diamond seams, to ensure trenching operations would not intersect the shallow underground workings.

The shallowest worked coal seam to the Susquehanna River is the Hillman Coal seam. The seam was worked at a depth of 60 feet (elevation 460) at the south bank of the river; however, the workings of this coal seam do not extend out under the river. When reviewing maps of the Hillman seam (PADEP BMAR

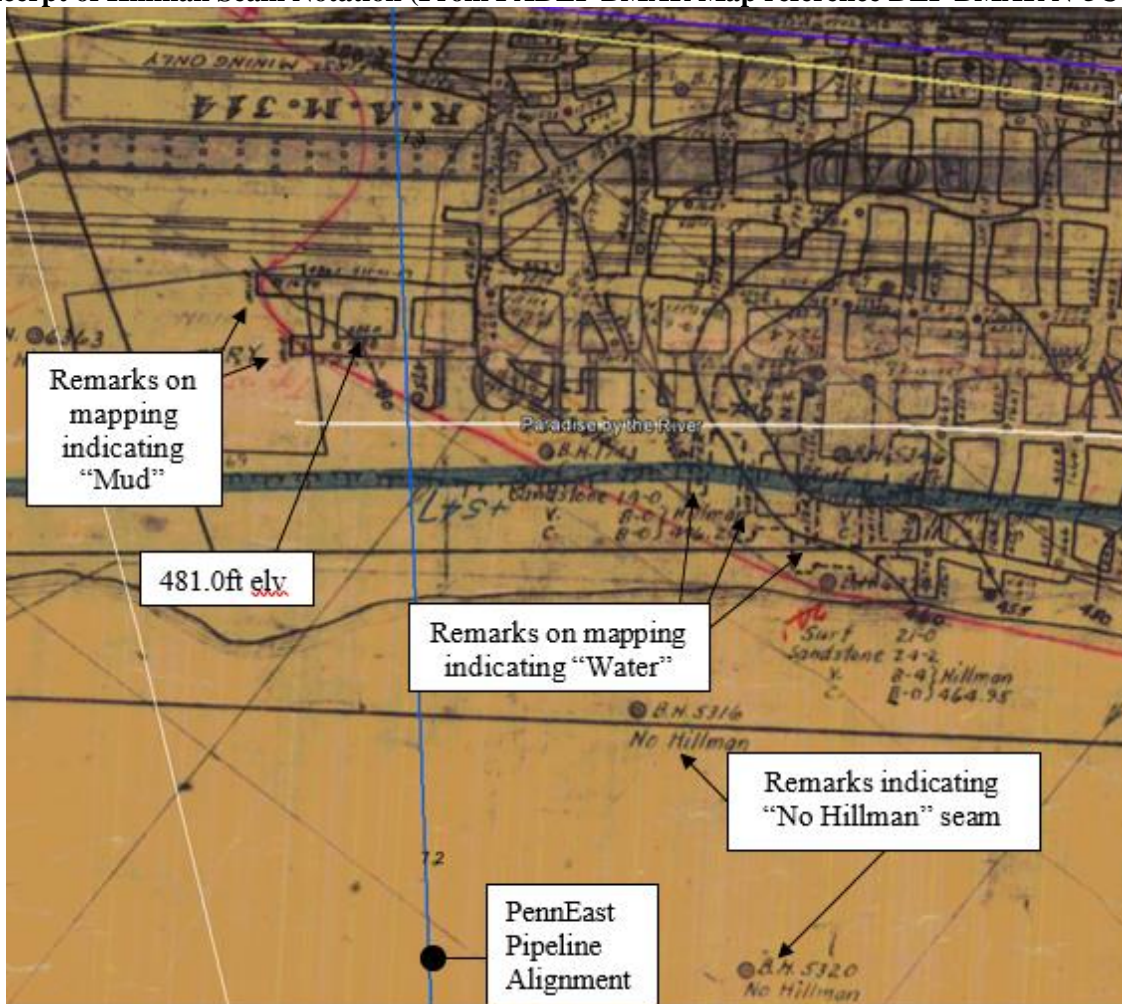
**Figure 2-2**  
**Excerpt of Hillman Seam Notation (From PADEP BMAR Map reference DEP BMAR N-5C-01)**

Map reference DEP BMAR N-5C-01) a number of historic exploratory boreholes advanced indicate the absence of the Hillman seam at the proposed crossing location. In addition, remarks on historic mapping at the termination of the workings contained notations of “Mud” or “Water” at the southeastern banks of the river, indicating the workings ran into ground conditions making it infeasible or impossible to continue extraction under the River. An excerpt of the No. 14 Colliery Map of the Hillman Vein showing this notation is provided as Figure 2-2 for reference. Given these available data, it is likely that the seam is not present beneath the River at this specific crossing, and that the layer was eroded out by the natural geologic valley in the bedrock surface beneath the Susquehanna River.

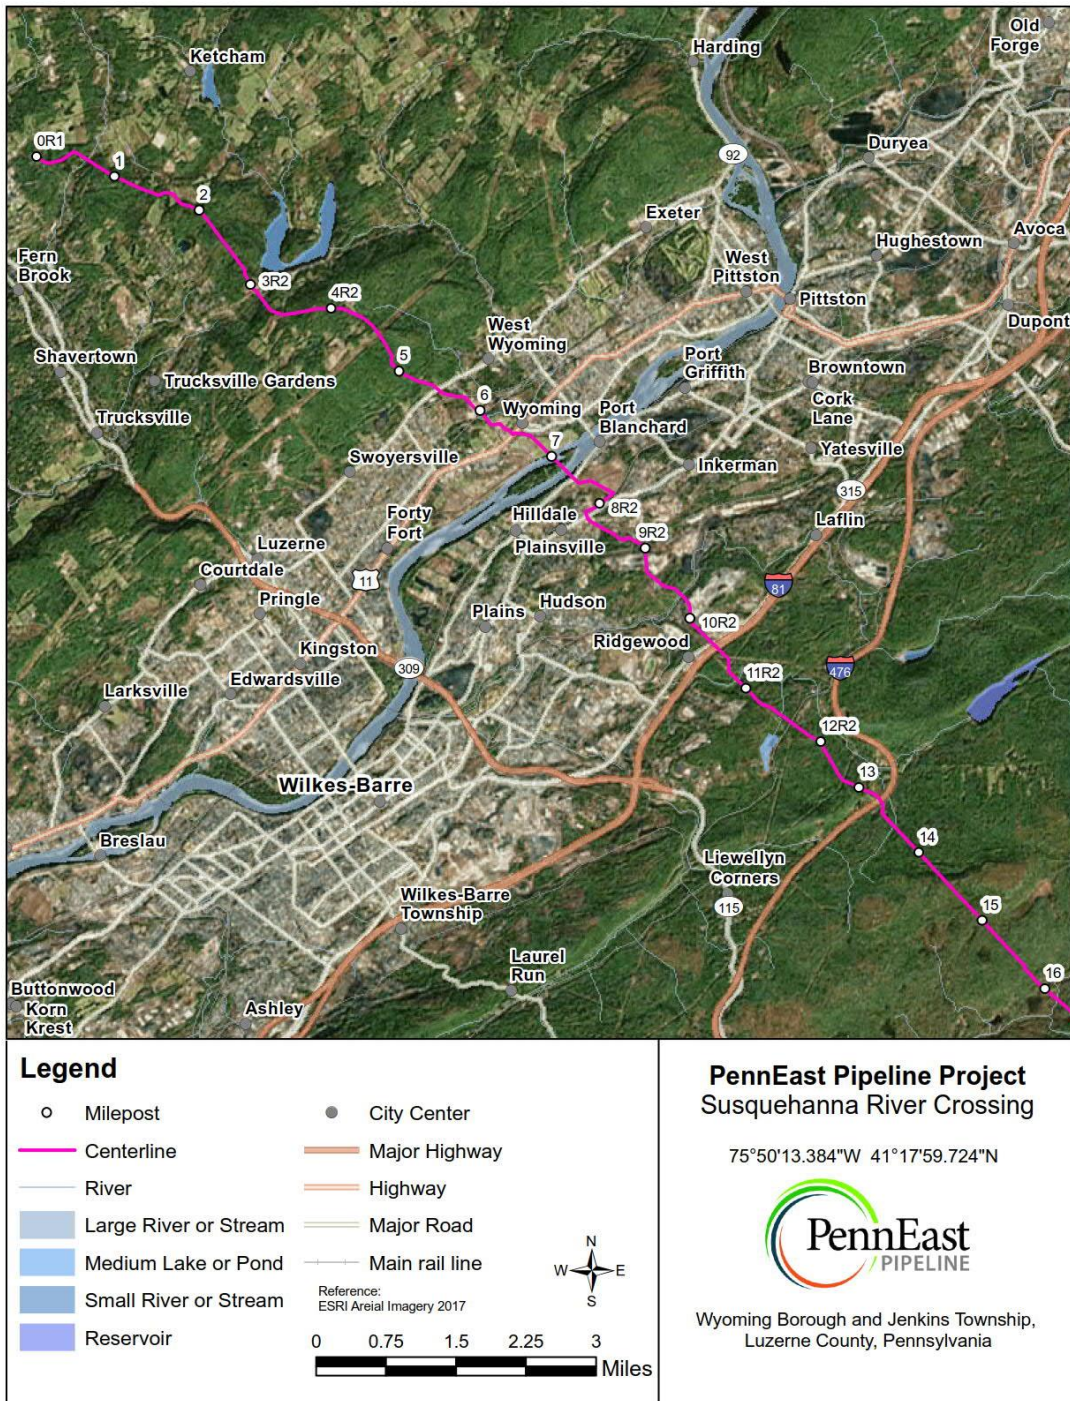
**Figure 3-1**  
**Dense Development Surrounding the Proposed Crossing Location**

The Susquehanna River crossing location presented a challenge due to the existing geologic setting and densely populated surroundings. The proposed crossing location was selected to maximize the use of open, previously-disturbed land and to avoid densely developed areas along the banks of the Susquehanna River. As shown in Figure 3.1, there is dense residential development northeast of the proposed crossing location, including the towns of Wyoming, Laflin, Port Griffith, and Pittston. Dense development to the southeast includes Swoyersville, Luzerne, Plain, Edwardsville, and Wilkes-Barre. The installation of the pipeline, further described in Section 4, will require significant workspace adjacent to the river to stage construction equipment and pipe. The proposed crossing location will allow PennEast to temporarily occupy open and agricultural land to complete the crossing, rather than disrupting residential or commercial areas. To find a similar crossing location with substantial workspace on both sides of the river that avoids dense development, the pipeline would need to be rerouted at least 13 river miles downstream of the proposed crossing location, which would result in a substantial increase in the Project length and increased environmental impacts.

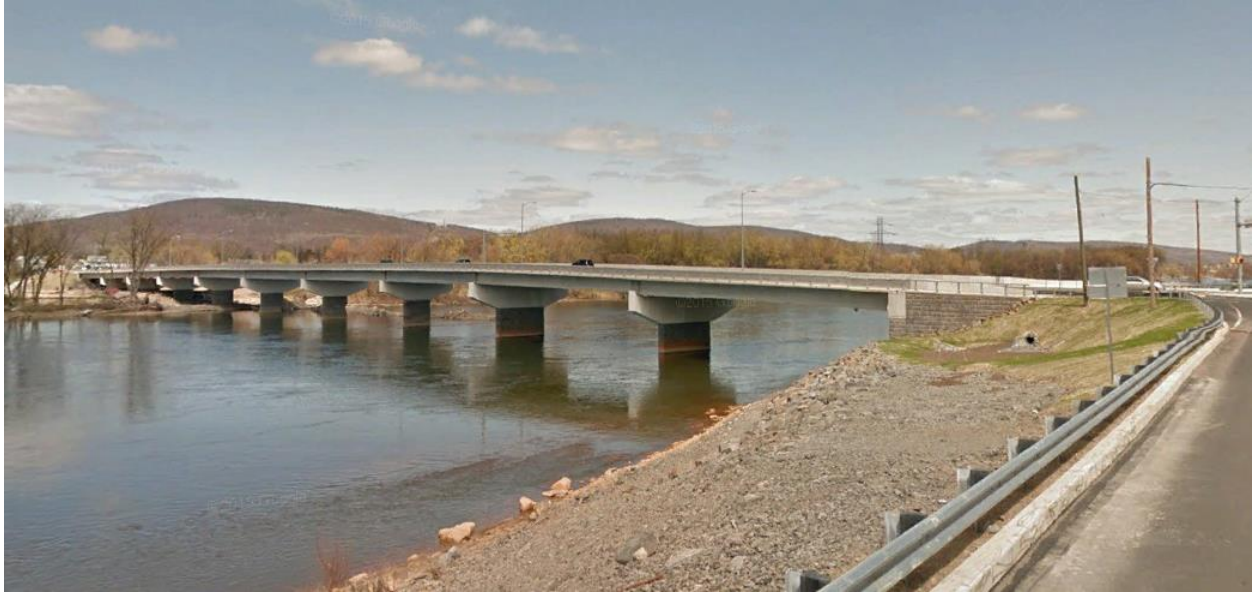
**Figure 3-2  
The Wyoming Bridge**

Other nearby existing infrastructure and sensitive resources also influenced the siting of the proposed crossing location. The crossing location is bordered by the Wyoming Valley Levee System and the Wilkes-Barre Wyoming Valley Airport to the southwest, and the Wyoming Monument and the recently constructed Wyoming Bridge (8<sup>th</sup> Street Bridge) to the north.

also restrict the floodway capacity under the bridge. In summary, burying pipelines and maintaining sufficient cover is an effective method of protecting the pipeline against potential external damage.

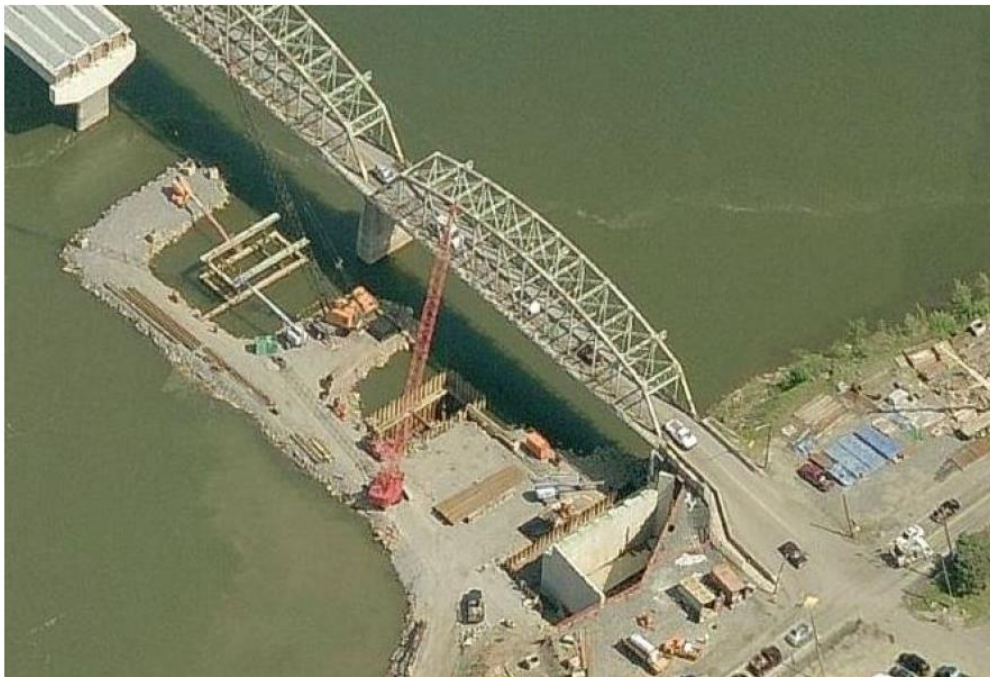
**Figure 4-1  
Sheet Pile Cofferdams Used to Construct the Wyoming Bridge**

Steel sheet piles are long structural sections with a vertical interlocking system that creates a continuous wall. Sheet pile walls are able to retain water by transferring pressure from the high side of the wall to the soil in front of the wall. The sheets could be designed support up to 15 feet water pressure, which could accommodate water levels higher than typical low flow conditions. A similar design had been utilized a short distance upstream in the Susquehanna River for the construction of the Wyoming Bridge piers, which proved to be an effective design. An overview of the Wyoming Bridge construction project is provided in Figure 4-1 below. Sheet pile cofferdam is a proven technology, but it would require mobilizing additional equipment and in-river work to install the cofferdam.

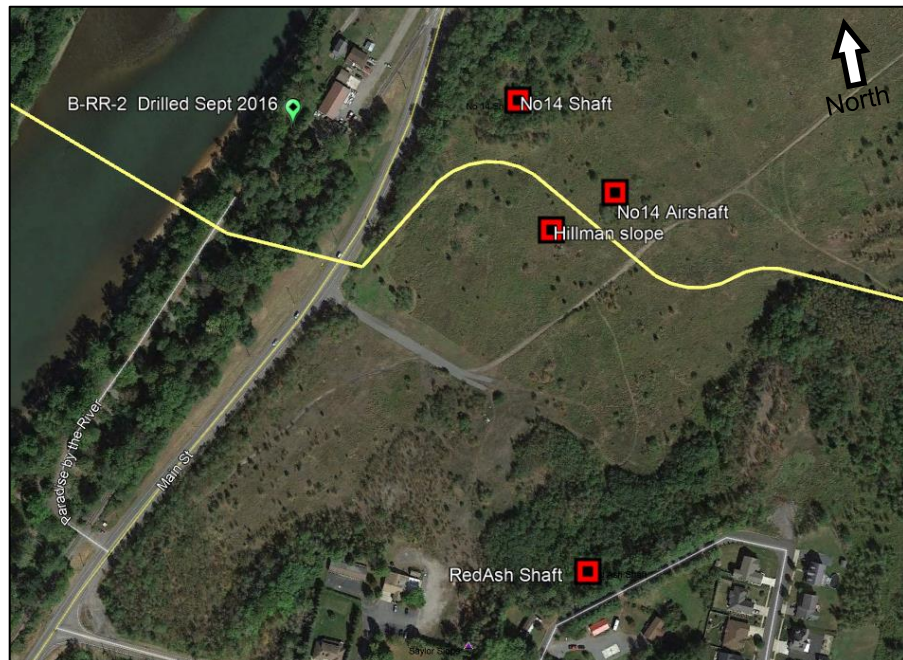
**Figure 1: Feature Location Plan.**

- No.14 Shaft
- No.14 Air shaft
- Slope to Hillman
- RedAsh Shaft

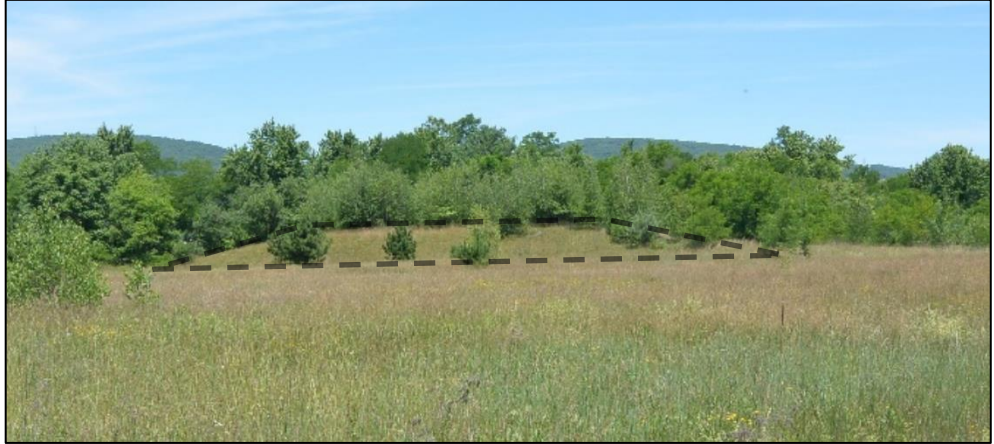
**Figure 2: No.14 Shaft viewed from South. Mounded area is shaft location.  
June 2016**

- Approximate depth: 370 feet, (vertical).
- Approximate opening size= 12 feet by 50 feet.
- Closure status: No documents found. Visual inspection shows evidence of shaft location and shows possible backfilling. Backfilling may be full or capping only.

Visual evidence of both the No.14 shaft and RedAsh shaft was observed. At the mapped location of both these features a mounded area with debris and derelict historic material was observed. Visual inspection could not confirm if the shafts have been filled or only capped therefore the stability of the shafts cannot be evaluated.

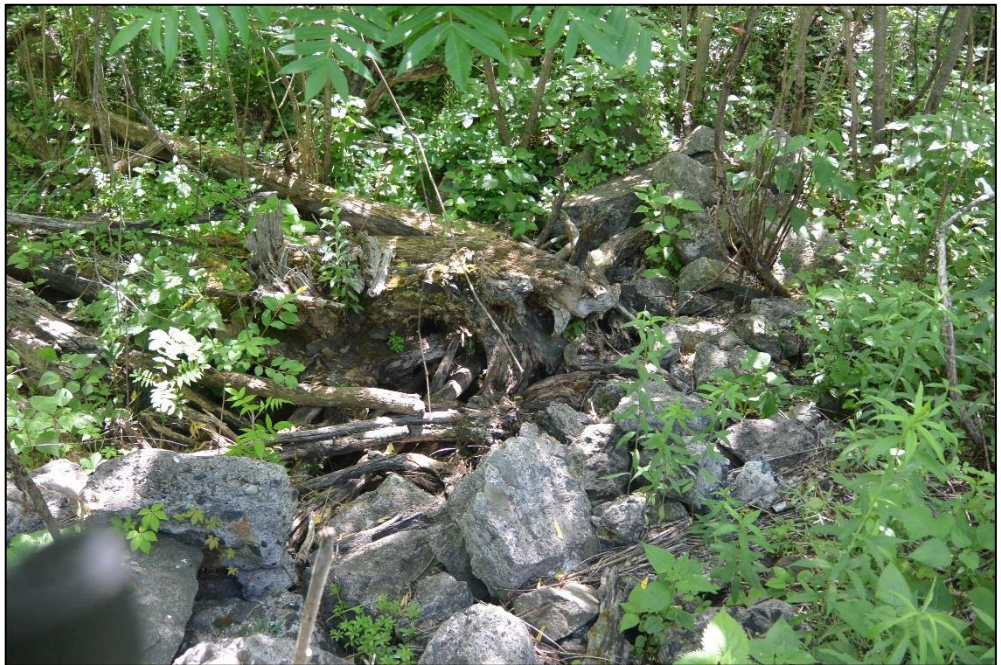
**Figure 3: No.14 Shaft. Close up of shaft mouth debris. June 2016**

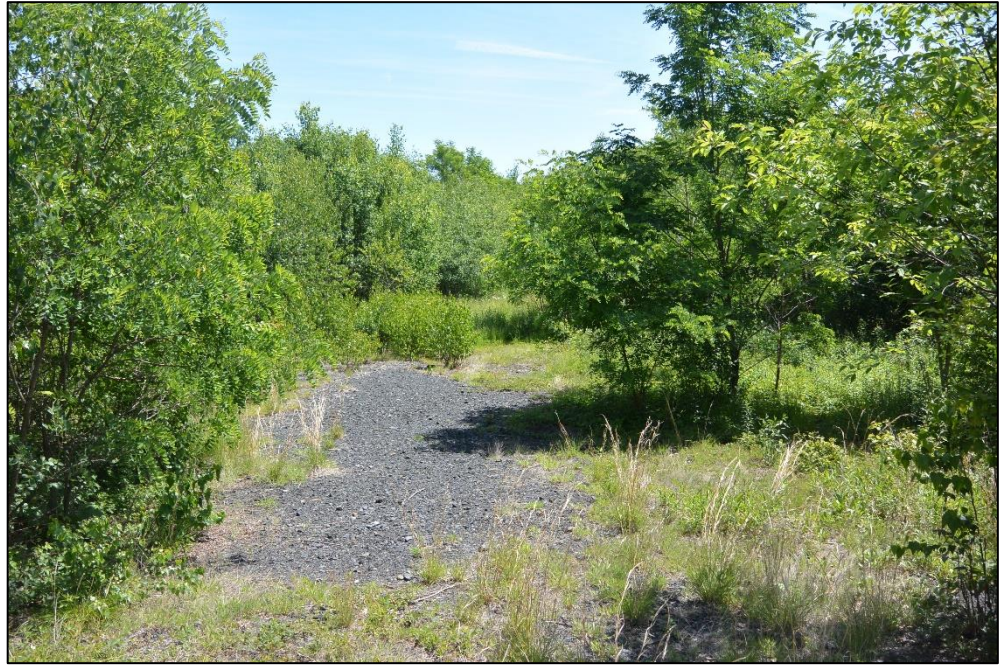
**Figure 4: No.14 Shaft, area adjacent North of Figure 3. June 2016**

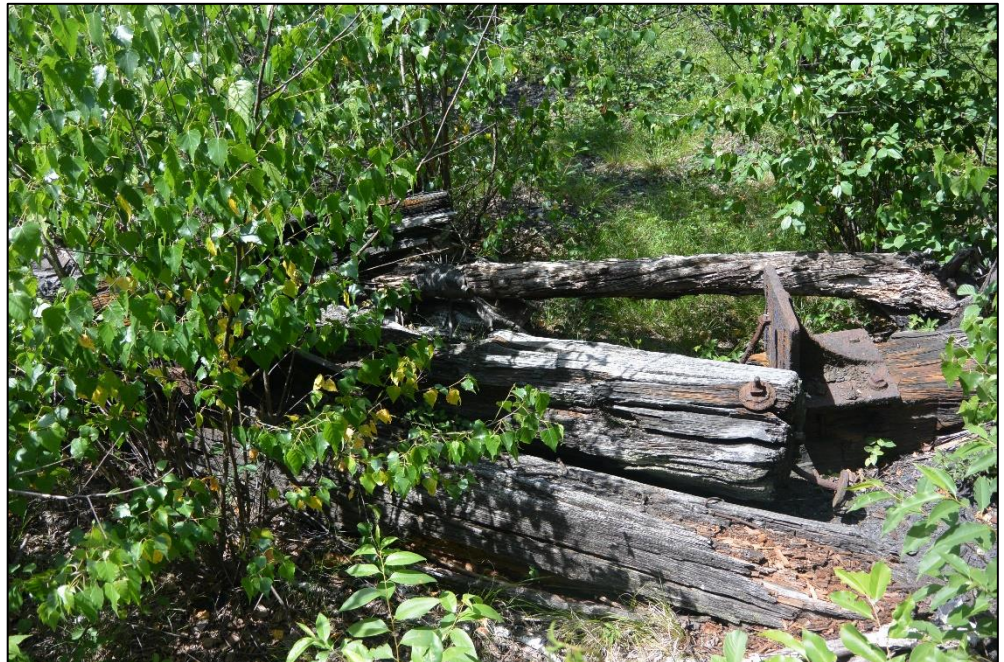
**Figure 5: No.14 Shaft, derelict structures 30ft east of mapped shaft location. June 2016**

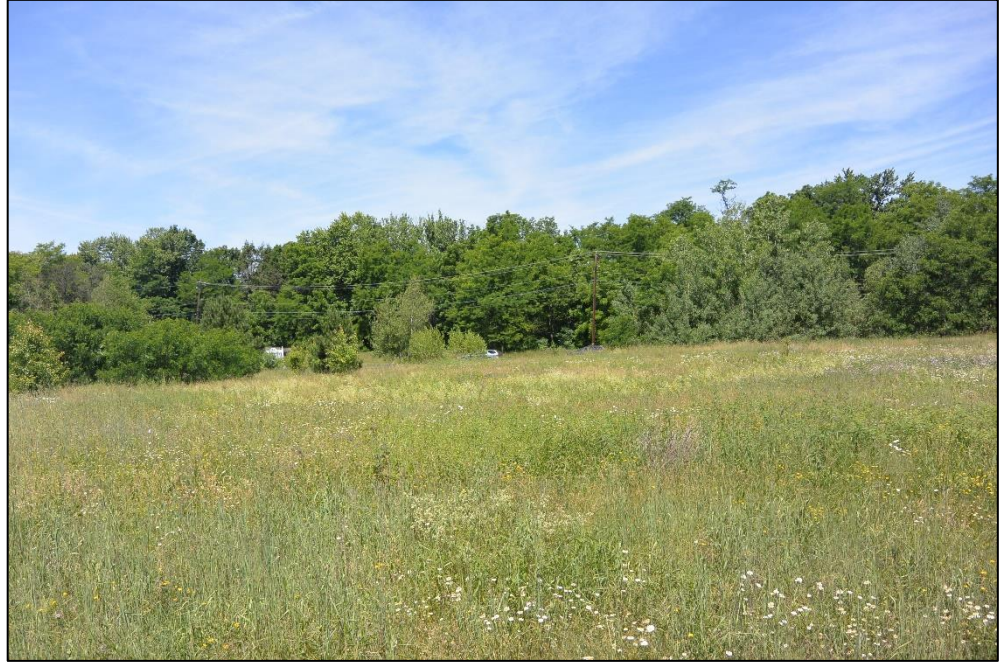
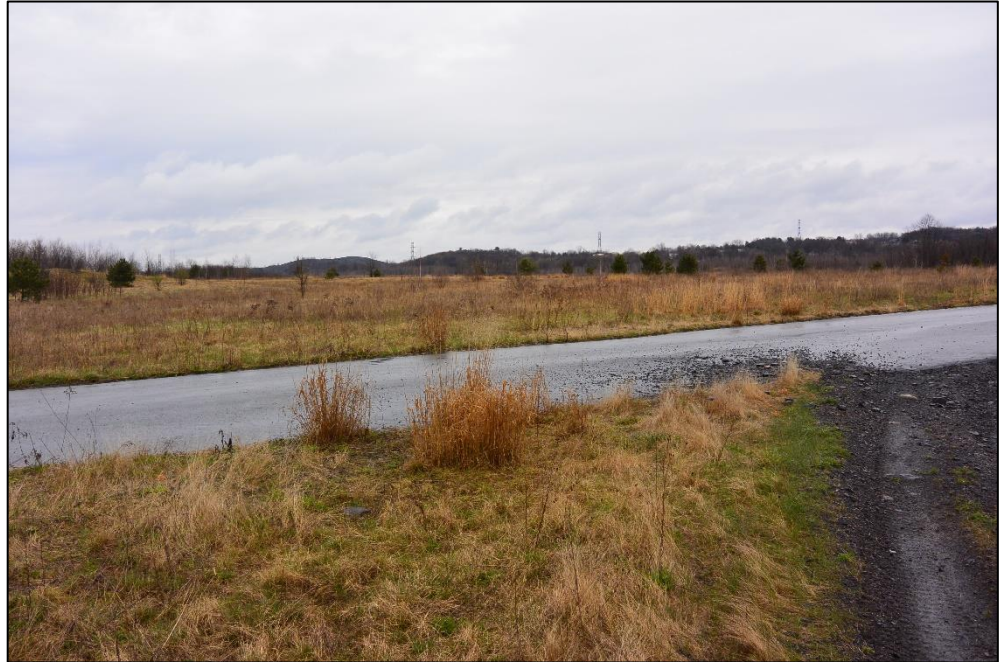
**Figure 6: No.14 AirShaft and Hillman slope, no evidence observed. Looking North West. June 2016**

**Figure 7: No14 AirShaft and Hillman slope, no evidence observed. Looking North East. April 2016**

Site grading works have removed any evidence of small mine entrance features which may have been present in the location of Figures 6 and 7.

No open shafts were observed by Mott MacDonald during site visits. No evidence of the No.14 Airshaft or Hillman Slope was observed. It is theorized that these small features were destroyed by later mining related operations and/or site grading works.

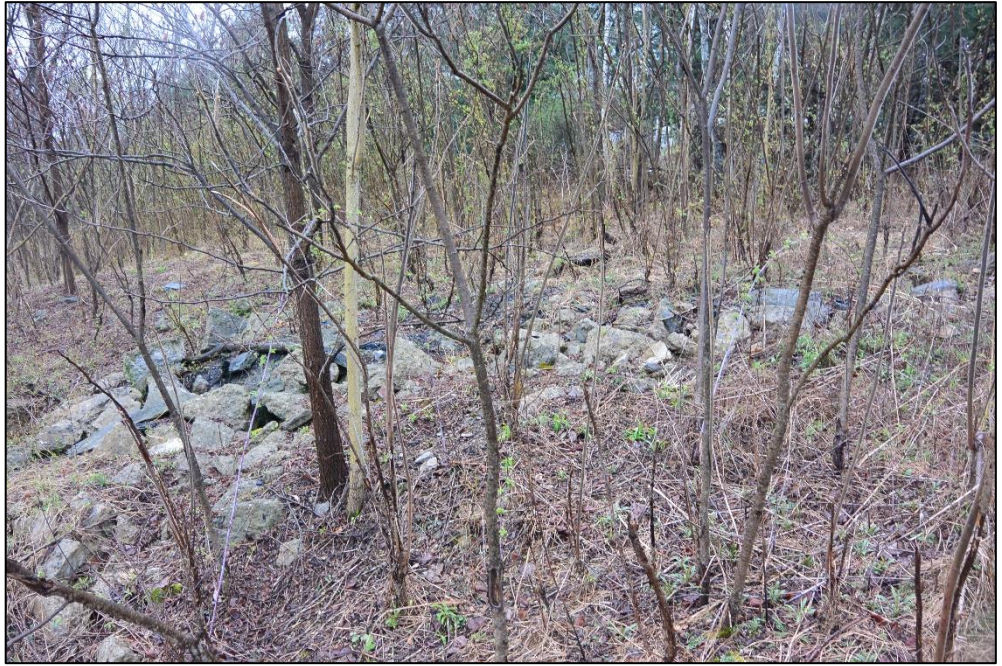
**Figure 8: RedAsh Shaft, Mounded area and debris in shaft mouth. April 2016**

- Approximate depth: 600ft, (vertical).
- Approximate opening size: 12ft by 24ft.
- Closure status: No documents found, visual inspection shows evidence of shaft location and shows possible backfilling, backfilling may be full or capping only.

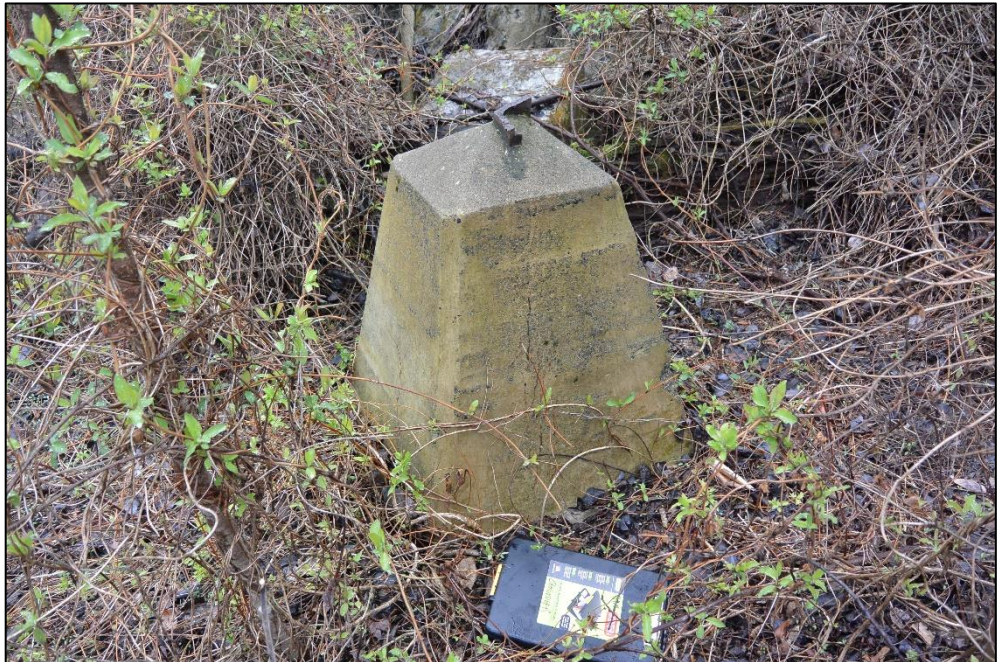
**Figure 9: RedAsh Shaft, relic structure adjacent to shaft. April 2016**

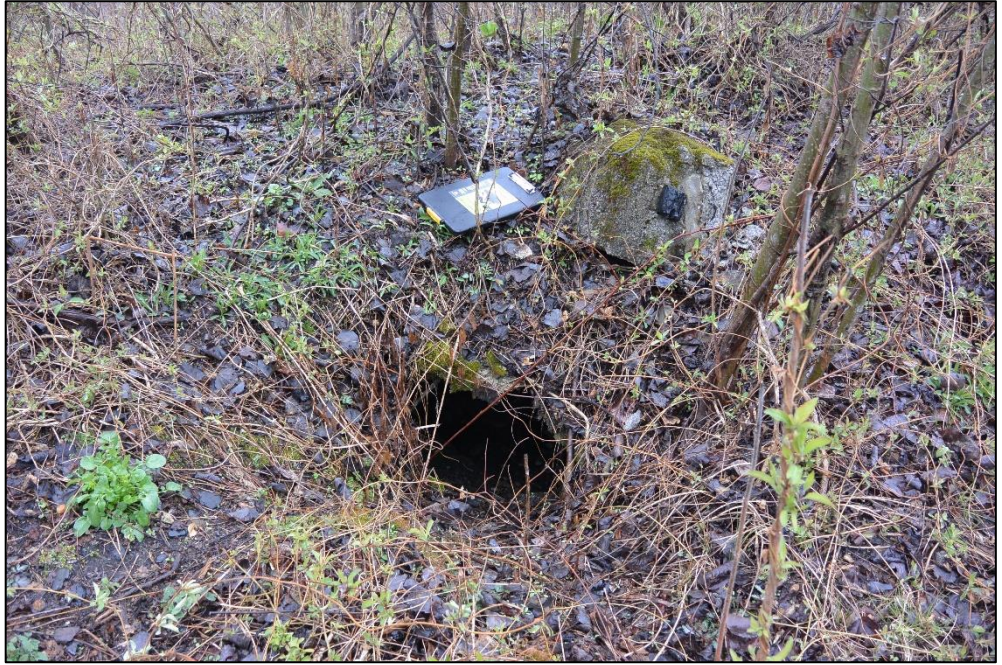
**Figure 10: RedAsh Shaft, void in mounded shaft area. April 2016**

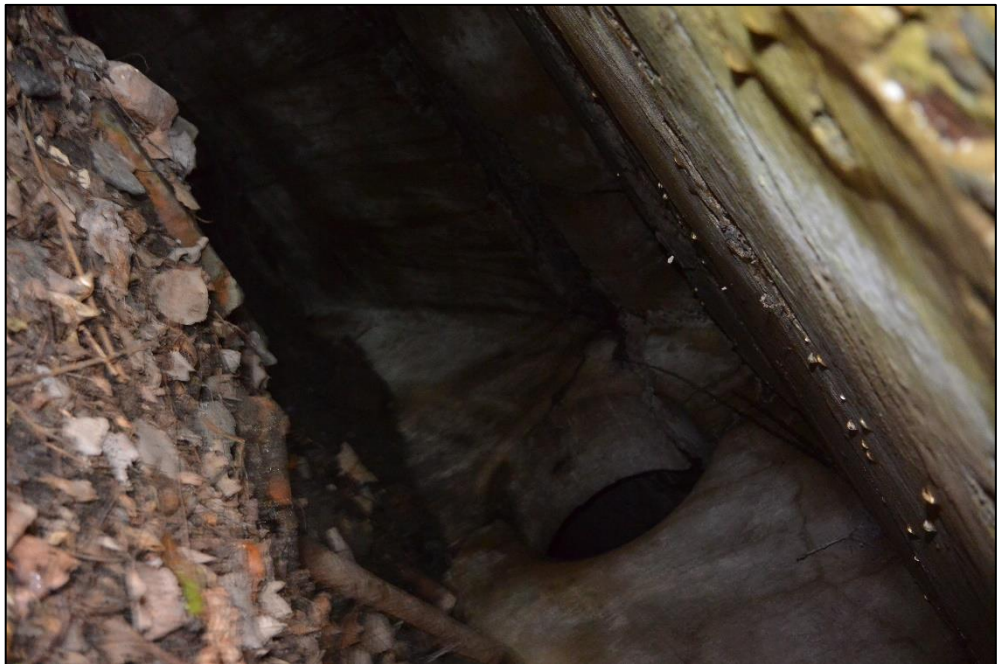
**Figure 11: RedAsh Shaft, photograph within void of Figure 10, showing concrete structure below surface debris. April 2016**

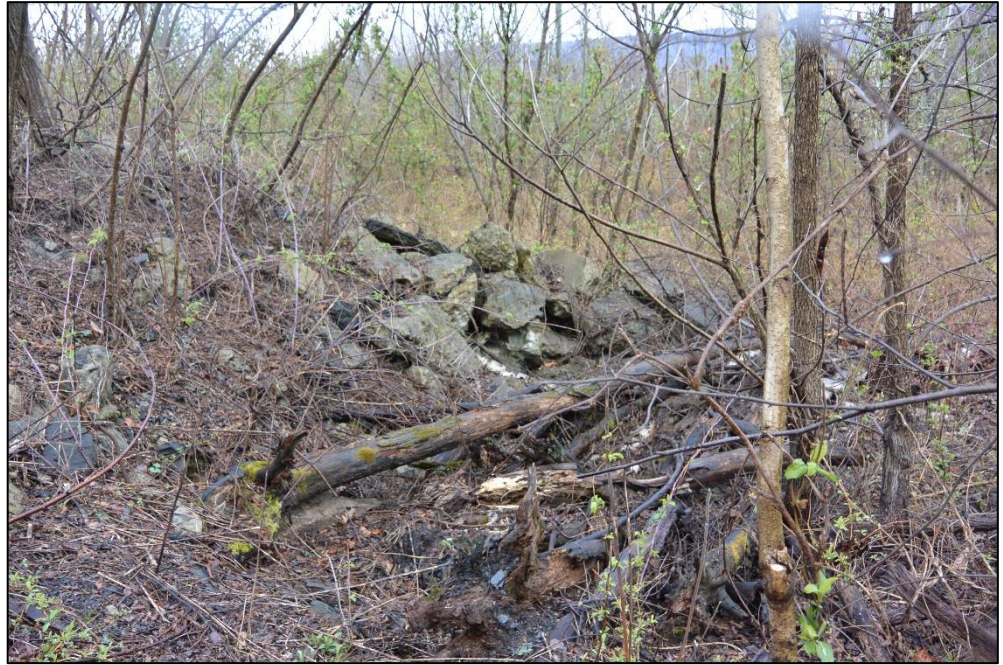
Figure 12: RedAsh Shaft, debris in area of shaft mouth. April 2016

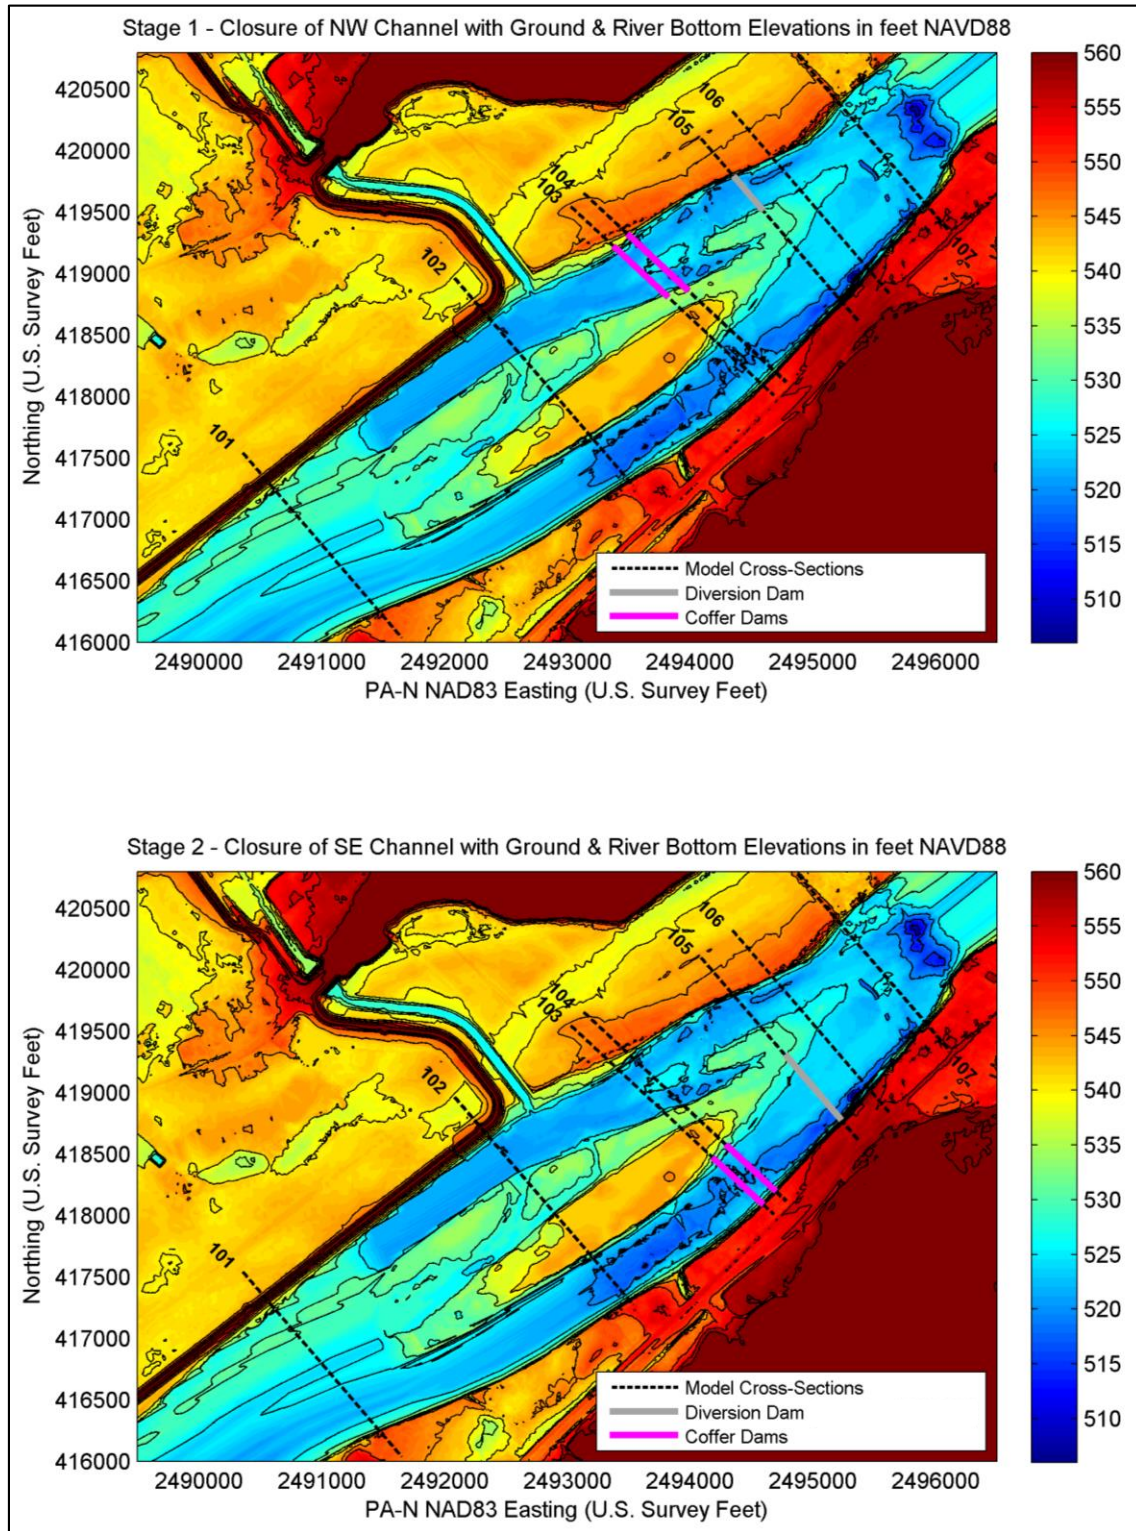
**Figure 1: River Bathymetry and Topography and Section Locations**

Output from the model is included in Table 1 and Figure 2 below. The model run used 5,476 cubic feet per second (cfs) as input flow rate. This is the average daily flow rate for the months of July, August, and September (92-day period). The open channel river water elevation at the flow rate of 5,476 cfs is approximately 527.7 feet at the diversion dam locations. The river water elevation is predicted to rise approximately 0.2 feet by closing either channel at this flow rate. The proposed crest of the Portadam® is approximately 531 feet based on the lowest elevation of the river bed. It is concluded that for the average daily flow rate of 5,476 cfs a Portadam® is unlikely to be overtopped.

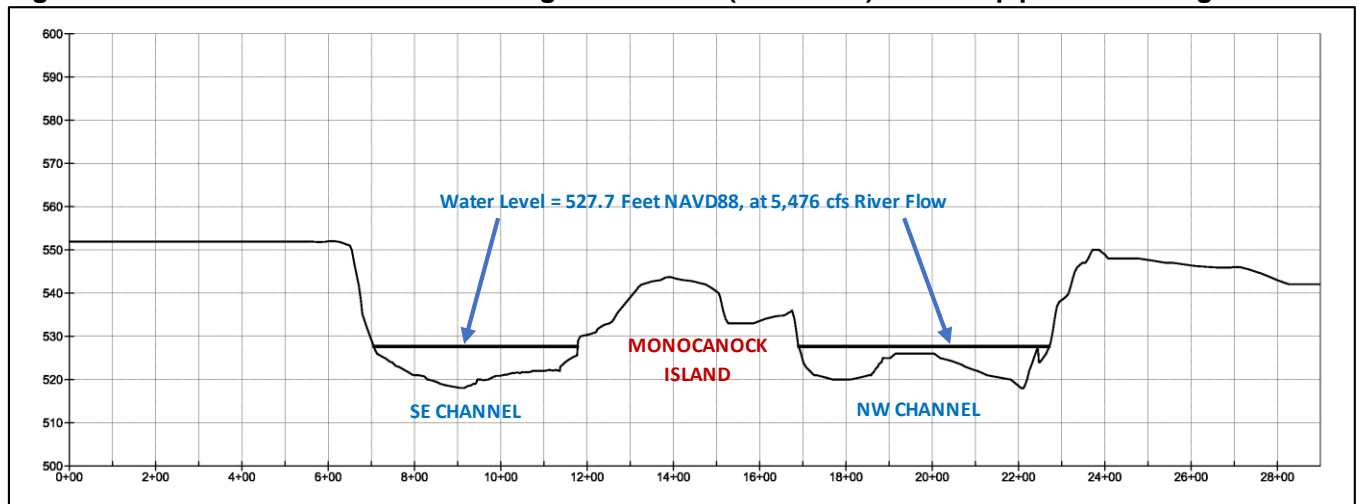
**Figure 2: Cross-section of river bed facing downstream (southwest) near the pipeline crossing**

Source: Contours based on April 2017 survey, 2015 Pennoni contours, and 2006 LIDAR
