**HORIZONTAL DIRECTIONAL DRILL ANALYSIS
SPINNER ROAD CROSSING
PADEP SECTION 105 PERMIT NO.: E11-352
PA-CA-0069.0000-RD-16
(SPLP HDD No. S2-0080-16)**

**ATTACHMENT 2
COAL MINE SUBSIDENCE AND STRESS ANALYSIS**

**SUBSIDENCE POTENTIAL REVIEW
SPINNER ROAD
HORIZONTAL DIRECTIONAL DRILLED PIPELINE PROJECT
MUNSTER TOWNSHIP, CAMBRIA COUNTY, PA
May 2018**

ROOT CAUSE ANALYSIS FOR THE 20-INCH PIPELINE INSTALLATION INADVERTENT RETURNS

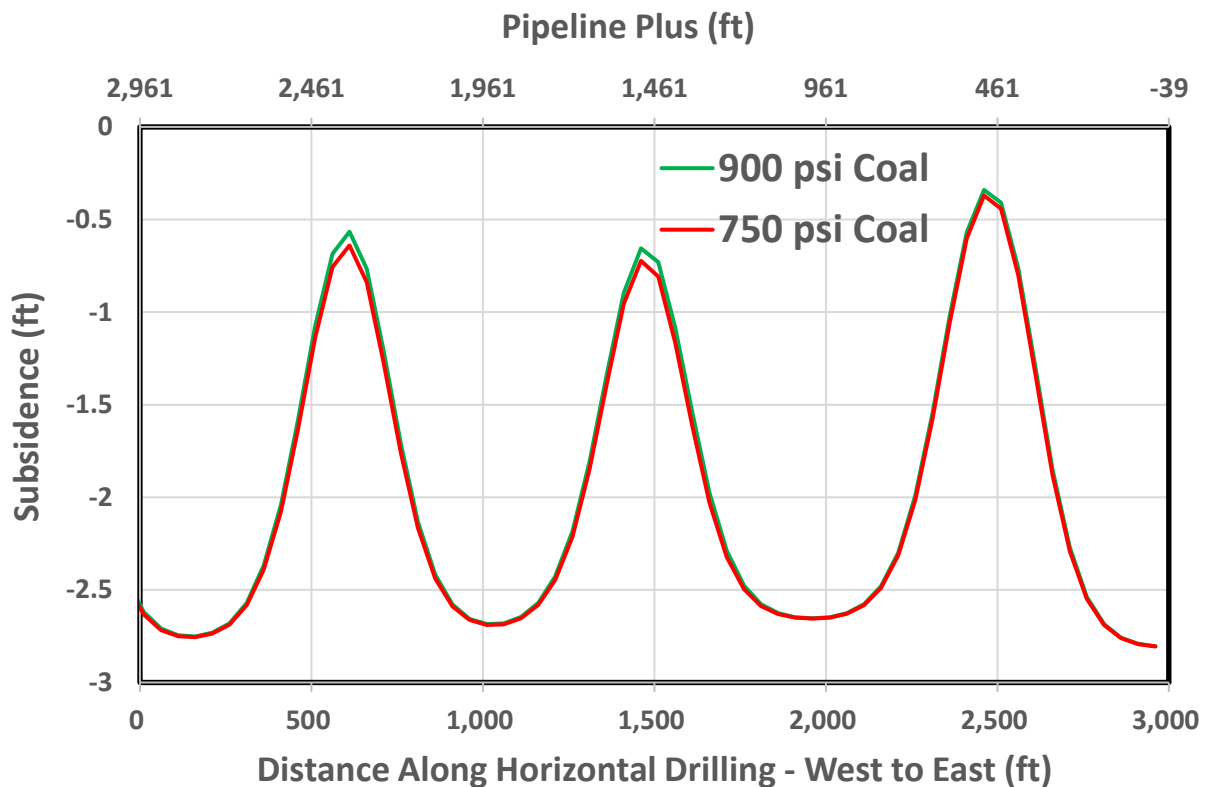
To examine the details of the previous subsidence along the pipeline alignment, the subsidence above the seam has been interpolated from the output shown in Figure 6 directly to the pipeline coordinates, as shown in Figure 6. In this plot, the subsidence under the pipeline as it crosses over the various gob and supporting gateroad pillar areas is clearly visible.

Figure 6. Subsidence prediction along the pipeline alignment at different coal strengths.

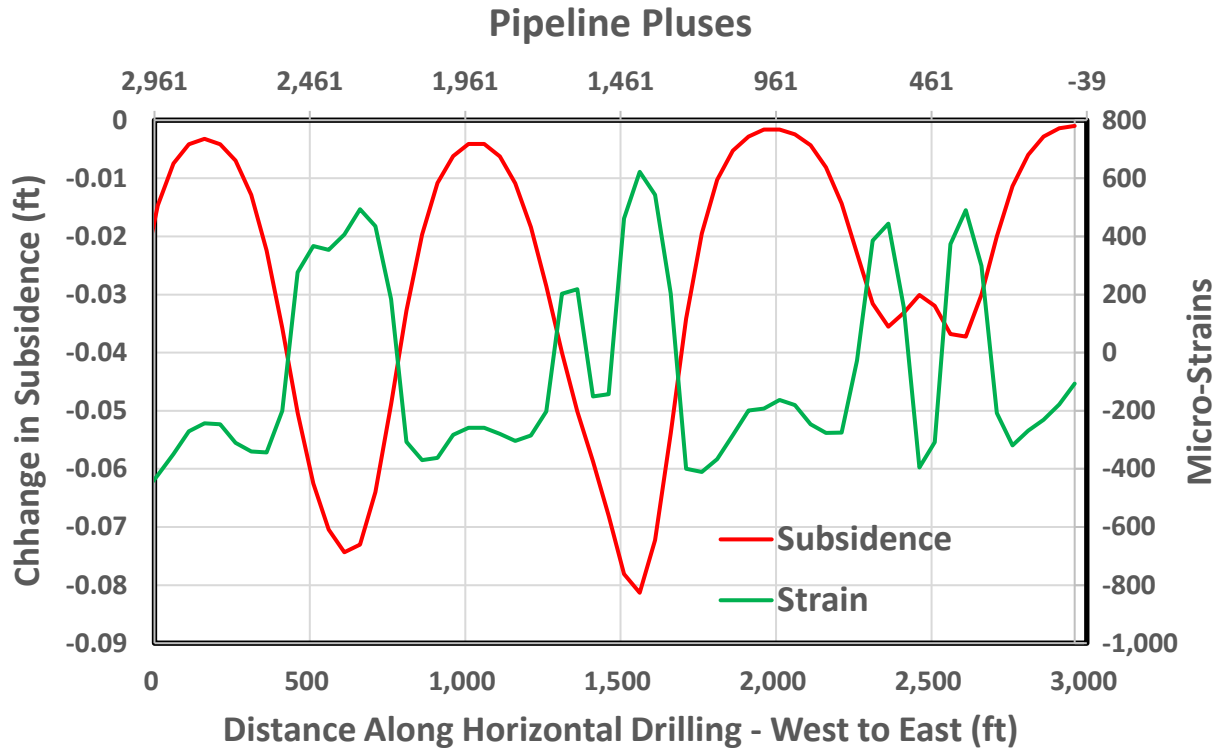
Figure 9. Predicted worst case subsidence and associated strains (tension is negative).

The estimated maximum subsidence that the pipeline may experience in the future is the difference between the subsidence estimated using the original strength (900 psi) of coal and the subsidence estimated using a degraded strength (750 psi) of coal. The differential in subsidence between the two coal strengths is plotted in Figure 7, along with the associated strains. There are three areas of potential increased subsidence. These three areas are located above the three gate-roads. The largest increased subsidence would be estimated to be about 0.074 feet (0.89 inches) - above the western most gate-road (centered at Station 700). The second area of increased subsidence occurs above Station 1650 - above the center gate-road. The estimated additional subsidence in this area is estimated to be about 0.081 feet (0.97 inches). The third area of increased subsidence occurs above Station 2700 - above the eastern gate-road. The estimated additional subsidence in this area is estimated to be about 0.037 feet (0.44 inches).

The maximum strain values range from -0.0005 to +0.0006 strain (compression is positive), and fluctuate continuously along the pipeline length, but being highest above the gate-roads. Figure 7 includes both the change in subsidence and the strain along the HDDP location. The level of strain that the pipeline may experience is a function of the ground movement and a function of how tightly the pipeline is coupled to the ground movement. If the pipeline can slide within the horizontal drilling distance, then areas of tensile or compressive strain can be reasonably canceled by adjacent areas of the opposite strain.

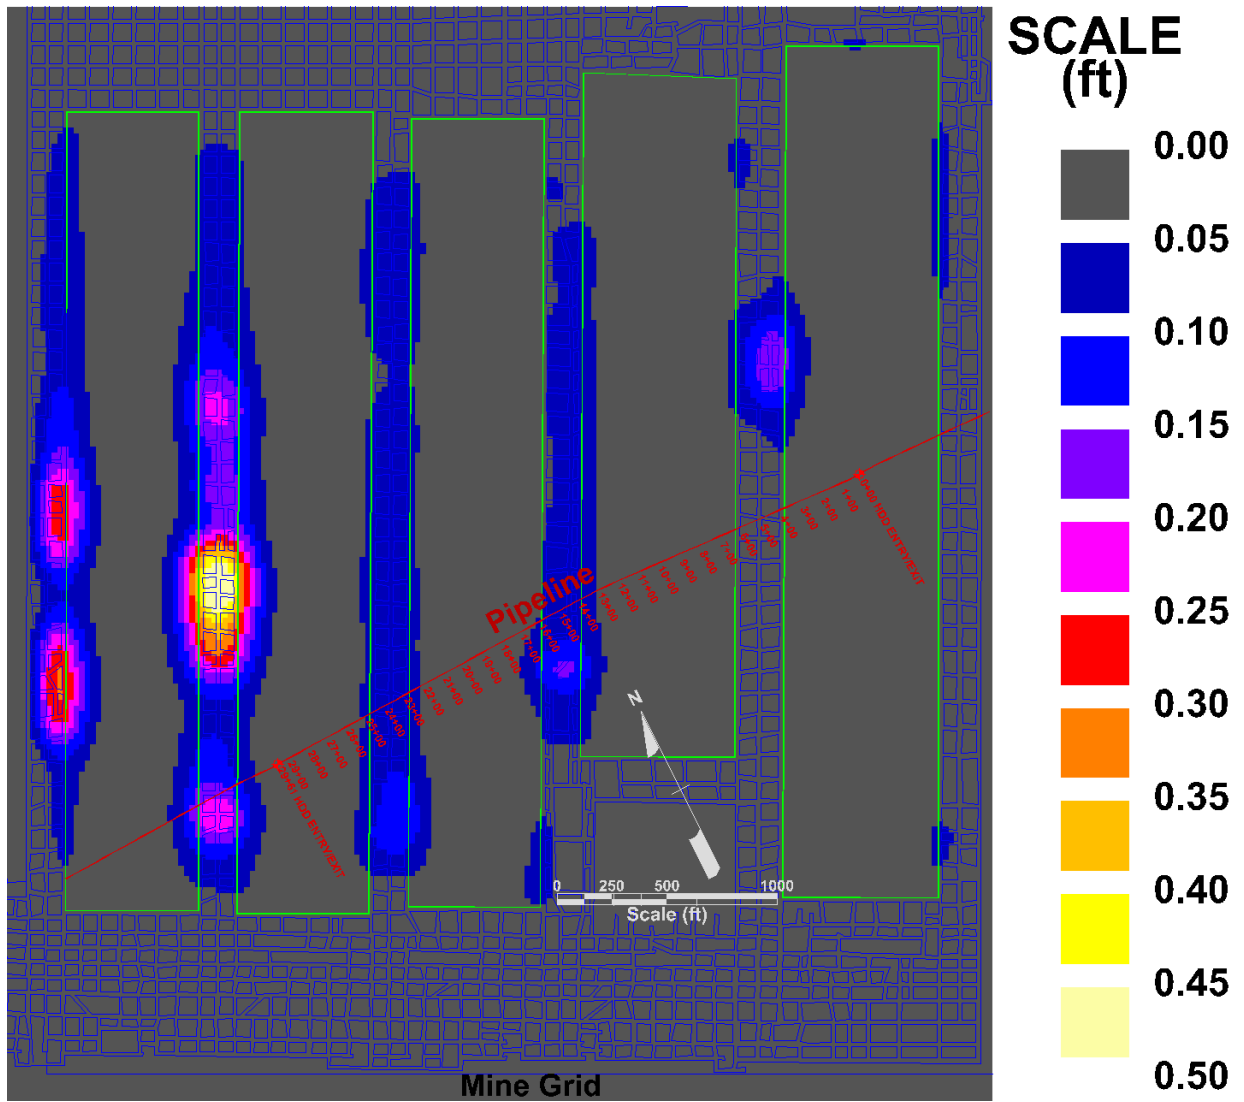
Figure 8. Increase in subsidence going from 900 psi coal to 750 psi coal.

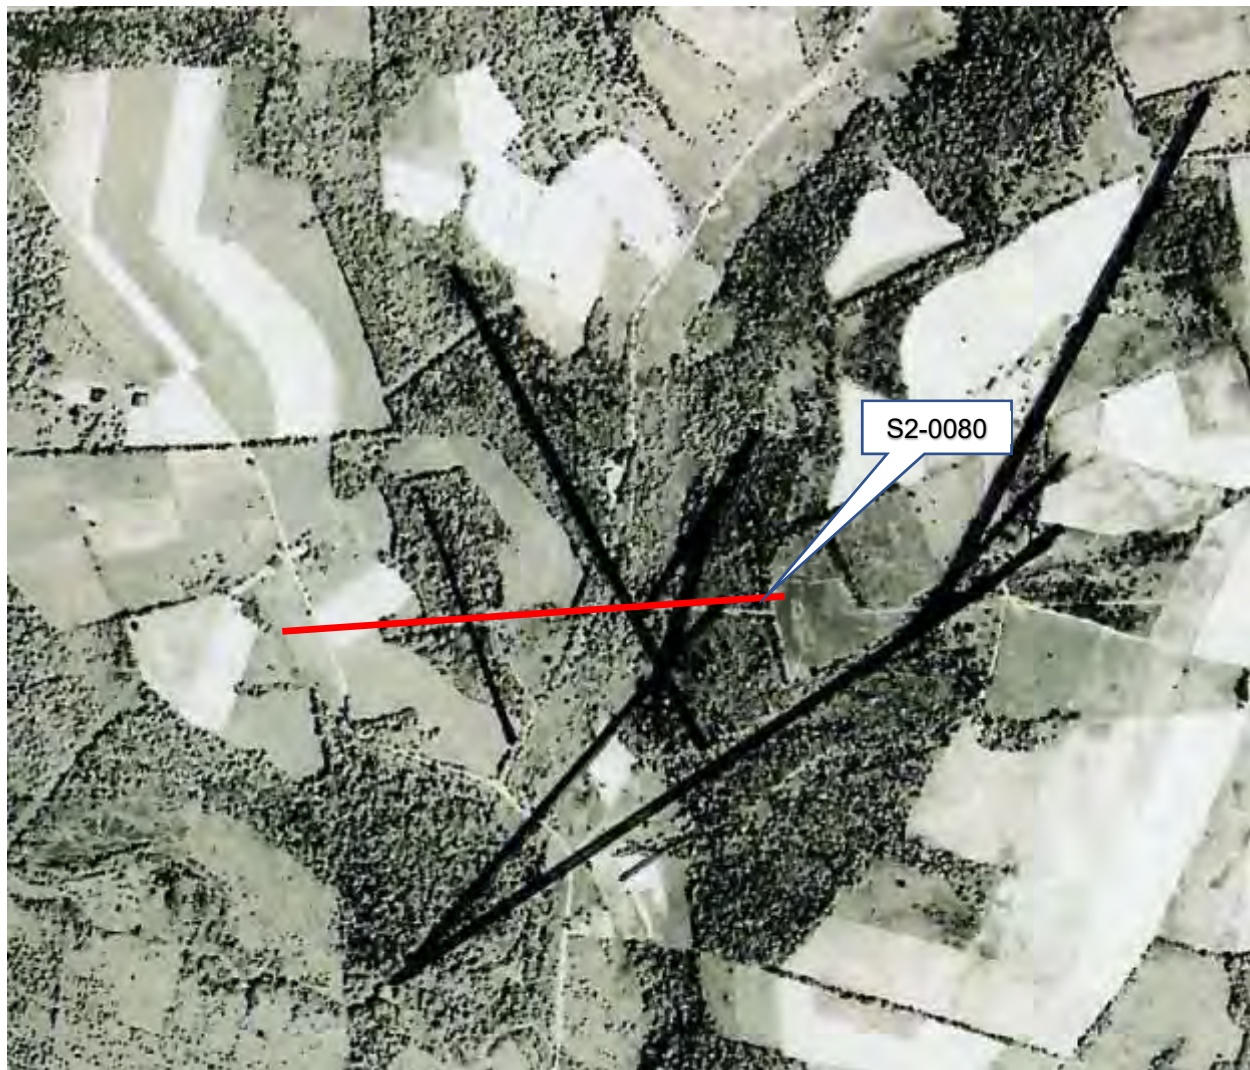
The proposed path of the revised boring is shown in red on **Figure 4** and transects five of the mapped fracture traces. Two of these traces intersect at a location east-central along the drill path. Fracture trace intersections can be areas of exceptionally fractured, low strength, bedrock.

Figure 4. Fracture Trace Map

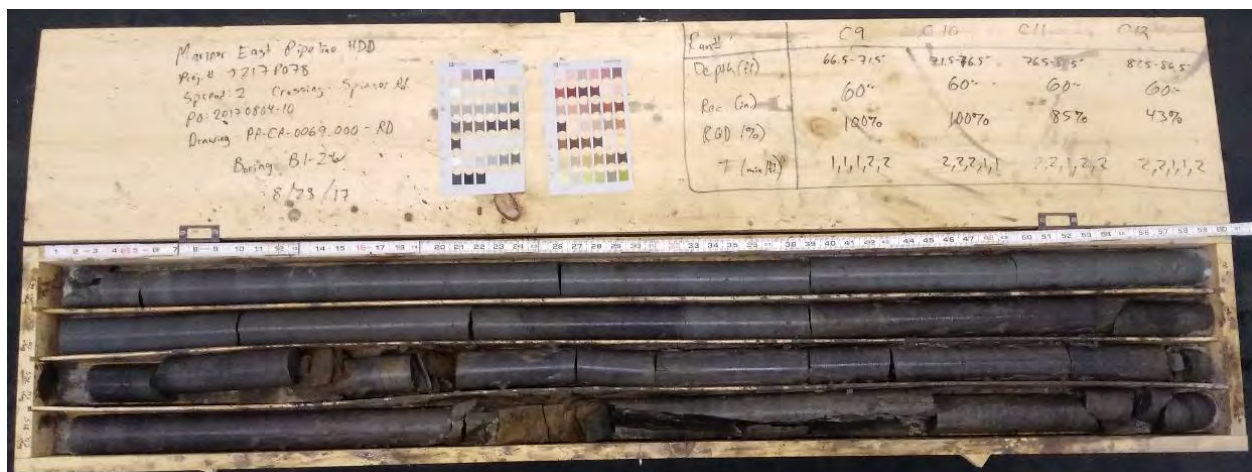
Photograph 2: B2-1W, Samples C-5 to C-8 (46.5 to 66.5 feet)

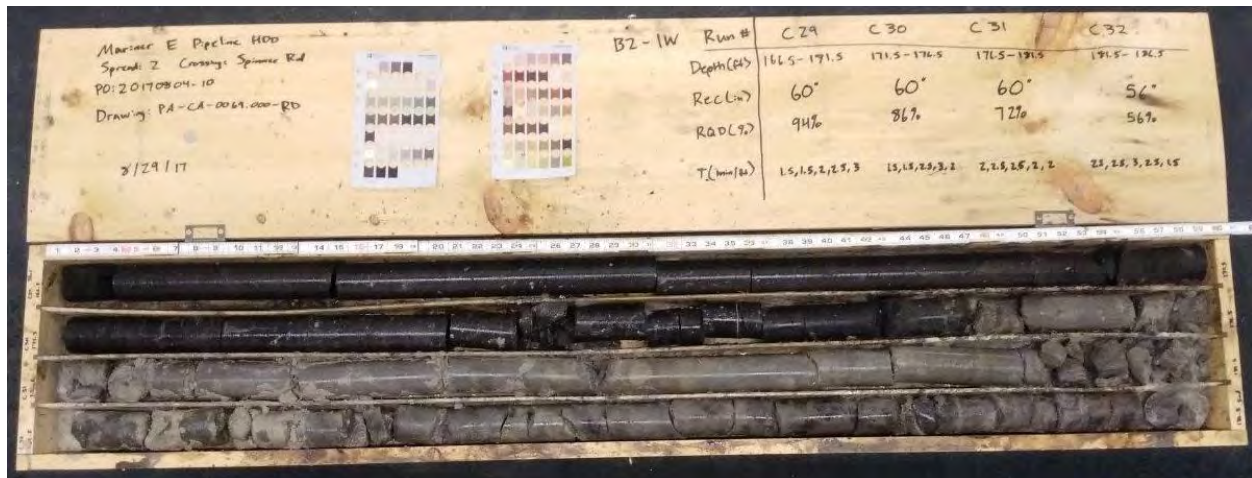
Photograph 7: B2-1W, Samples C-25 to C-28 (146.5 to 166.5 feet)

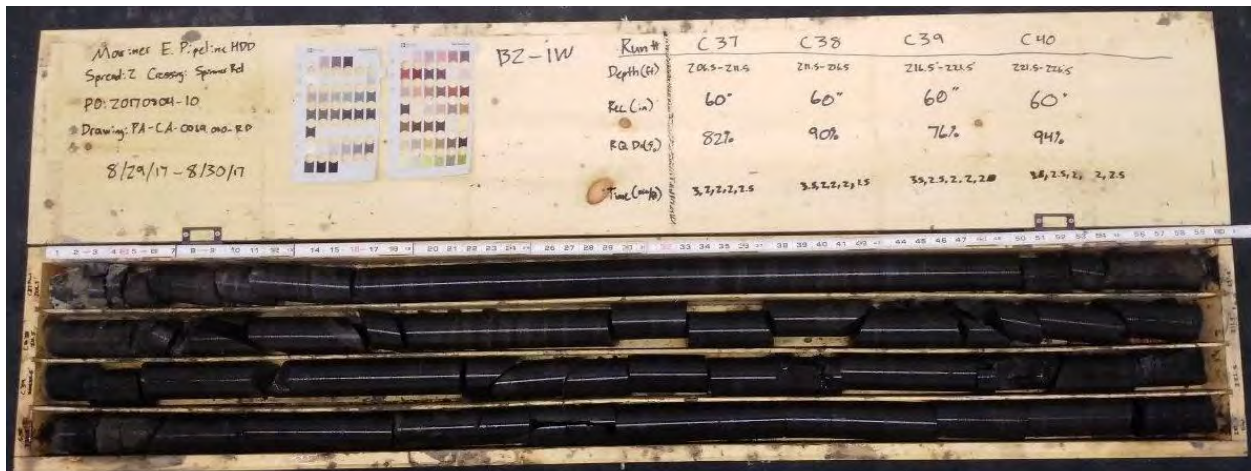
Photograph 9: B2-1W, Samples C-33 to C-36 (186.5 to 206.5 feet)

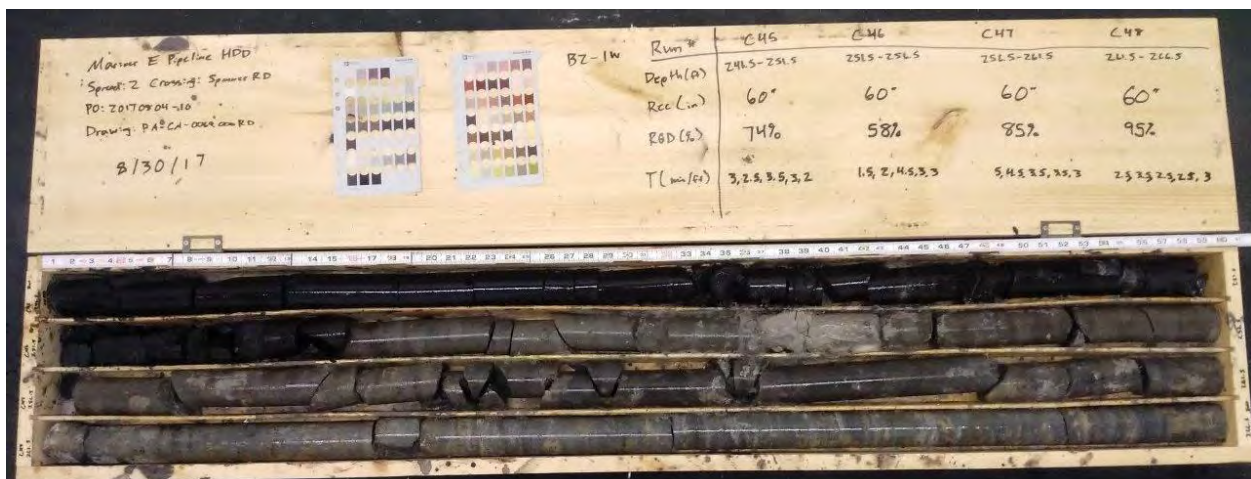
Photograph 11: B2-1W, Samples C-41 to C-44 (226.5 to 246.5 feet)

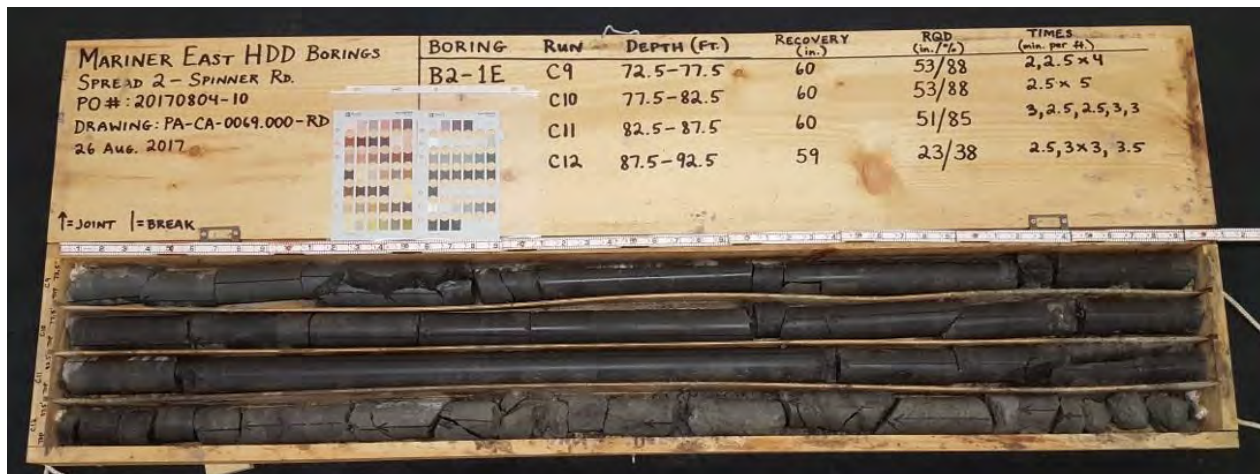
Photograph 2: B2-1E, Samples C-5 to C-8 (52.5 to 72.5 feet)
