Re: Reevaluation Report
Yellow Breeches Creek Re-Evaluation (S2-0250)
Permit No. E21-449
Upper Allen Township, Cumberland County

**HORIZONTAL DIRECTIONAL DRILL ANALYSIS
YELLOW BREECHES CREEK CROSSING
PADEP SECTION 105 PERMIT NO.S: E21-449
PA-CU-0203.0000-WX & PA-CU-0203.0000-WX-16
(SPLP HDD No. S2-0250)**

**YELLOW BREECHES CROSSING
PADEP SECTION 105 PERMIT NO.S: E21-449
PA-CU-0203.0000-WX & PA-CU-0203.0000-WX-16
(SPLP HDD No. S2-0250)**

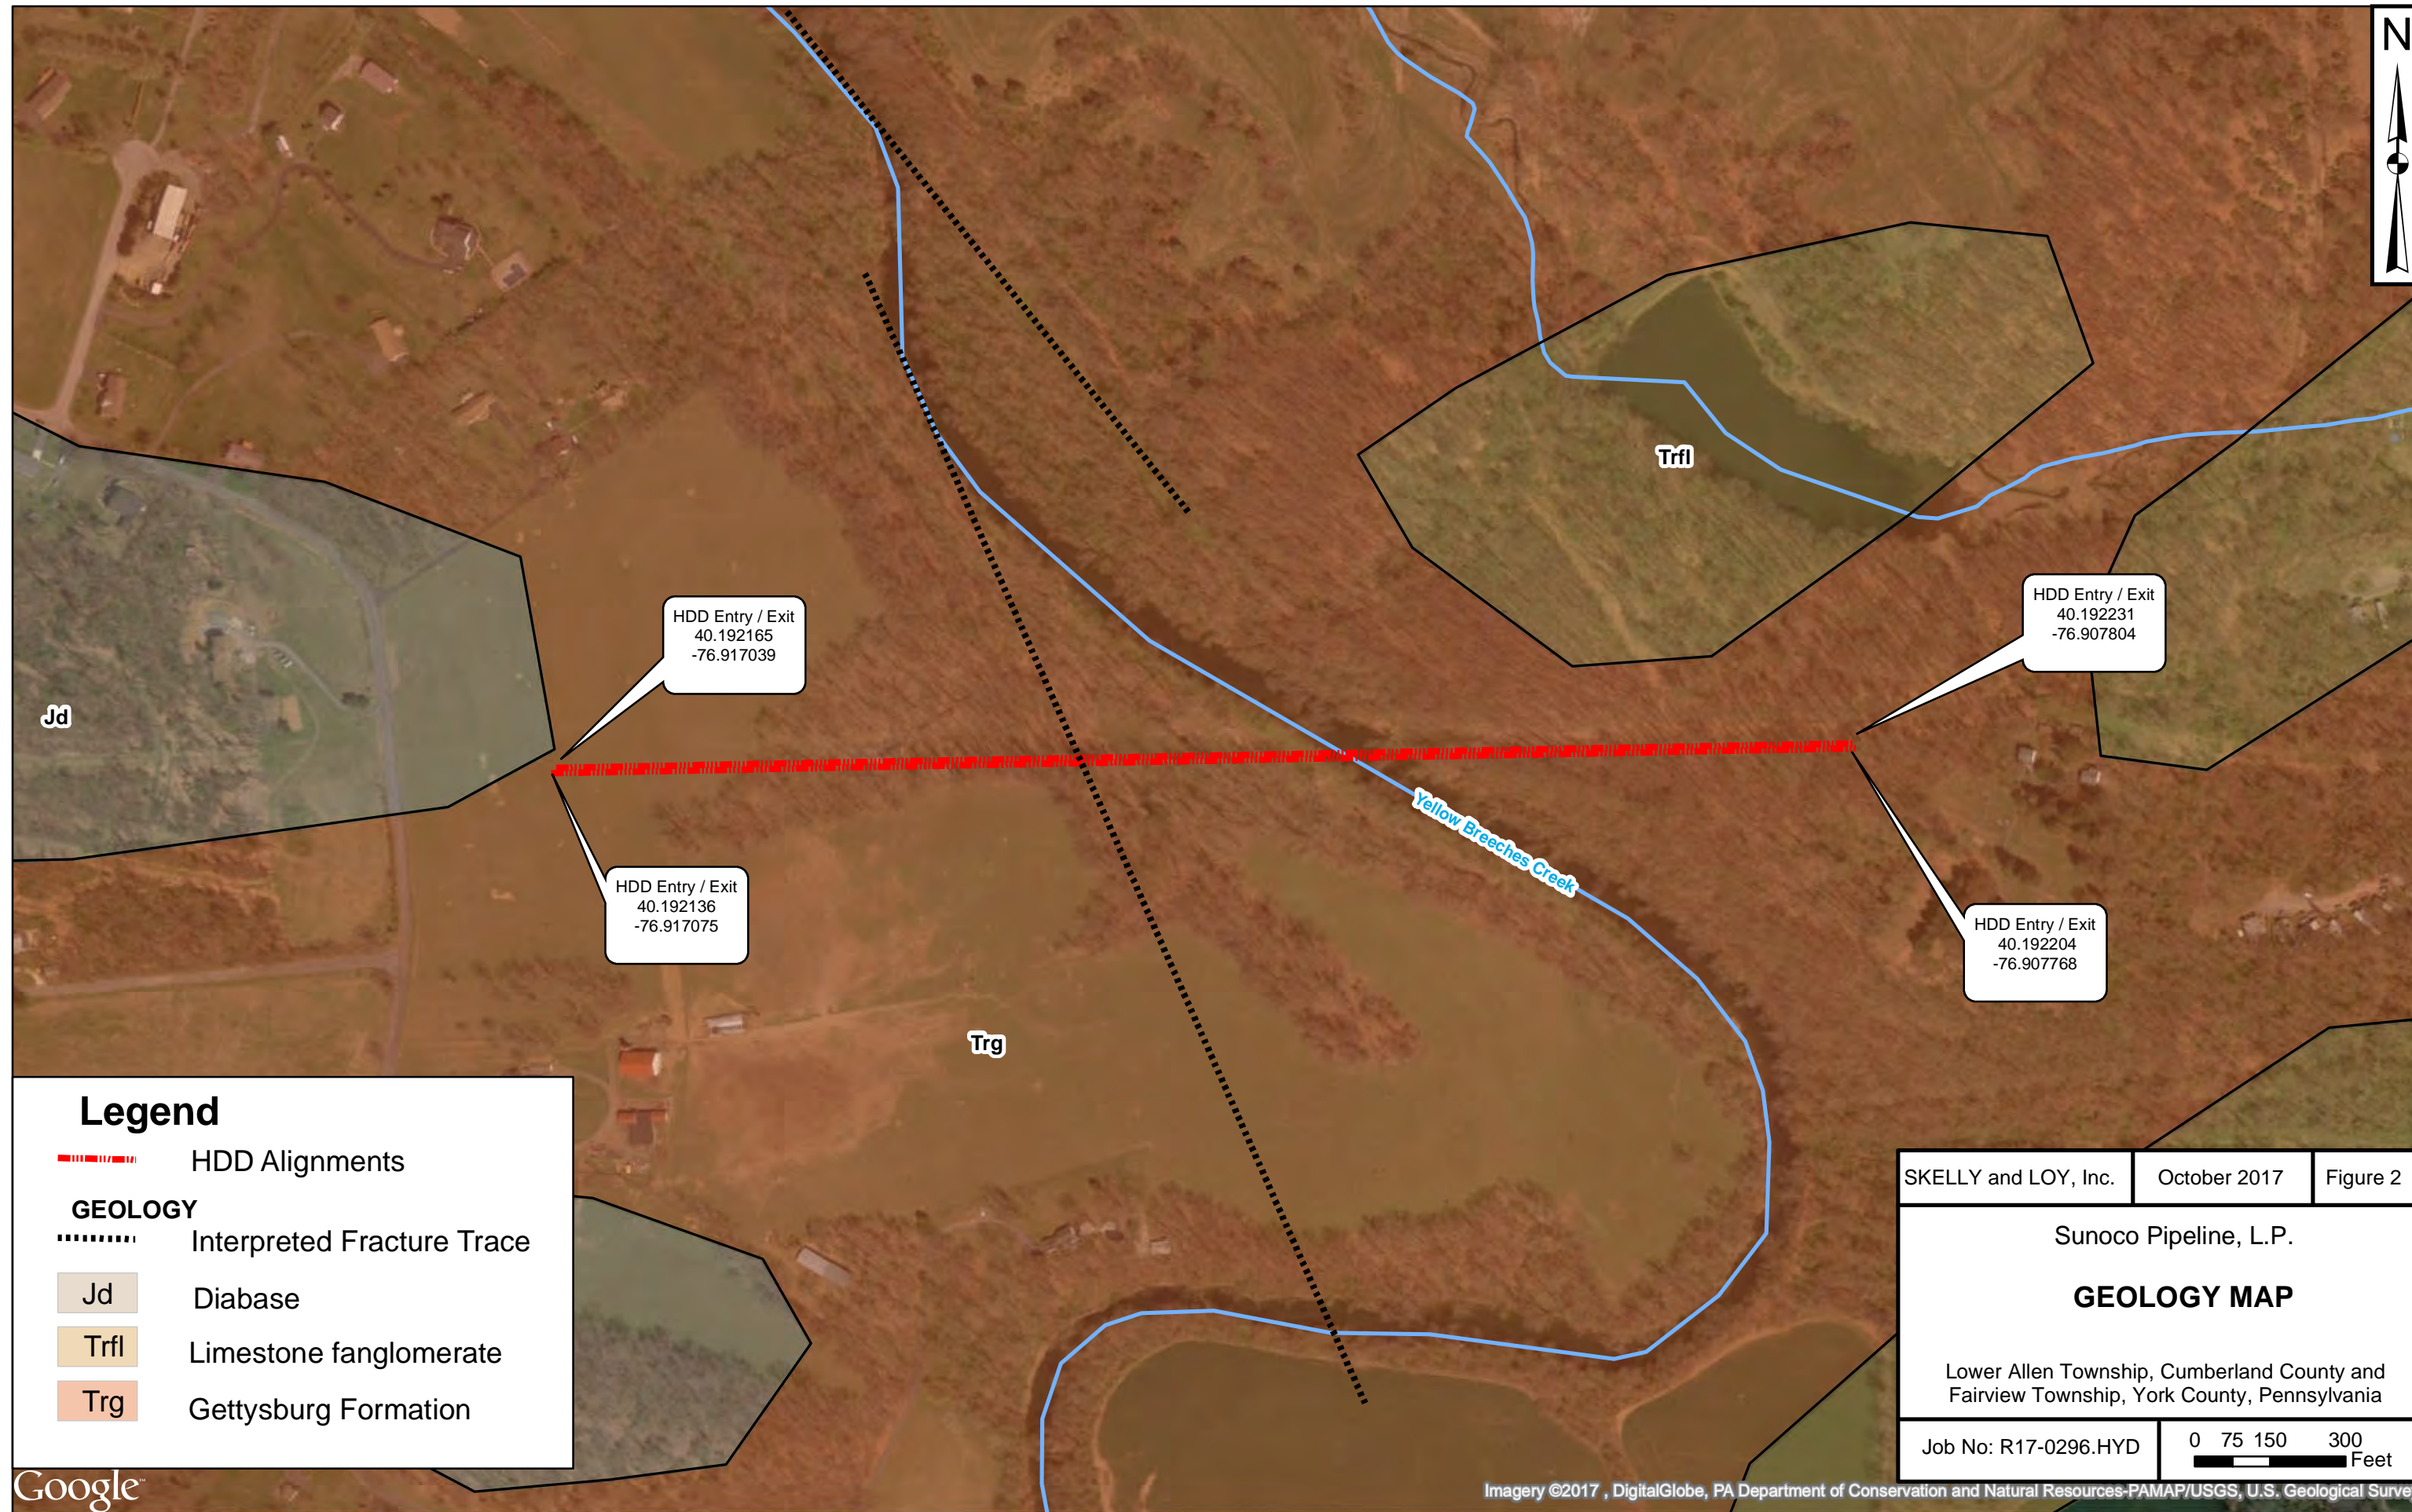
SKELLY and LOY, Inc.	October 2017	Figure 2
Sunoco Pipeline, L.P.		
GEOLOGY MAP		
Lower Allen Township, Cumberland County and Fairview Township, York County, Pennsylvania		
Job No: R17-0296.HYD

Interpreted Fracture Trace
-

According to Wood (1980), two NW-SE trending fracture traces are mapped in the vicinity of the HDD path. One of these interpreted fracture traces crosses the HDD path approximately 1,000 feet east of the western end (entry point) of the HDD. The second trace terminates approximately 500 feet north of the central portion of the HDD path. These mapped fracture traces are shown on **Figures 2 and 3**.

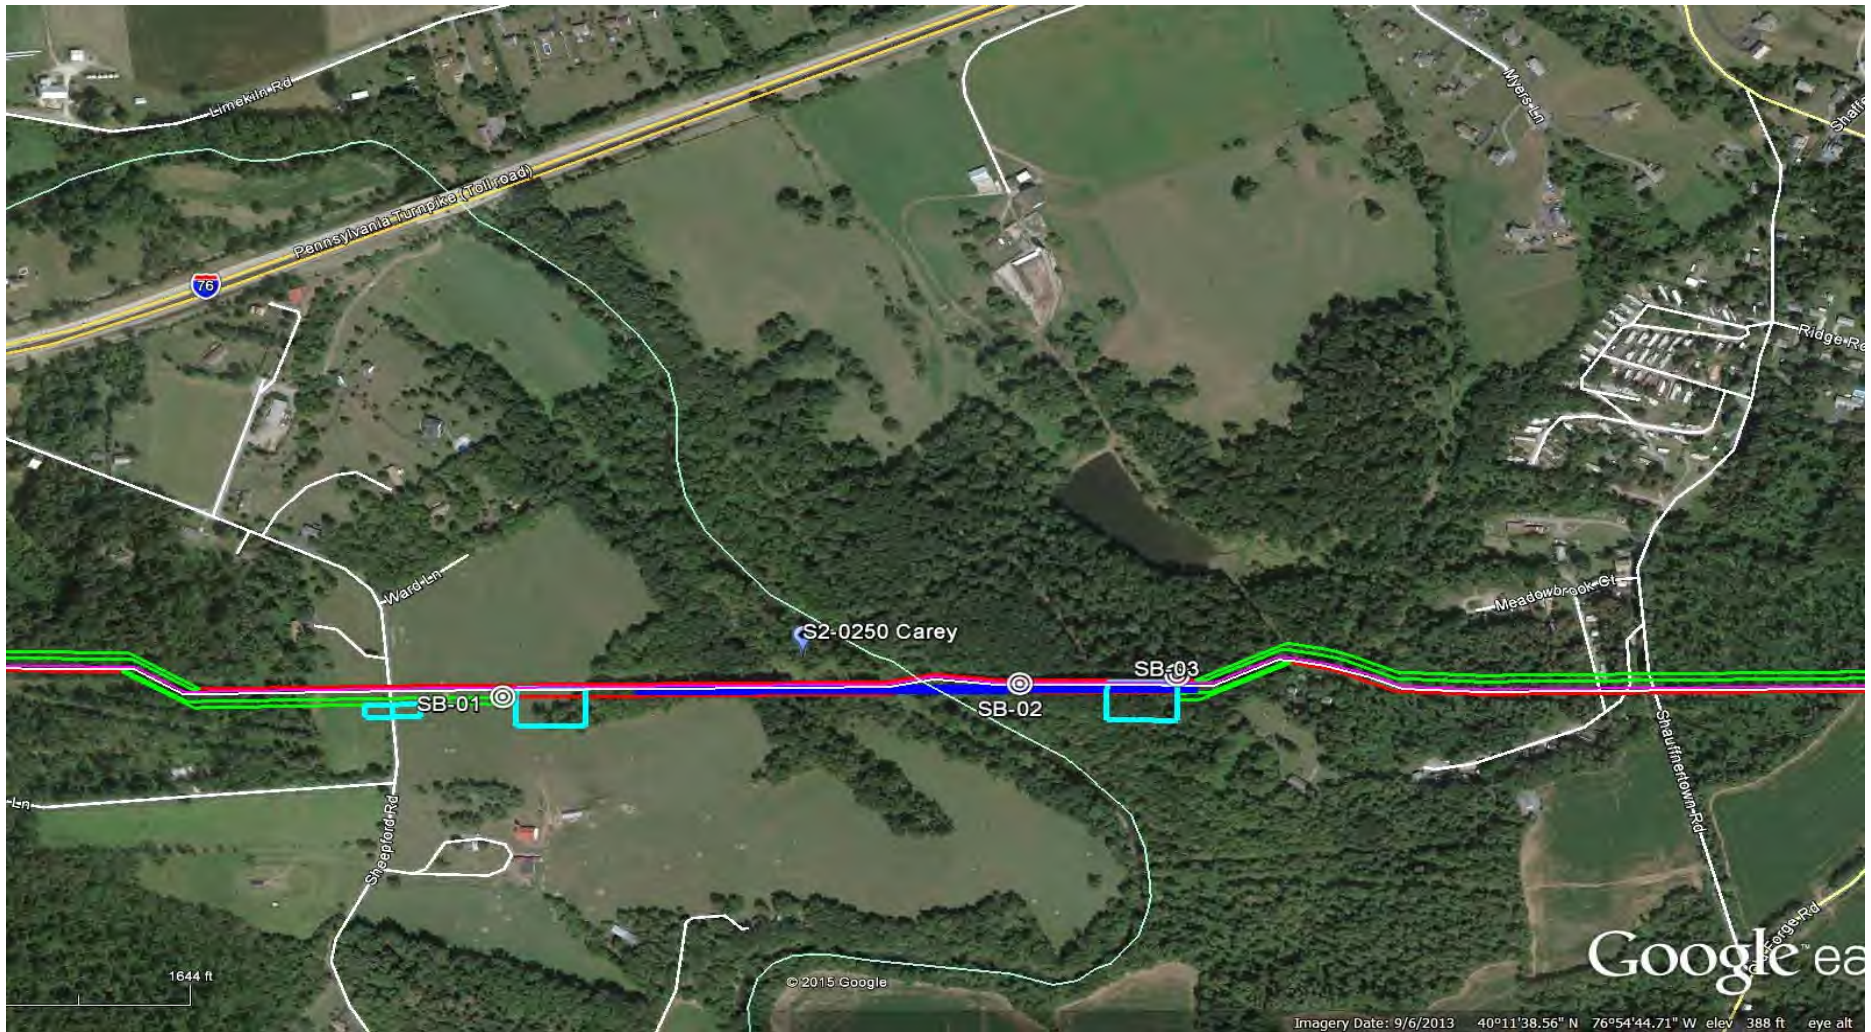
⊙ Geotechnical Soil Boring (SB) Locations

Five geotechnical borings were completed from October 25, 2014, through August 31, 2017, during the preliminary investigation of HDD S2-0250 and prior to initiating HDD operations. The five borings are located within the HDD limit of disturbance (LOD). The borings were completed to investigate soil, residual soil, and bedrock conditions using hollow-stem auger drilling methods for the soil investigation and core barrel/bit for the bedrock investigation. **Attachment 2** presents a map depicting the boring locations, boring logs, and a geotechnical report for the two studies.

SB-01 was located near the western HDD entry/exit point, SB-02 was located just east of Yellow Breeches Creek and the wetland, and SB-03 was located near the easternmost entry/exit point. The generalized subsurface profile observed in SB-01 through SB-03 is described below.

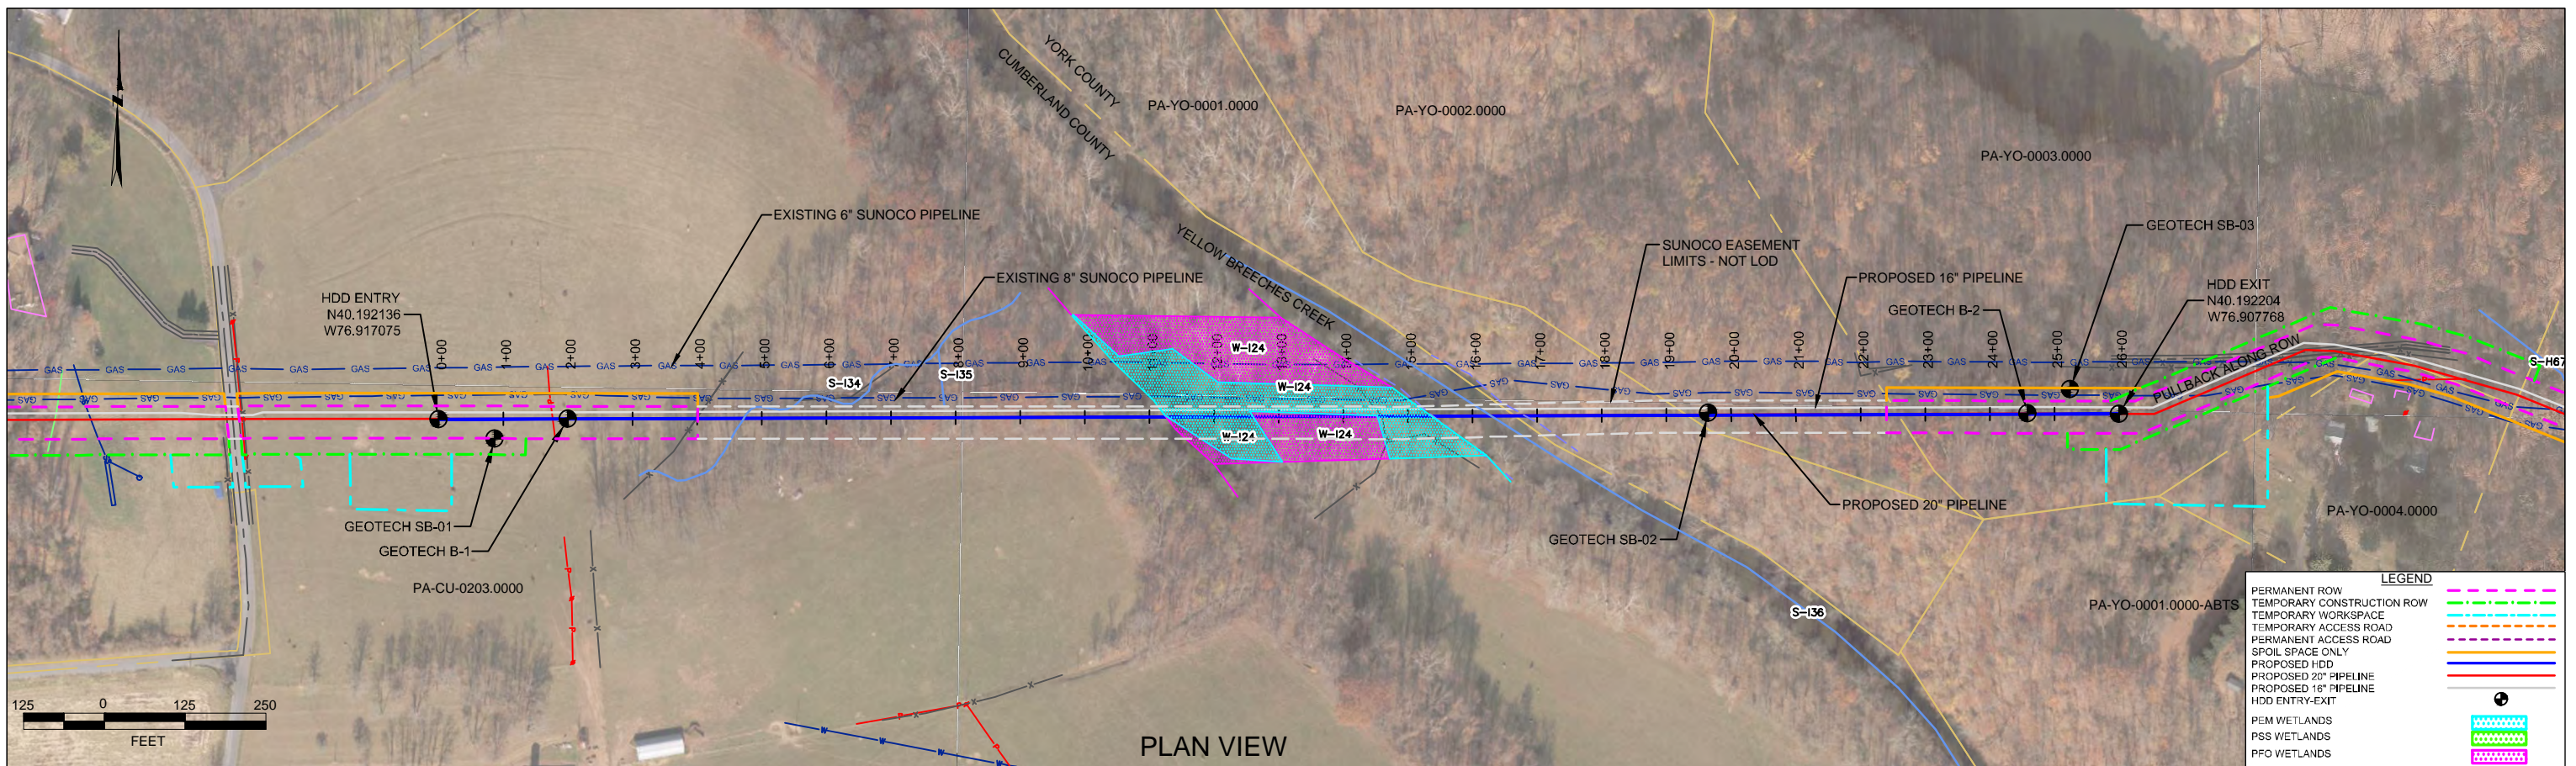
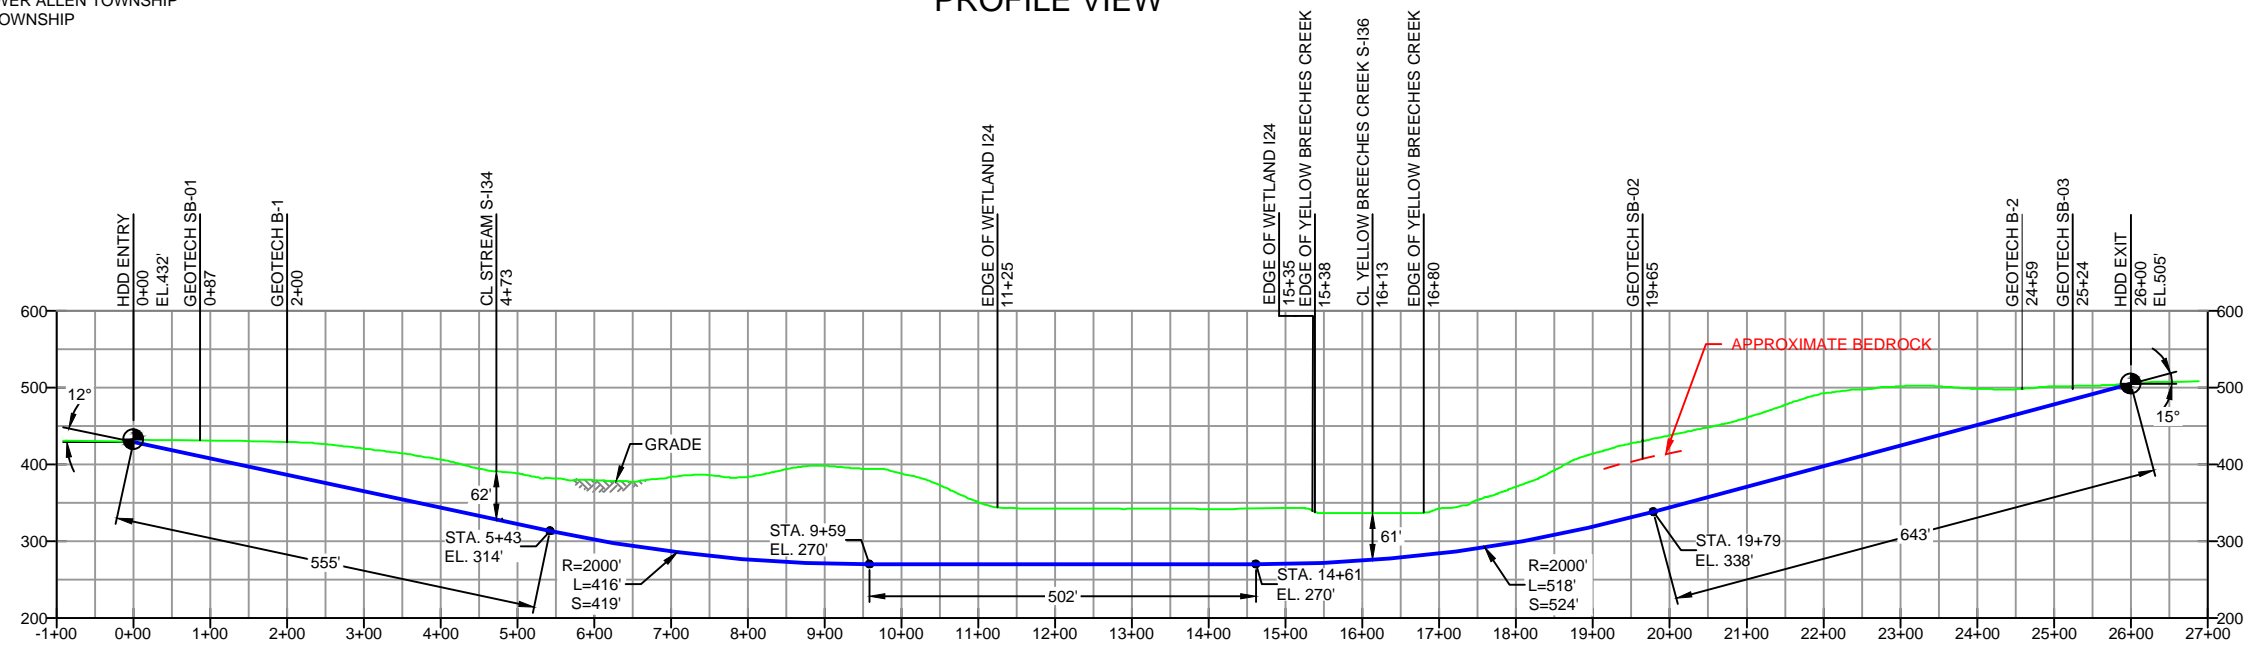
SCALE: 1"=250'
 DWG. NUMBER: PA-CU-0203.0000-WX

PLAN VIEW

PROFILE VIEW

- GEOTECH SB-01**
 -NG EL. 432'
 -TOPSOIL (0.0' - 0.5')
 -CL/ML (0.5' - 6.5')
 -SANDSTONE (6.5' - 7.2')
 -AUGER REFUSAL (7.0')
 -COMPLETION DEPTH EL. 425'
- GEOTECH SB-02**
 -NG EL. 430'
 -SM (0.0' - 25.0')
 -SANDSTONE (25.0' - 34.0')
 -AUGER REFUSAL (34.0')
 -REDDISH BROWN SANDSTONE (34.0' - 43.0')
 -COMPLETION DEPTH EL. 388'
- GEOTECH SB-03**
 -NG EL. 498'
 -TOPSOIL (0' - 0.4')
 -SM (0.4' - 12.5')
 -MLVCL (12.5' - 18.5')
 -SILTY SAND (18.5' - 22.8')
 -COMPLETION DEPTH EL. 475'

- GEOTECH B-1**
 -NG EL. 429'
 -LEAN CLAY CL (0.0' - 2.0')
 -CLAYEY GRAVEL GC (2.0' - 4.0')
 -SILTY SAND SM (4.0' - 8.0')
 -GROUNDWATER (7.0')
 -SILTY SAND SM (8.0' - 12.0')
 -DIABASE/SANDSTONE (12.0' - 180.0')
 -COMPLETION DEPTH EL. 249'

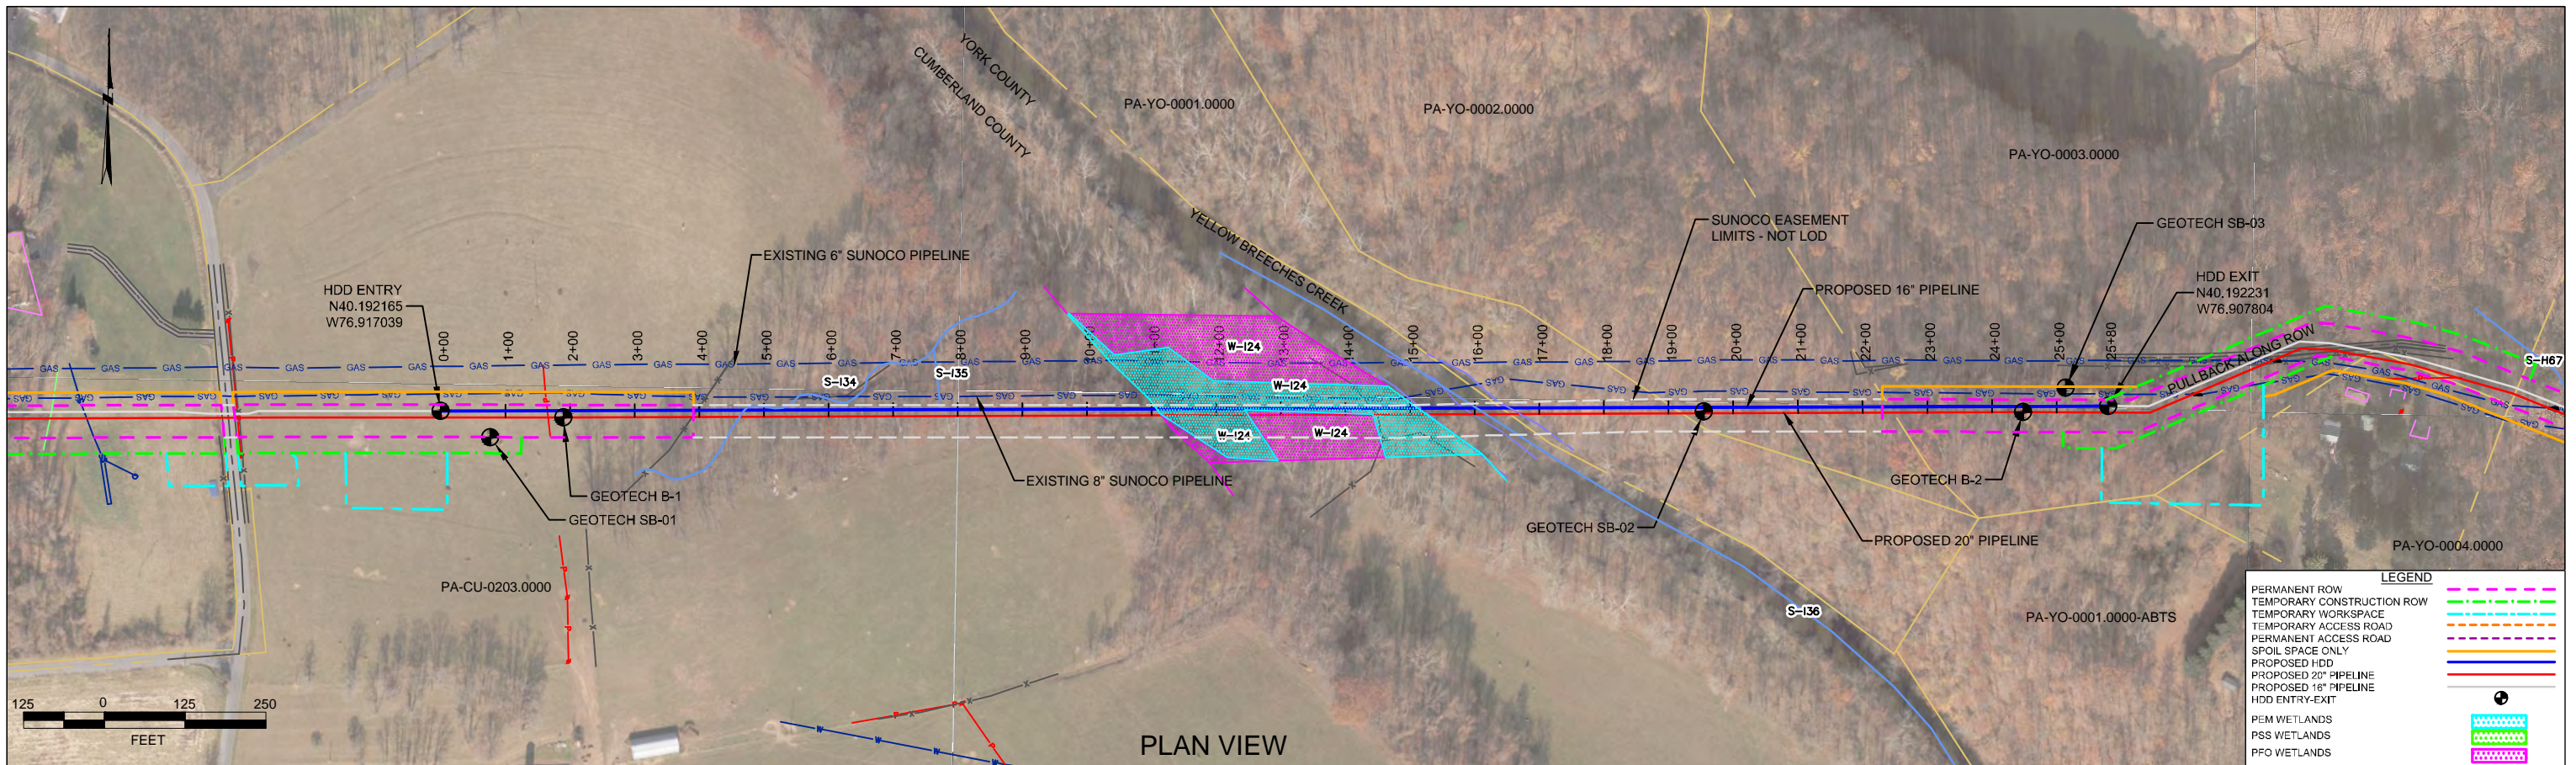
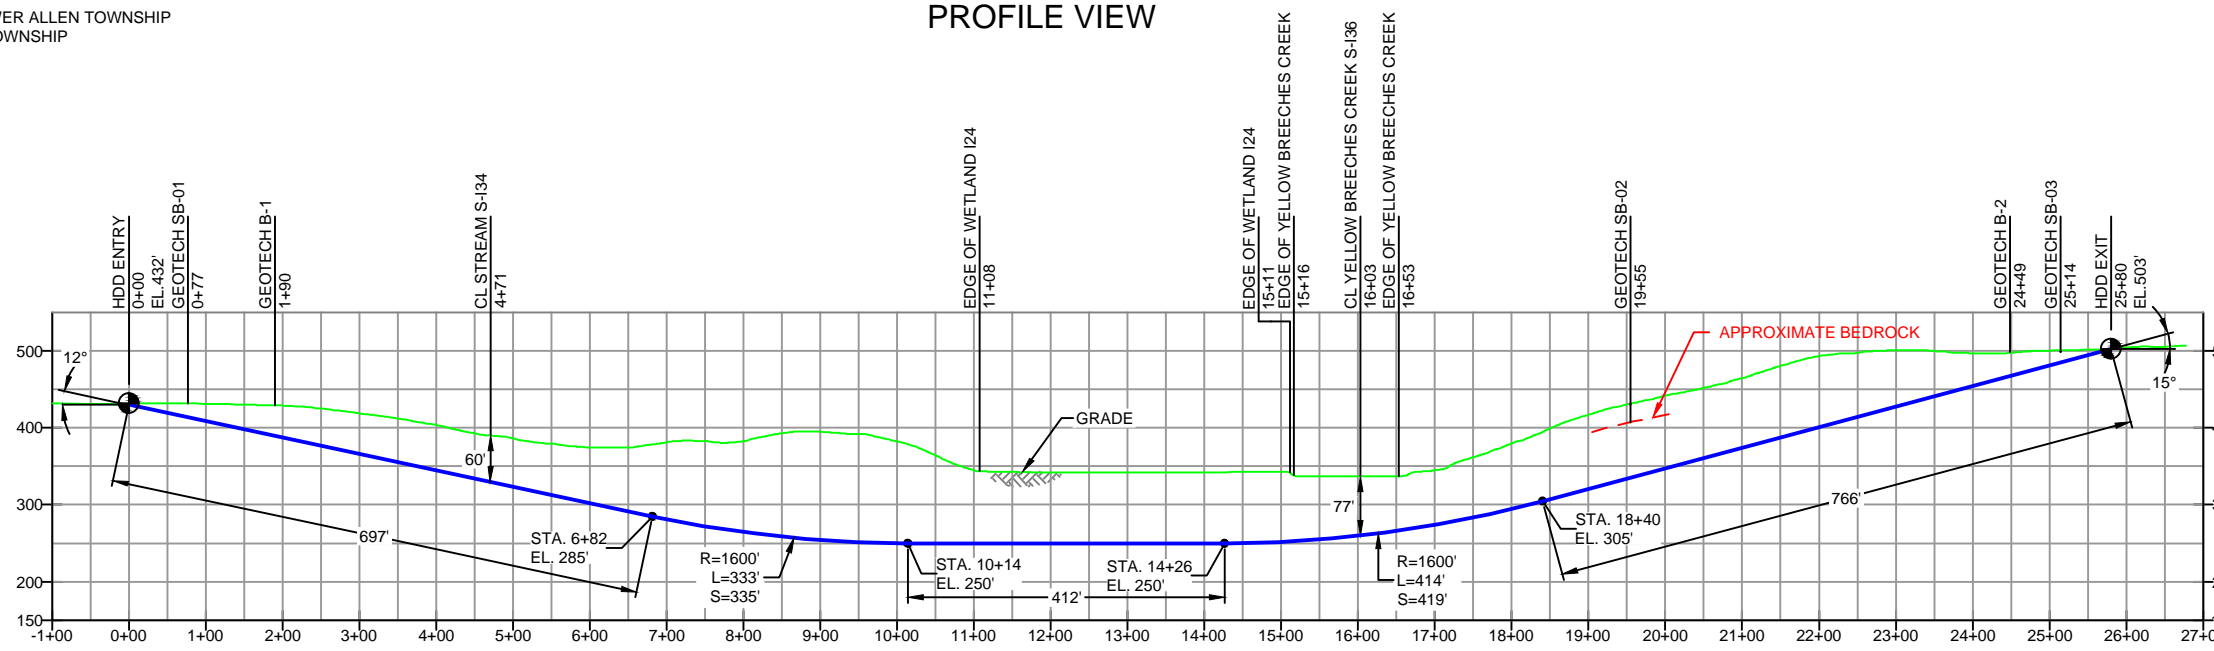
CUMBERLAND COUNTY, PENNSYLVANIA - LOWER ALLEN TOWNSHIP
 YORK COUNTY, PENNSYLVANIA - FAIRVIEW TOWNSHIP
 S2-0250-16

PLAN VIEW
 PROFILE VIEW

- DESIGNED IN ACCORDANCE WITH CFR 49 195 & ASME B31.4
 - CROSSING PIPE SPECIFICATION:
 HDD HORZ. LENGTH (L_H): 2580'
 HDD PIPE LENGTH (S): 2629'
 16" x 0.438" W.T., X-70, API5L, PSL2, ERW, 8FW
 COATING: 14-16 MILS FBE WITH 30-35 MIL ARO (POWERCRETE OR ENGINEER APPROVED EQUAL)

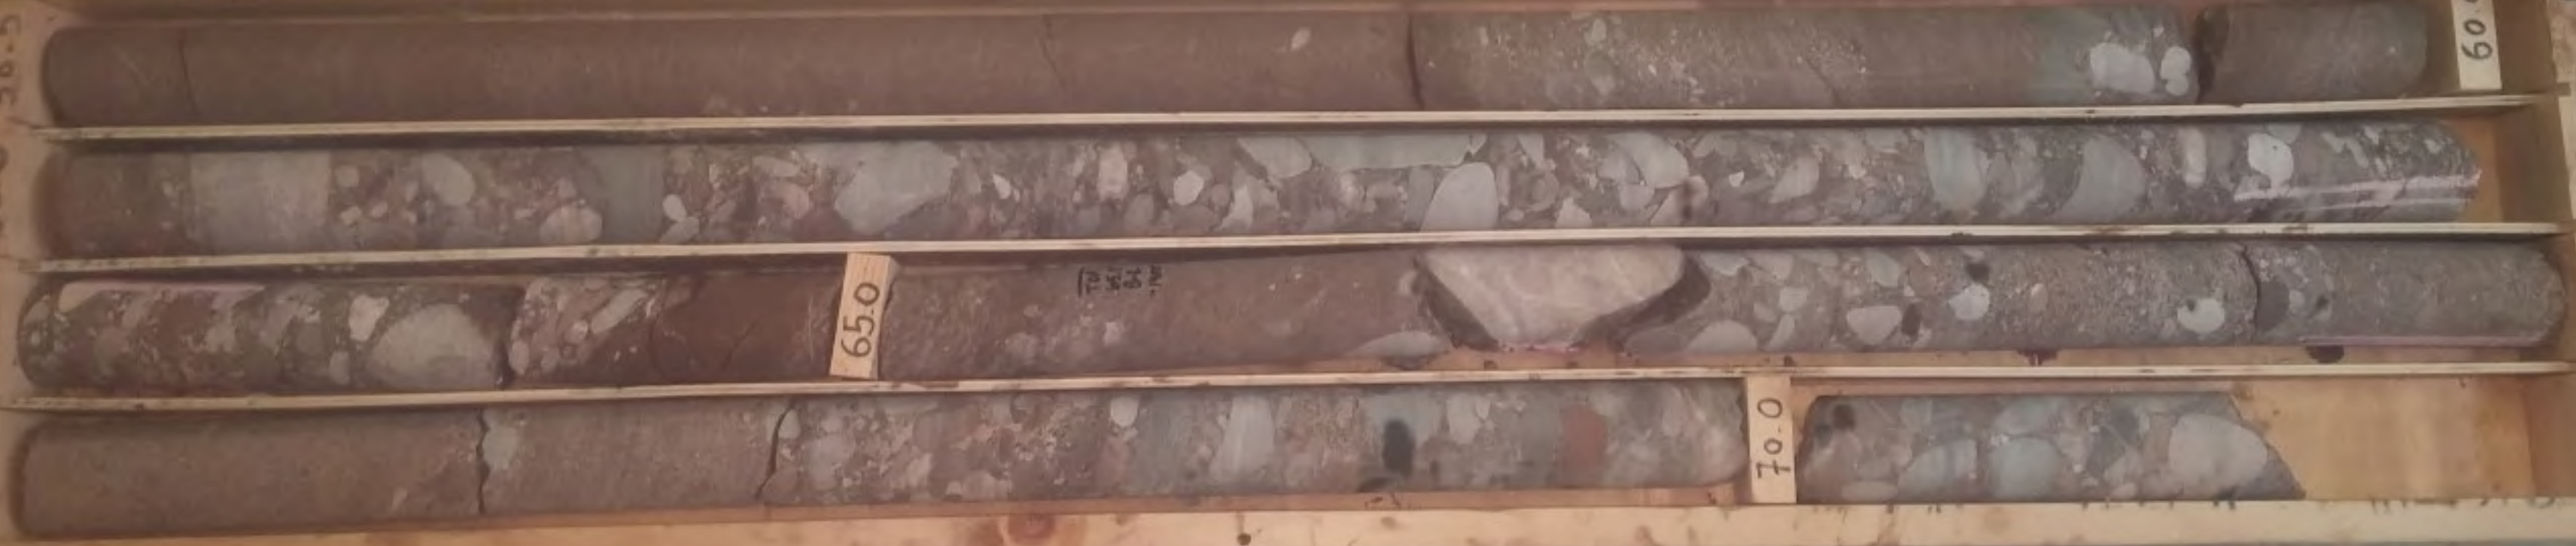
Run	Depth	Reclin	RQD (%)
8	60-65	60"	52"
9	65-70	60"	58"
10	70-75	58"	53"

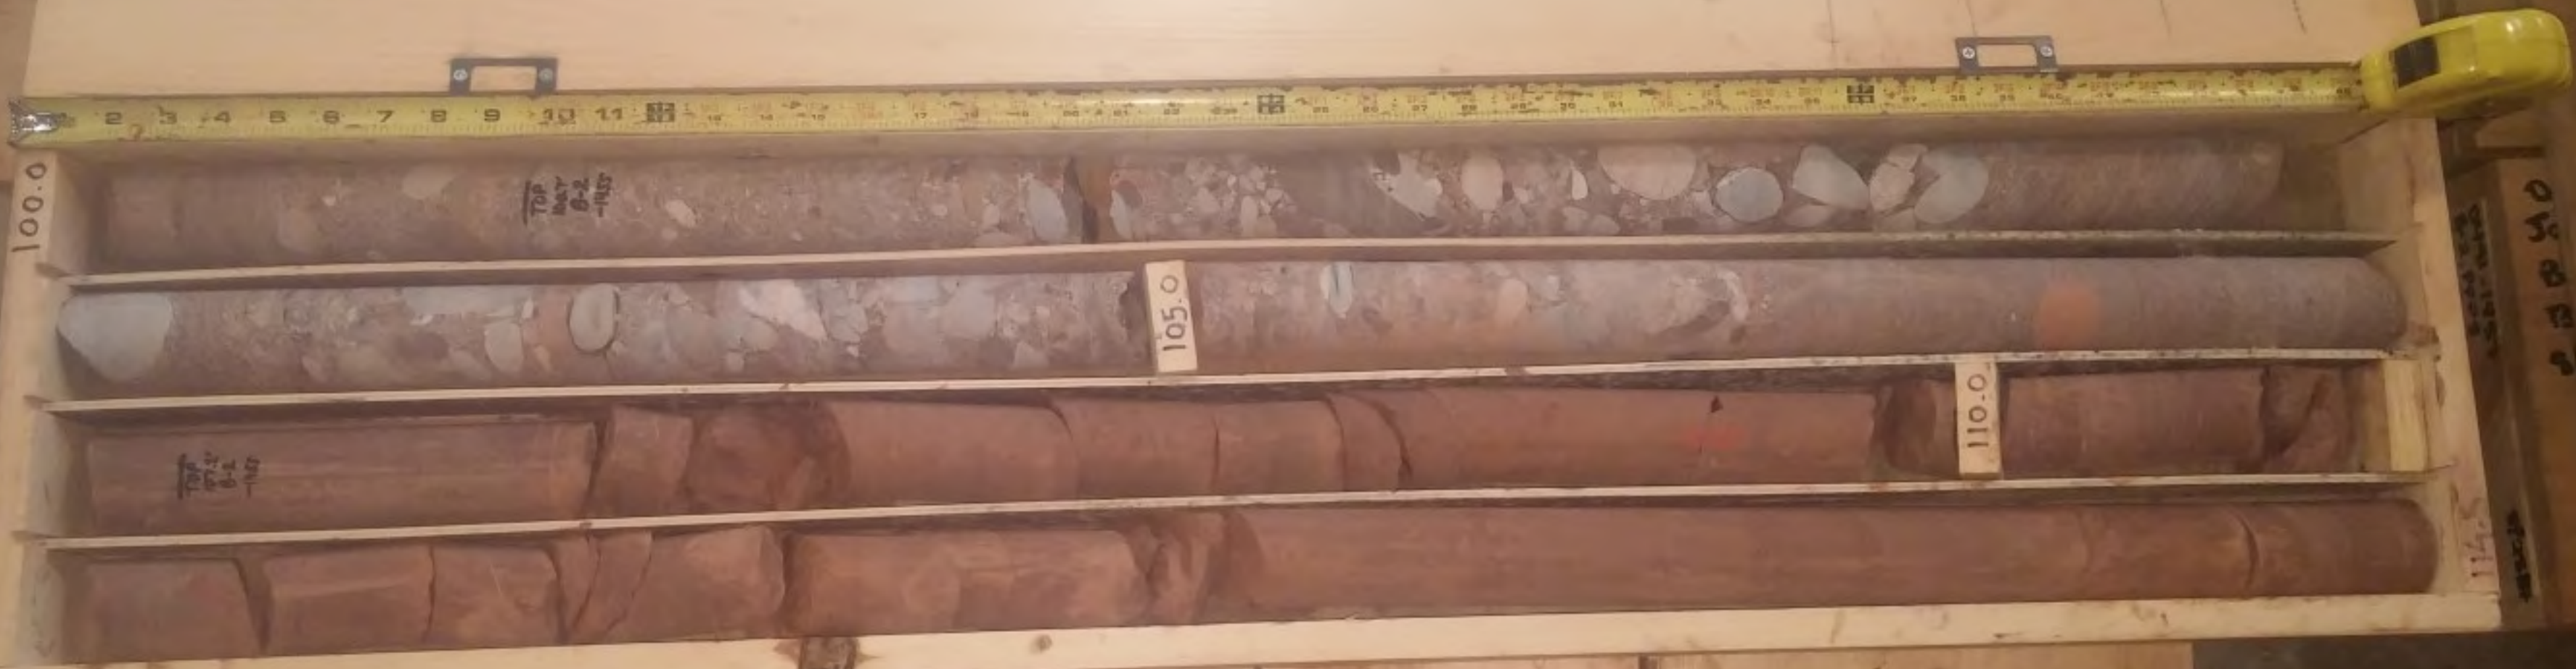
PPP 4
 0491 1455
 HDD Boring (B-2)
 08/29/17
 Depth: 100.0ft - 114.5ft.
 Box: 60ft
 Shaferstown Rd, New Cumberland, PA

Run Box	Depth	Rec	Rqd
16	100-105	60"	56"
17	105-110	60"	49"
18	110-115	60"	37"

The bedrock in both borings was described as ranging from moderately hard to extremely hard and broken to massive. Photographs of the cores obtained from B-1 and B-2 are included in **Attachment 2**.

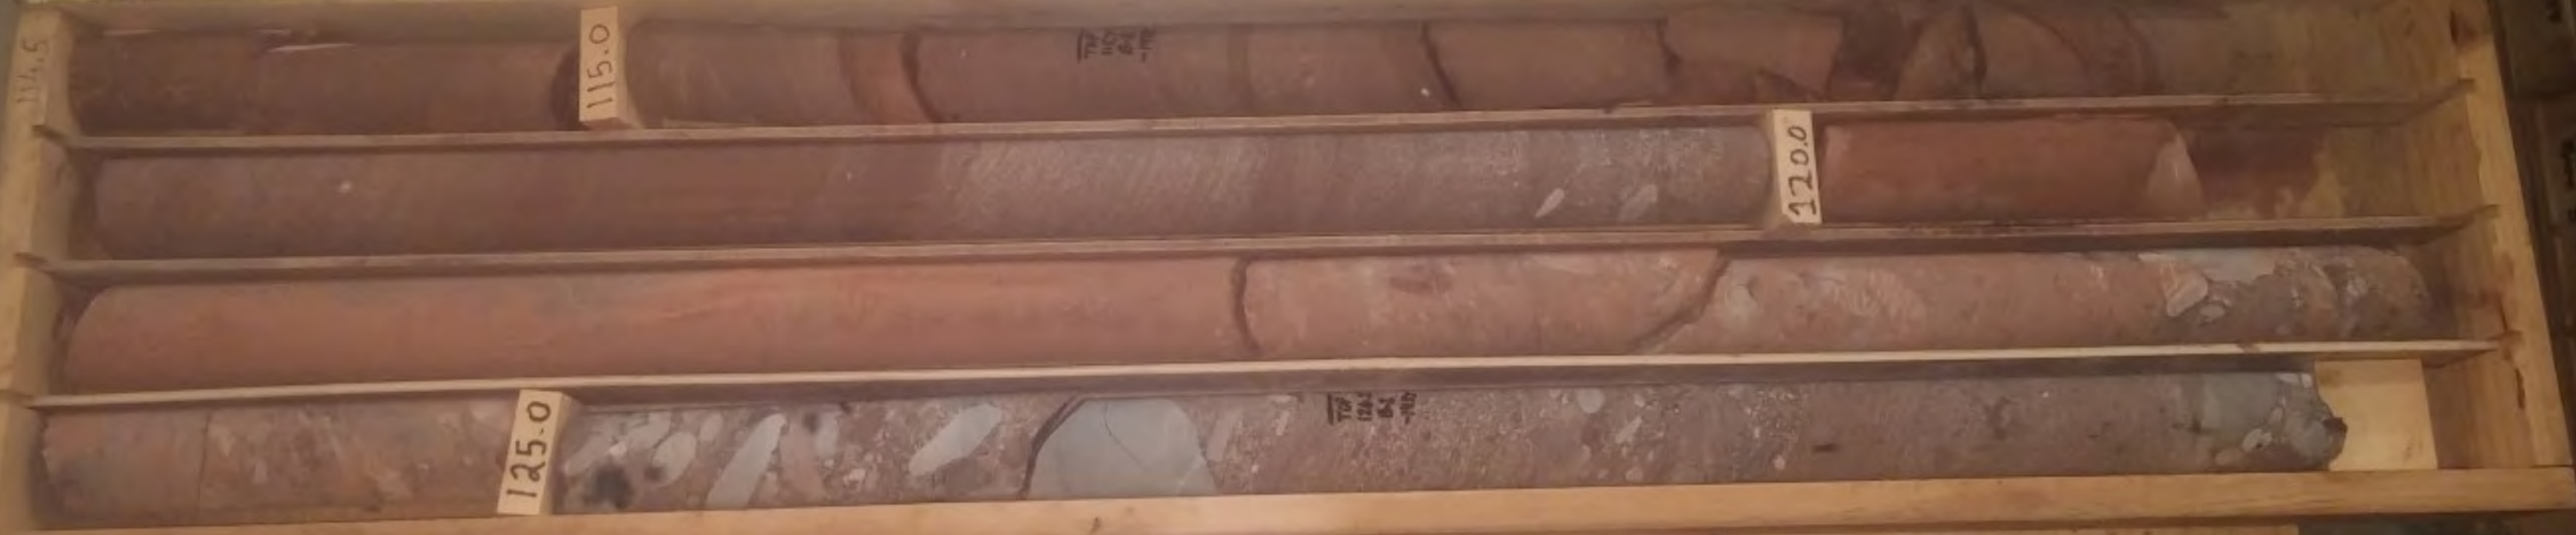
0491 1455
HDD Boring 15-20
08/29/17
Depth: 114.5ft - 128.0ft.
Box: 7 of
Schaffertown Rd, New Cumberland, PA

Run	Depth	Rec 60"	Rec 55"
19	115-120	60"	55"
20	120-125	60"	56"
21	125-130	60"	56"

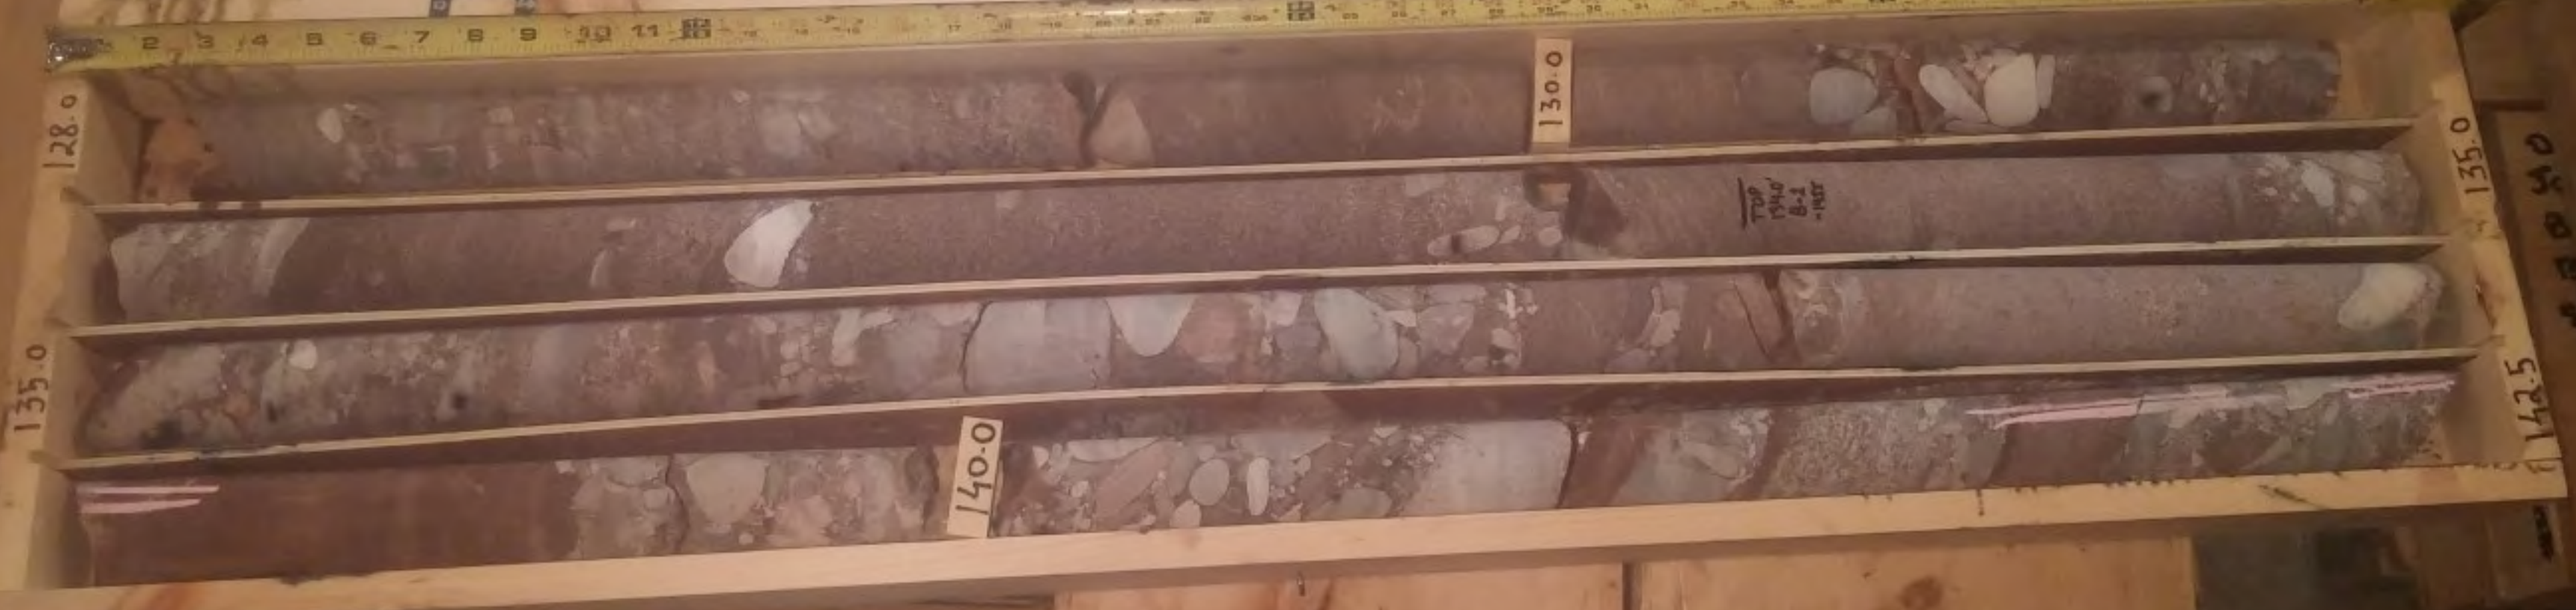
PPP4
 0491 1455
 HDD Boring (B-2)
 08/30/17
 Depth: 128.0ft - 142.5ft
 Box: 8 of
 Schuylkilltown Rd, New Cumberland, PA

Run	Depth(ft)	Rec(in)	RQD(%)
22	130 - 135	60"	55"
23	135 - 140	60"	56"
24	140 - 145	60"	56"

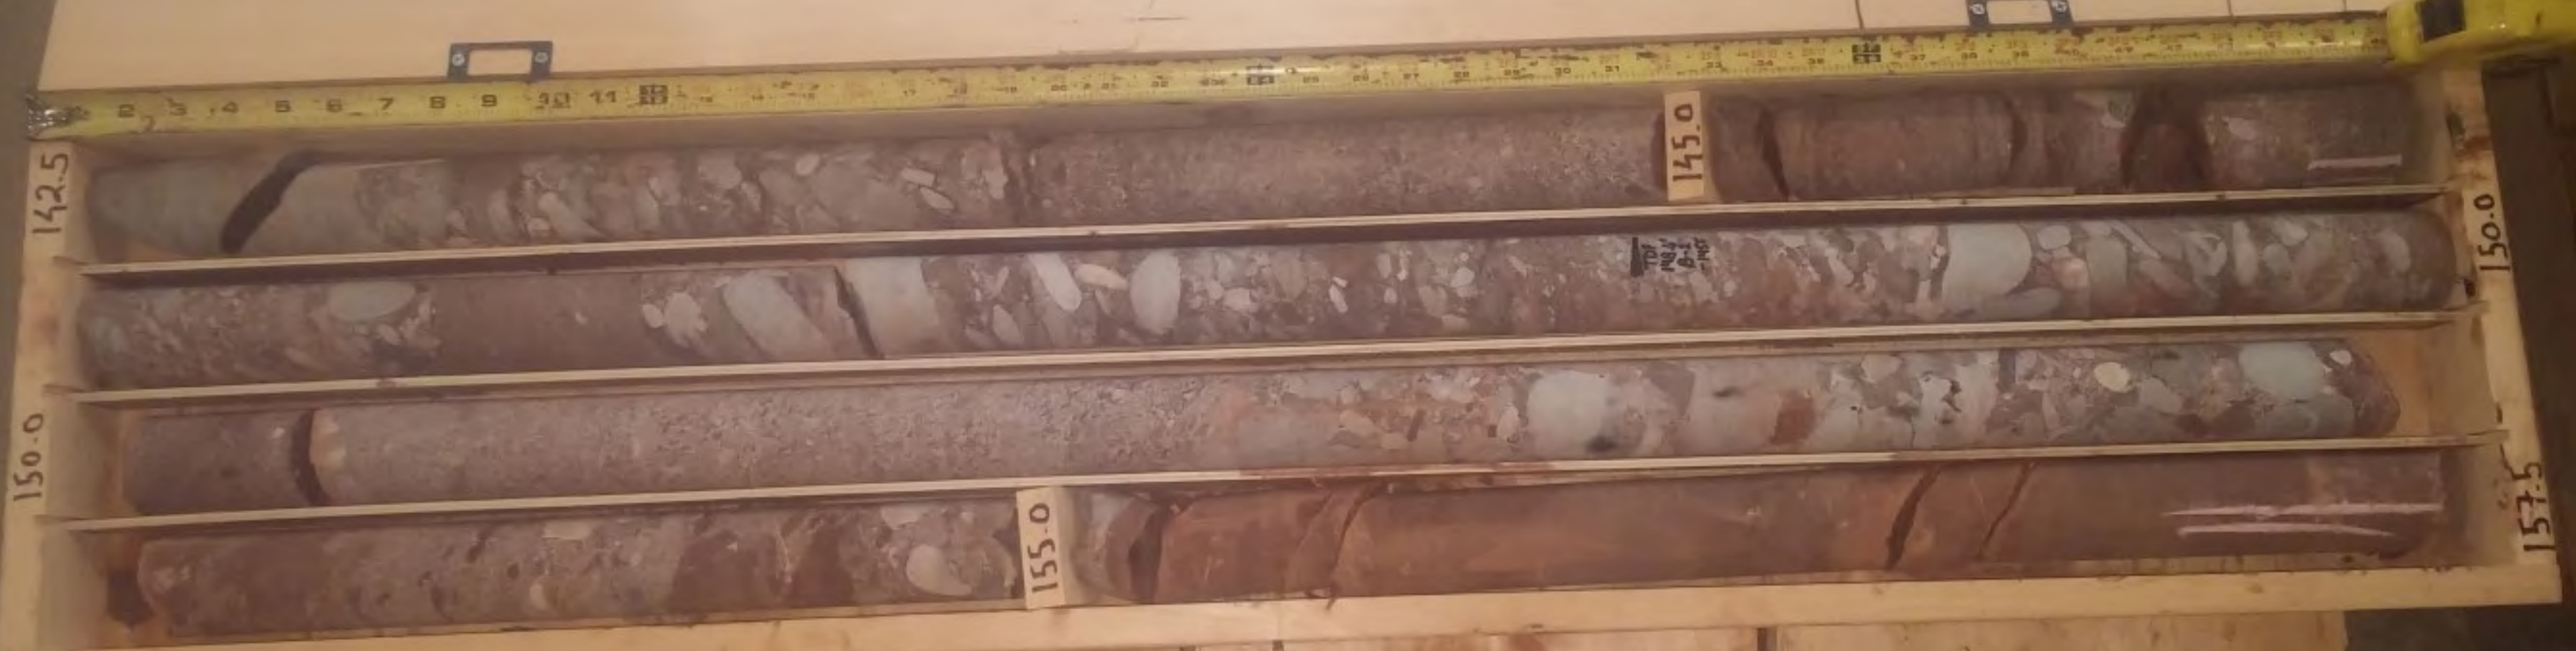
PPP 4
 0491 1455
 HDD Boring (B-2)
 08/30/17
 Depth: (142.5 - 157.5) ft
 Box: 9
 Schauffnertown Rd.

Run	Depth (ft)	Ru	RQD
25	145.0-150.0	60"	50"
26	150.0-155.0	60"	56"
27	155.0-160.0	60"	41"

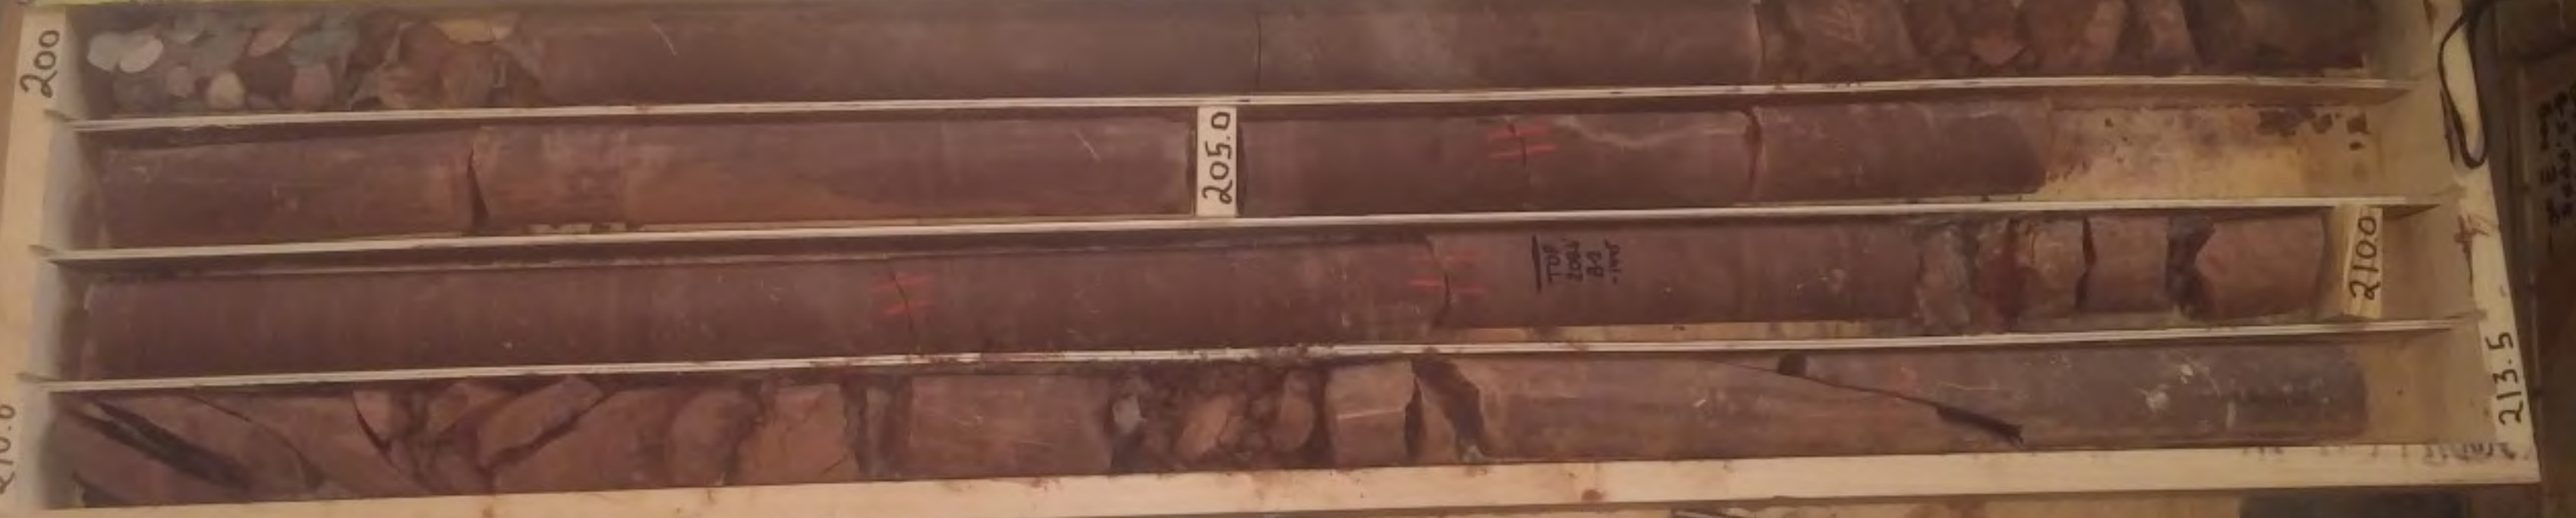
PPP 4
 0491 1455
 HDD Boring (B-2)
 08/30/17
 Depth: 200ft - 213.5 ft
 Box 13 of
 Schauffner town Rd.

Run	Depth	Rec (in)	ROD(S)
36	200 - 205	60"	42"
37	205 - 210	60"	51"
38	210 - 215	60"	36"
