Re: Reevaluation Report
Yellow Breeches Creek Re-Evaluation (S2-0250)
Permit No. E21-449
Upper Allen Township, Cumberland County

**HORIZONTAL DIRECTIONAL DRILL ANALYSIS
YELLOW BREECHES CREEK CROSSING
PADEP SECTION 105 PERMIT NO.S: E21-449
PA-CU-0203.0000-WX & PA-CU-0203.0000-WX-16
(SPLP HDD No. S2-0250)**

**YELLOW BREECHES CROSSING
PADEP SECTION 105 PERMIT NO.S: E21-449
PA-CU-0203.0000-WX & PA-CU-0203.0000-WX-16
(SPLP HDD No. S2-0250)**

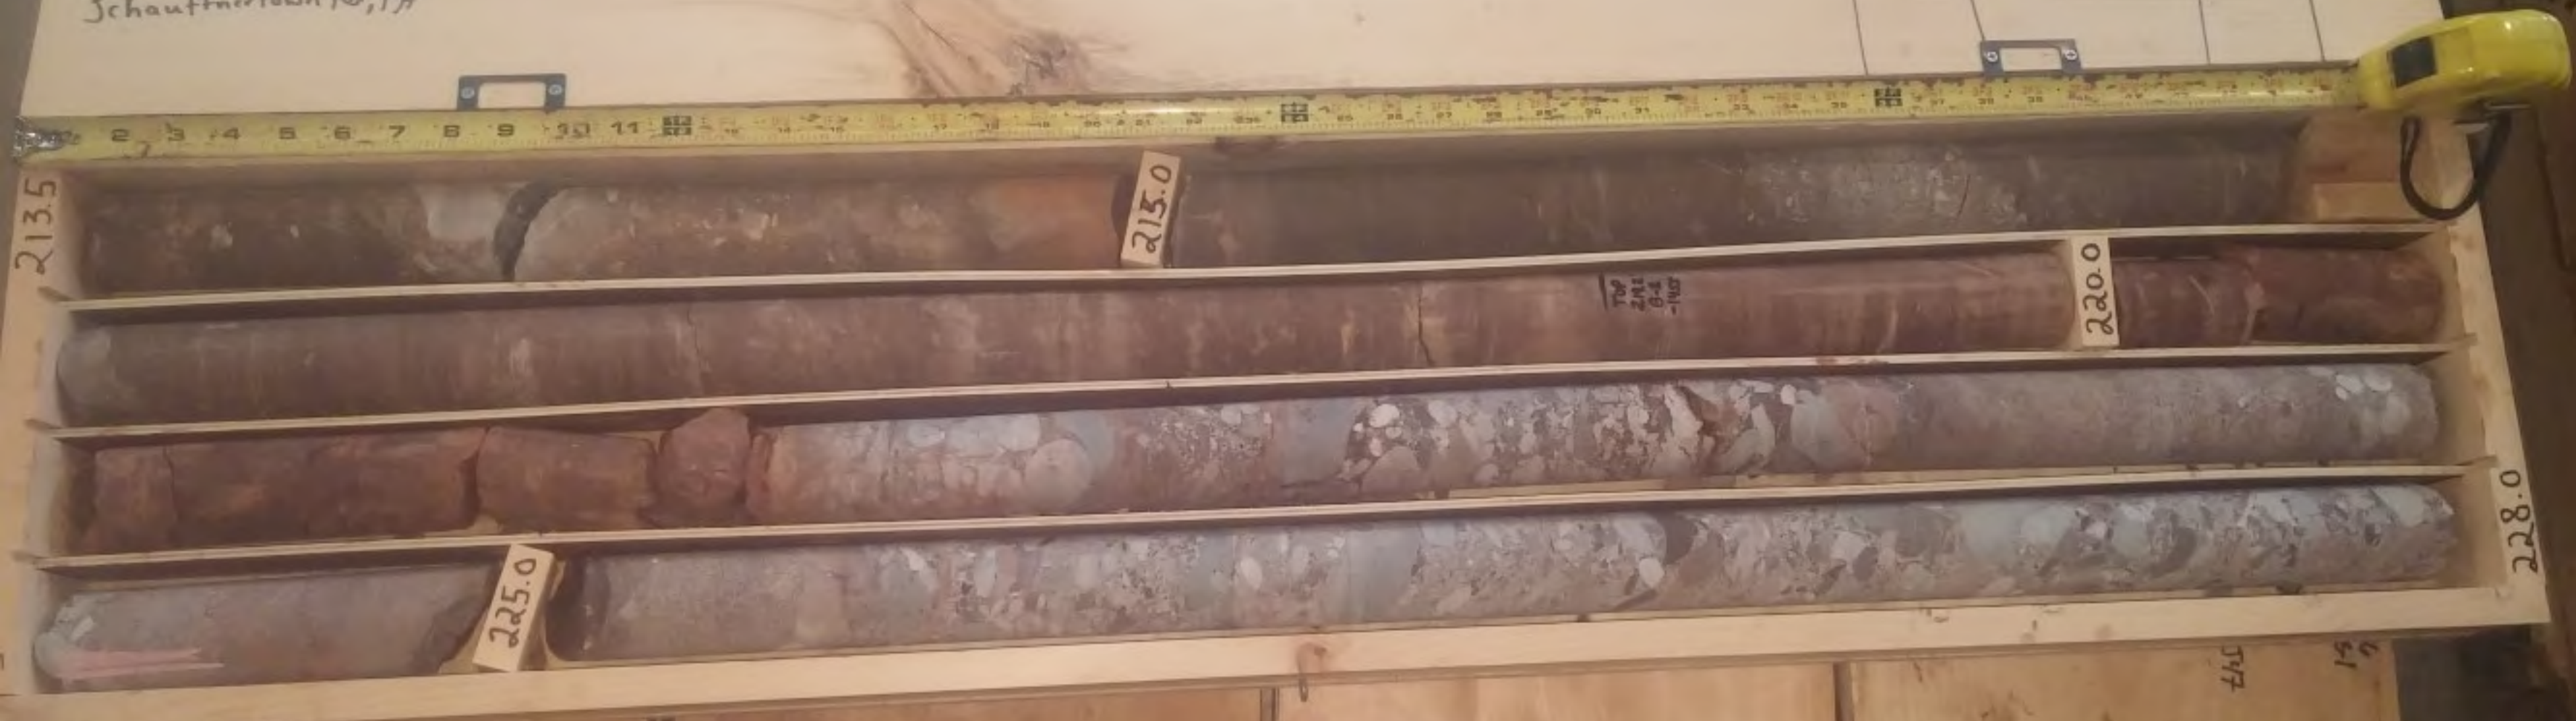
PPP 4
 0491 1455
 HDD Boring (B-2)
 Depth: (213.5 - 228.0) ft
 Box: 14 of
 Schauffertown Rd, PA

Run	Depth	Ree	RQD
39	215.0 - 220.0	60"	59"
40	220.0 - 225.0	60"	43"
41	225.0 - 230.0	60"	60"

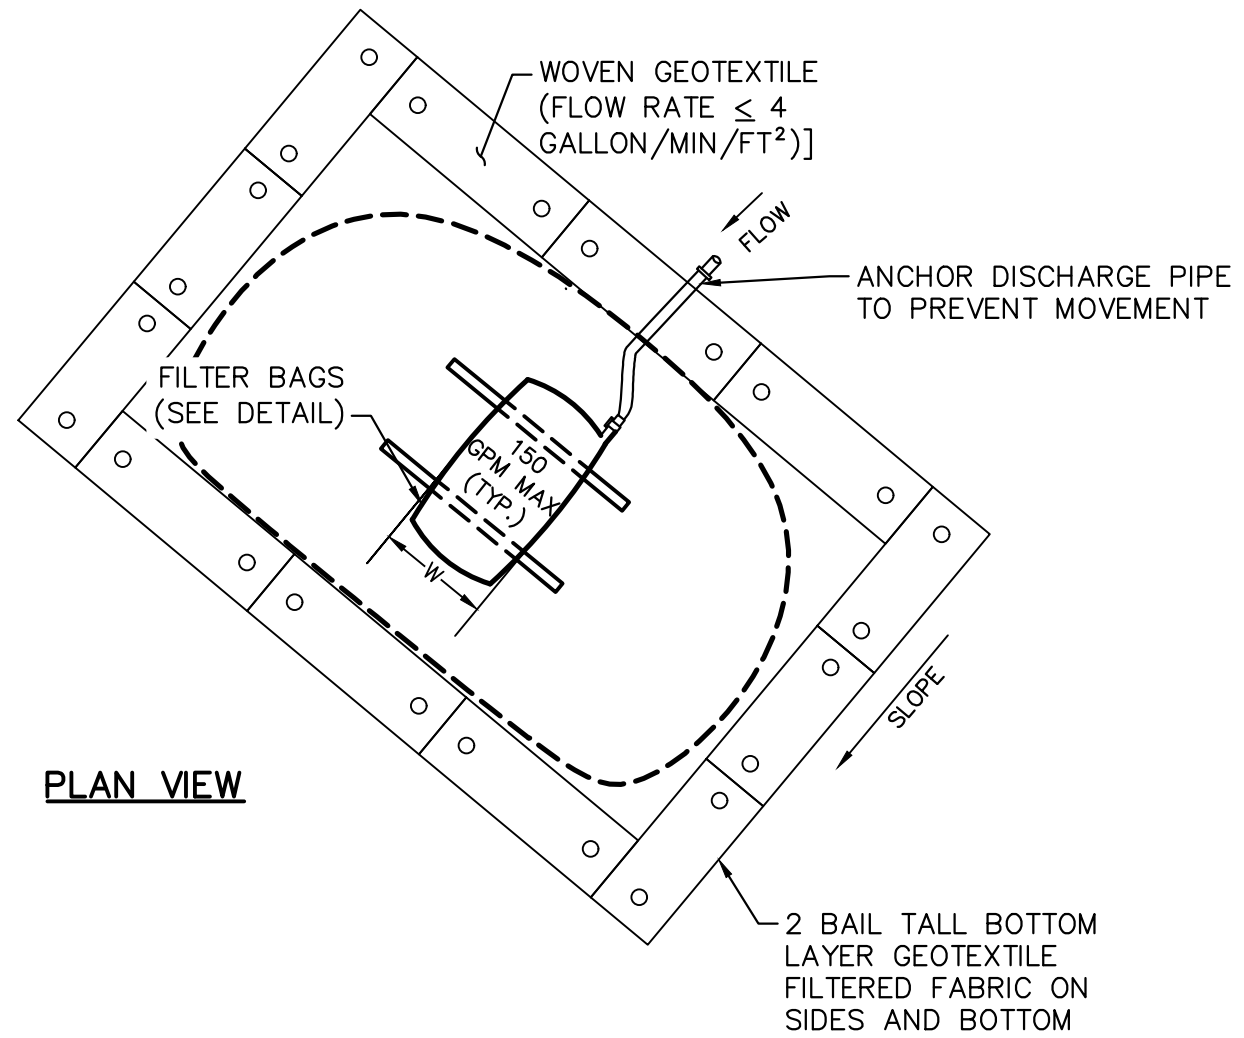
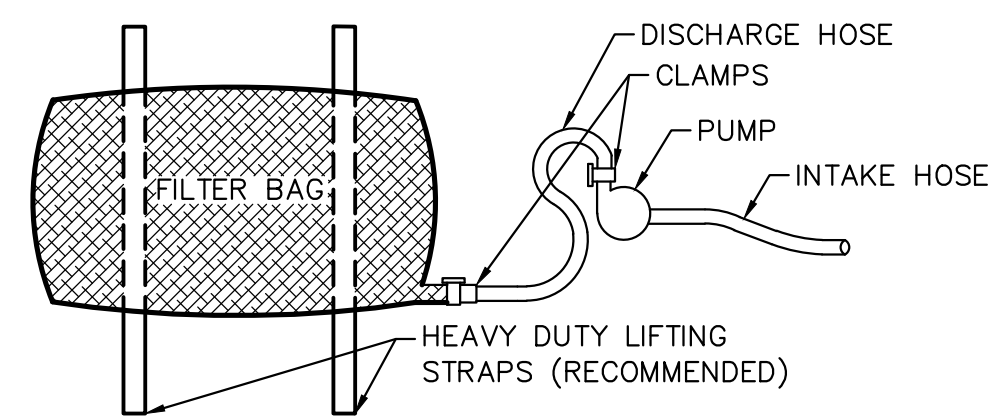
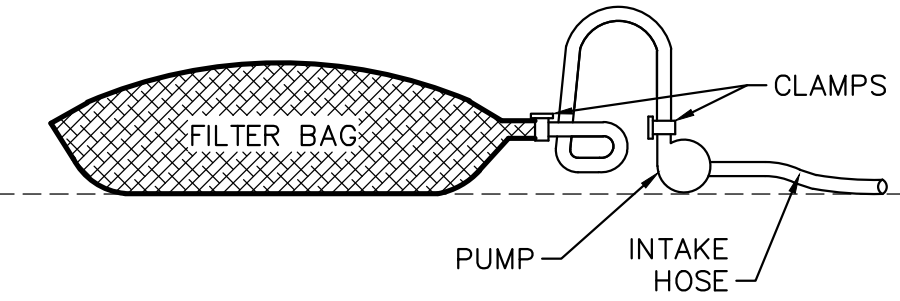
FILTER BAG DETAIL USE IN HAY BALE DISCHARGE STRUCTURE
NOT TO SCALE

PLAN VIEW

ELEVATION VIEW

NOTE:
LOW VOLUME FILTER BAGS SHALL BE MADE FROM NON-WOVEN GEOTEXTILE MATERIAL SEWN WITH HIGH STRENGTH, DOUBLE STITCHED "J" TYPE SEAMS. THEY SHALL BE CAPABLE OF TRAPPING PARTICLES LARGER THAN 150 MICRONS. HIGH VOLUME FILTER BAGS SHALL BE MADE FROM WOVEN GEOTEXTILES THAT MEET THE FOLLOWING STANDARDS:

The attachments to the Reevaluation Report have been revised. Attachment 2 presents the revised E&S sheets detailing the water management control locations, and details on the discharge filtration structure. The original and revised HDD Plan and Profile are now in Attachment 3.

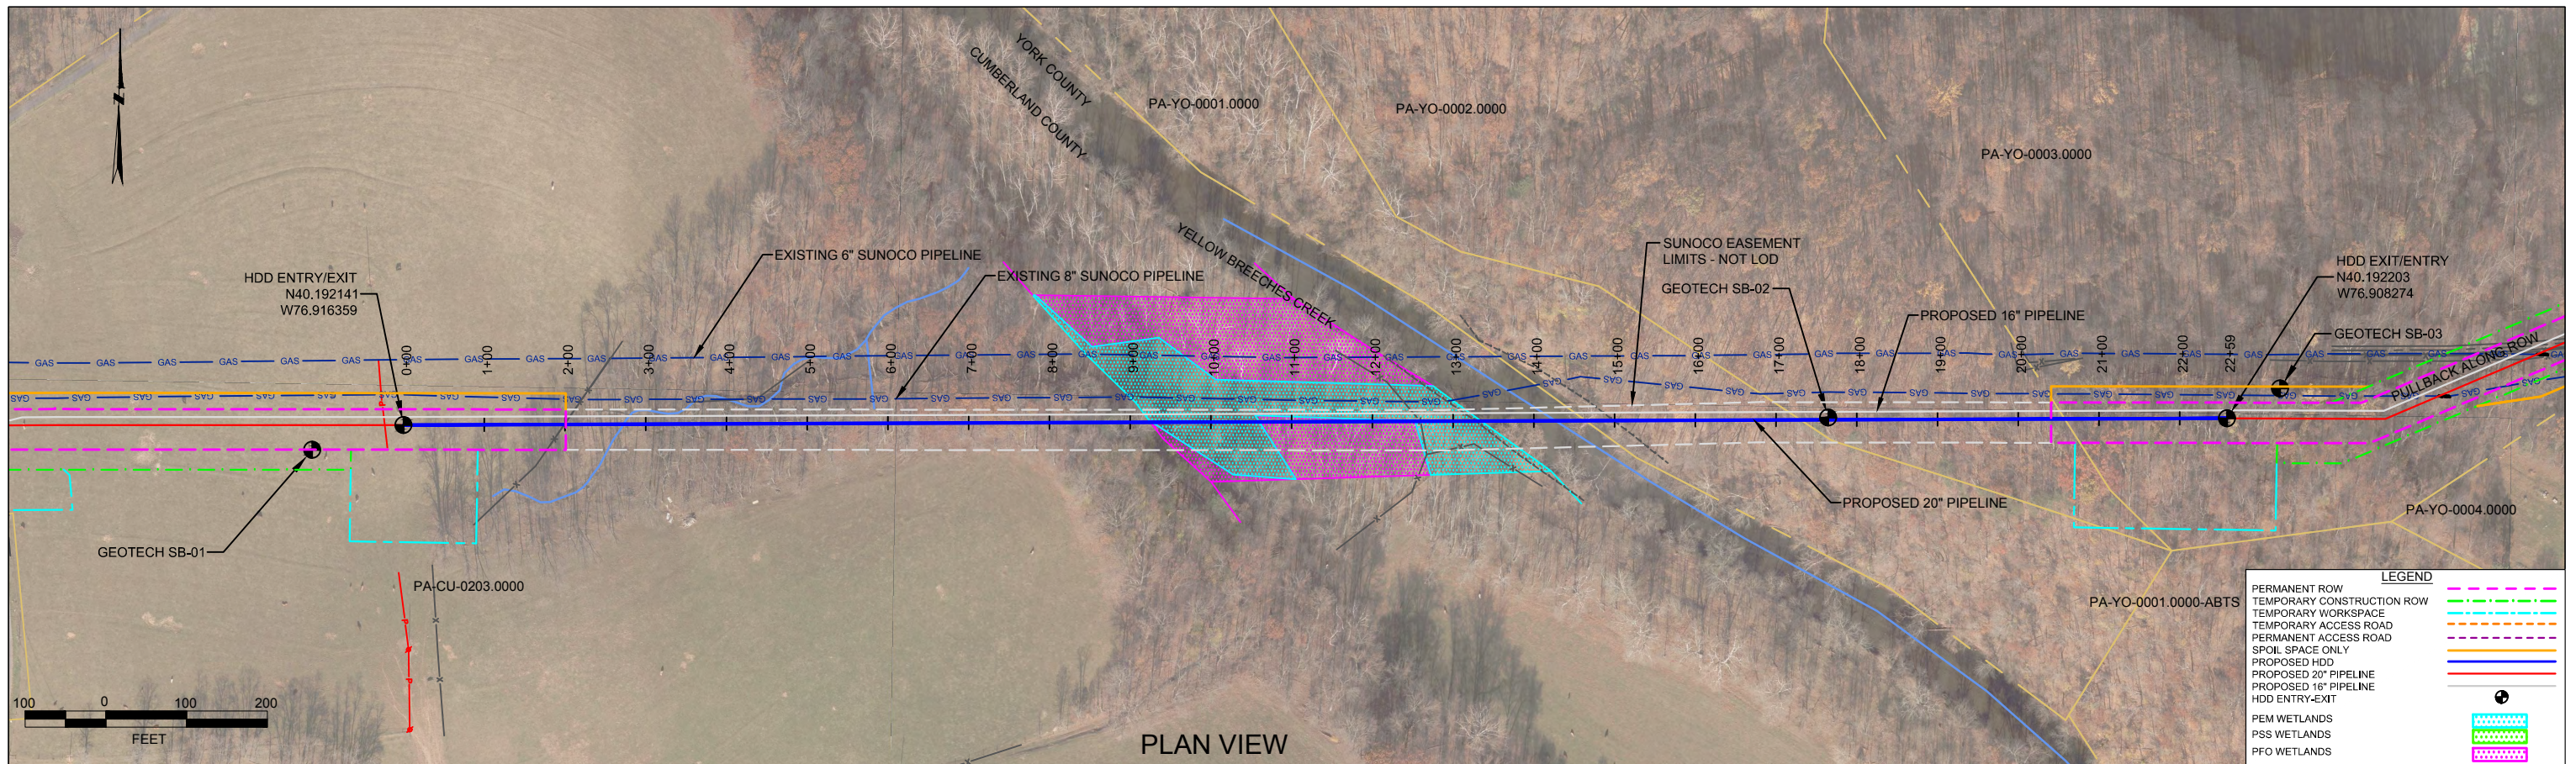
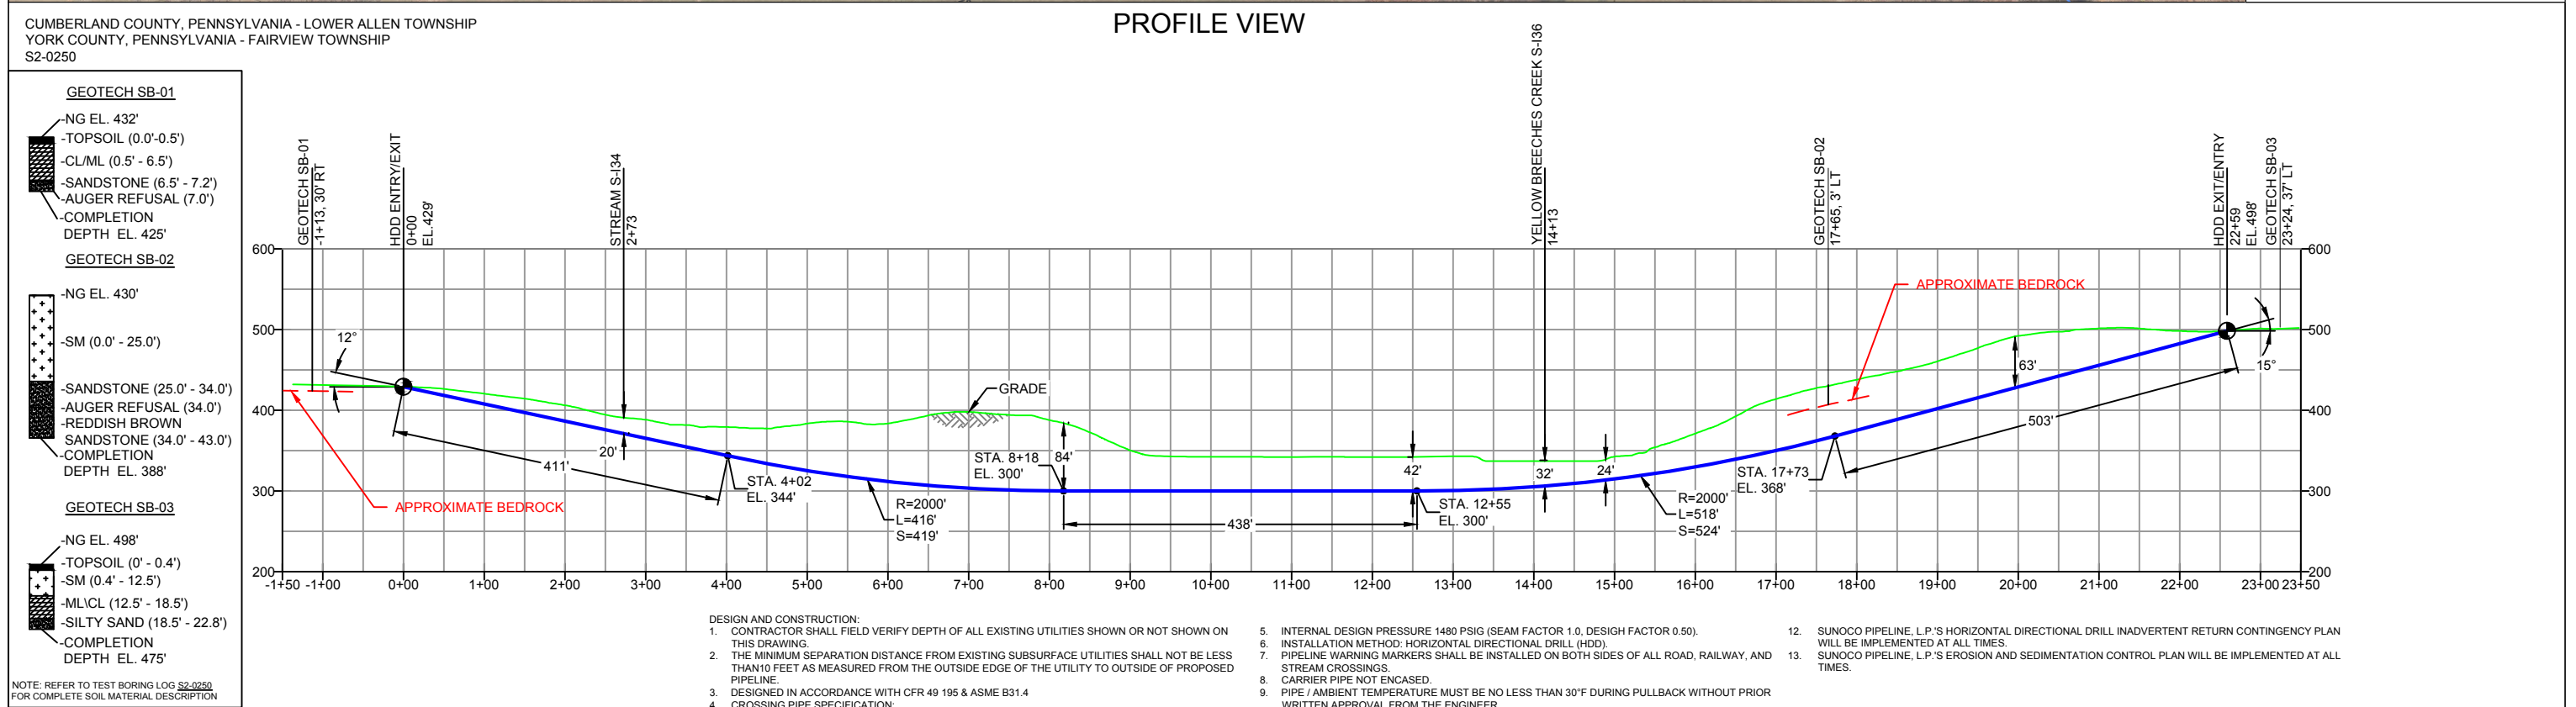
Figure 1. Original 20-Inch HDD Plan and Profile

PLAN VIEW

PROFILE VIEW
