**Biblical Life Institute Stream Restoration**  
**SW160140**  
**Armstrong Conservation District**

**PROJECT DESCRIPTION:** Severe erosion on an UNT to Pine Run was contributing to sediment pollution in the Buffalo Creek Watershed. This stream is designated as an HQ-TSF, but the stream is impaired from siltation and currently not meeting this designation. The bank was stabilized using concrete bin blocks, rip rap, turf reinforcement matting, and live stakes. Five J-hooks were installed to direct flow away from the bank while creating fish habitat. The project timeframe was 01/01/2018 to 09/30/2021. Additional phases are planned to stabilize the remaining sections of the bank along the pond.

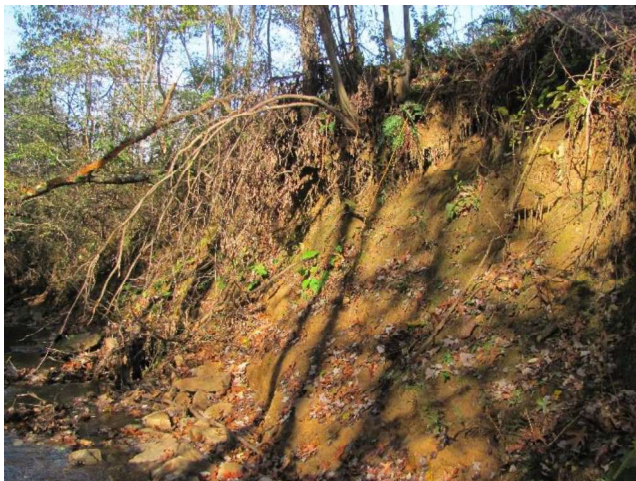
Before Construction

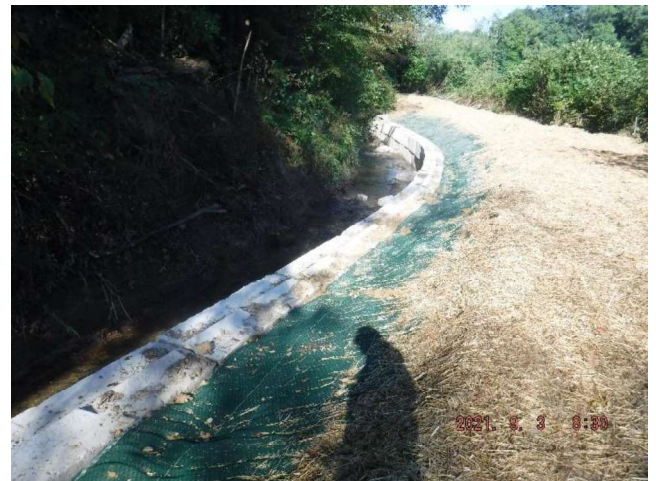
After Construction
