## **GROWING GREENER GRANT NORTHUMBERLAND COUNTY CONSERVATION DISTRICT CARL ROSS PROJECT**

### **PROJECT DESCRIPTION**

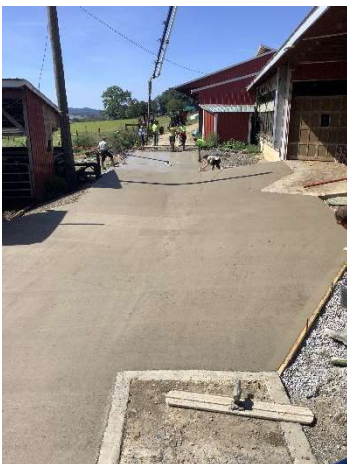
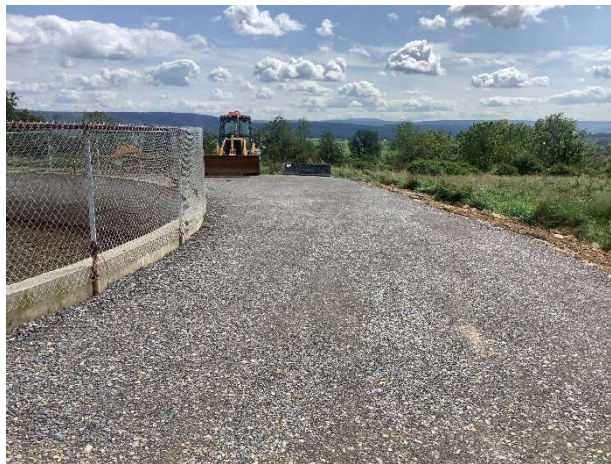
### **PICTURES**

Upon completion of the project and after the first rainstorm it was evident that this project's goals were met. The Farmers were more than patient with the district as well as the contractors during the several months it took to bring the project to a finish. Almost all the credit must be given to Ferster Excavating LLC. for their cooperation in preparing the site and meeting all the concrete company's needs. The concrete work required the perfect pitch and slope in order that the rain might run off it just right. Hours of thought and shooting grade was needed to make sure that water would not flow into any building but around them all and out the swale at the bottom of grade.
