Project Description - The Glenburn Dam was located on Ackerly Creek in Glenburn Township, Lackawanna County on property owned and maintained by Natural Lands. The dam was originally 16 feet high but was partially breached in 2007 for safety reasons. The dam was 140 feet wide and with the partial breach, formerly stood 8' high. The dam consisted of a large rock fill embankment with a clay core. Rock filled gabion baskets lined both sides of the spillway. Removing Glenburn Preserve's dam was essential because it was listed as a "high hazard potential" dam by PA DEP. "High hazard potential" describes a dam whose failure or mis-operation—which could happen in case of a storm or big weather event—would cause loss of human life and significant property destruction downstream.

Project Timeframe – December 28, 2022 through May 25, 2026

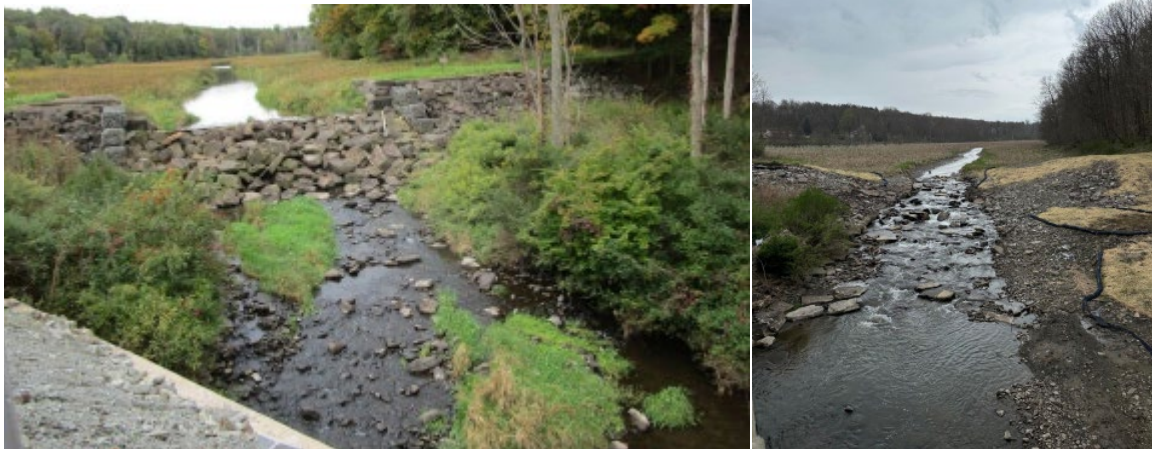
Pictures –

Project Results - The design included a partial vertical breach (~6 feet) and the construction of a fortified rock riffle downstream of the former dam. The rock riffle was located 100 feet downstream of the dam. A large rock grade control structure was installed at the downstream end of the riffle. Rock removed from the dam was used to create the riffle. Rock fill began at the grade control structure and consisted of large rock mixed with smaller cobbles (salvaged from the gabion baskets) and gravel on-site to choke any voids in the rock fill. The channel in the rock fill was shaped using data obtained from USGS StreamStats. A bankfull bench was established on the west side of the channel and with a slope consistent with the constructed channel in the riffle. The project was built as designed; no modifications were needed.
