# PA DEP Small Drinking Water Systems Engineering Services Program (ESP) Case Study

Client Name: Knoxville Borough Water Department  
Location: Knoxville Borough, Tioga County  
Project Name: Finished Water Reservoir Cover Replacement

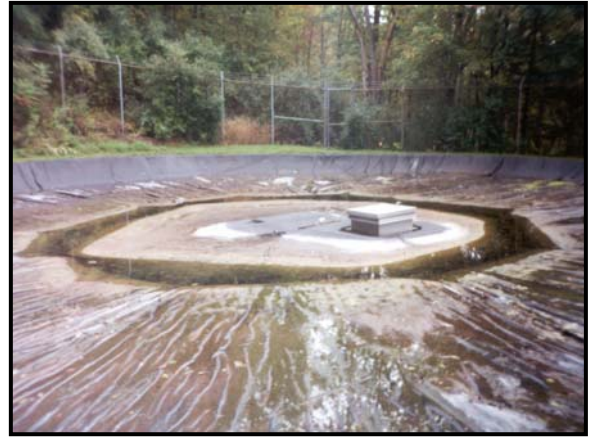
The Knoxville Borough Public Water System (PWS) serves approximately 590 people through 320 connections and has an average daily use of 45,000 gallons per day. The system is served by ground water wells, which are treated and pumped through the distribution system to an existing 500,000-gallon reservoir. An inspection by PADEP determined that the geomembrane cover over the reservoir had holes and tears and needed to be repaired. A large amount of standing water with an algae bloom was collecting on the cover.

The tears in the cover were a potential pathway for contamination into the finished water storage in violation of the PA Filter Rule. PADEP issued a consent Order and Agreement that required the Borough to provide increased chlorine levels until the reservoir cover was replaced.

**Technical** – The 90-foot diameter reservoir cover needed to be replaced with a cover suitable to the environmental conditions (high on a mountainside). The existing geomembrane floating cover did not last through its design life.

Based on a Feasibility Study, completed as part of the ESP, it was determined that construction of an aluminum dome cover over the existing reservoir was the most feasible option through a 20-year life cycle cost analysis. The ESP provided engineering services that included project design, contract and construction administration, and project financing. The construction project was funded by an interim loan from a local bank and long-term funding was provided by the Pennsylvania Infrastructure Investment Authority (PENNVEST).

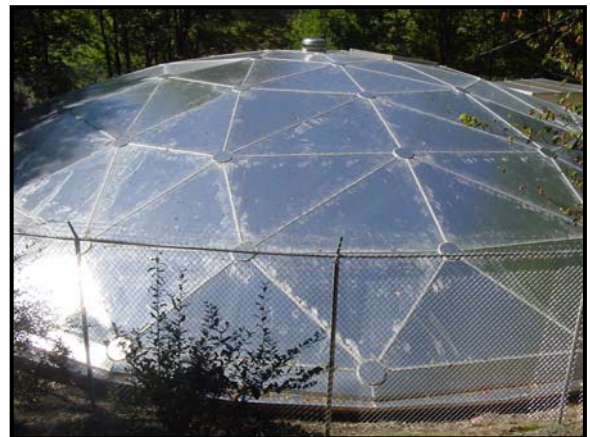
The aluminum dome was completed in accordance with design specifications and DEP issued an operations permit for the reservoir with the aluminum dome cover in August 2003. The completed project allowed the Borough to reduce the amount of chlorine used for disinfection. The project eliminated a source of contamination and brought the PWS into compliance with the PA Filter Rule.
