HAMMER CREEK
LEBANON AND LANCASTER COUNTIES

WATER QUALITY STANDARDS REVIEW
STREAM REDESIGNATION EVALUATION

Segment: Source to Speedwell Forge Lake Dam
Stream Code: 07664
Drainage List O

WATER QUALITY MONITORING SECTION (TES)
DIVISION OF WATER QUALITY STANDARDS
BUREAU OF WATER STANDARDS AND FACILITY REGULATION
DEPARTMENT OF ENVIRONMENTAL PROTECTION

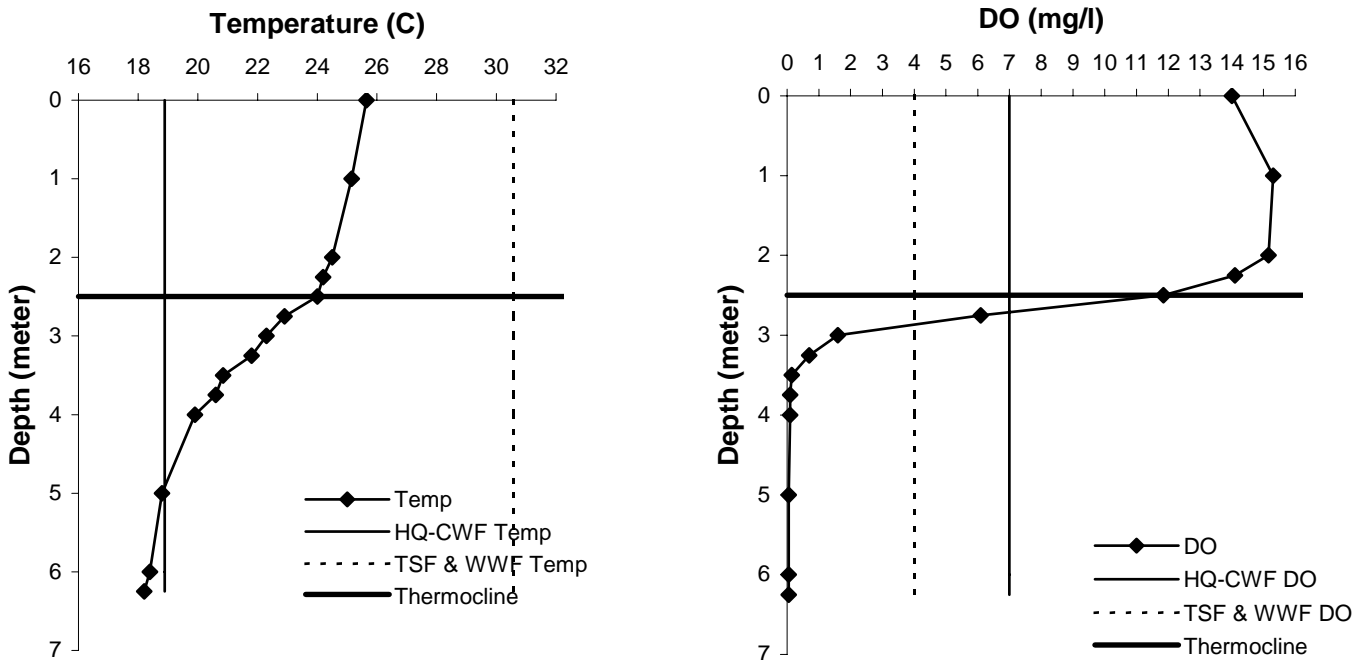
FIGURE 8.
SPEEDWELL FORGE LAKE - WATER CHEMISTRY
Temperature and Dissolved Oxygen Profiles - Dam
 DEP

August 29, 1997
