APPENDIX D STREAM CORRIDOR ASSESSMENT

DEP staff conducted a walking survey of portions of Walnut Creek, using the Stream Corridor Assessment (SCA) survey protocols, developed by the State of Maryland - Department of Natural Resources, as a guide. These protocols are intended as a rapid assessment tool to identify potential environmental problems, such as:

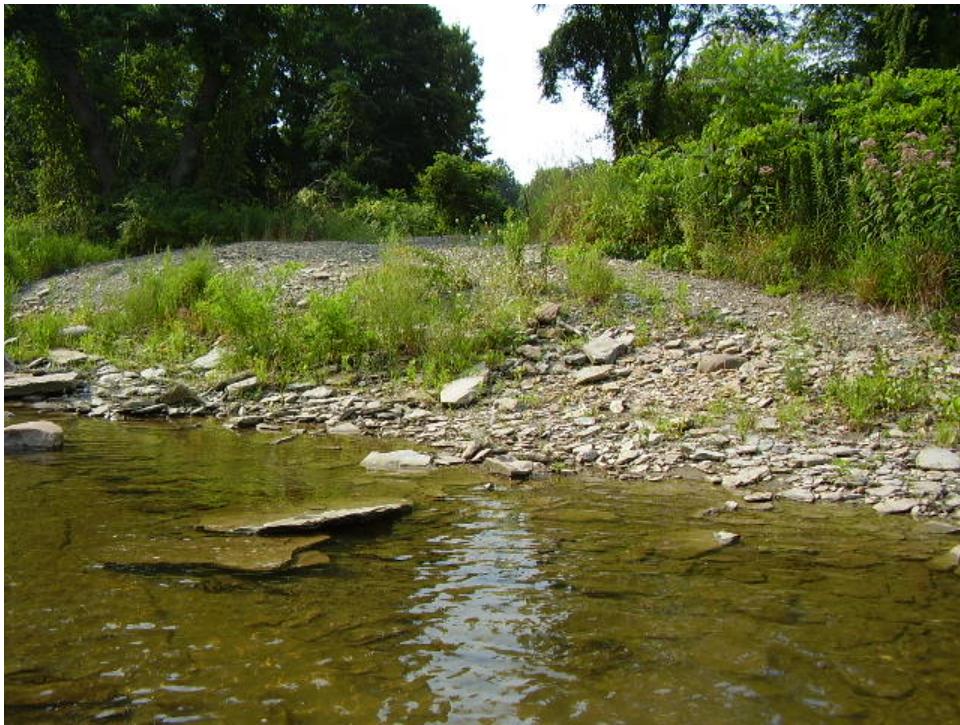
Photo 6 – Channel Alteration for habitat improvement/ potential fish barrier, PFBC Manchester Facility

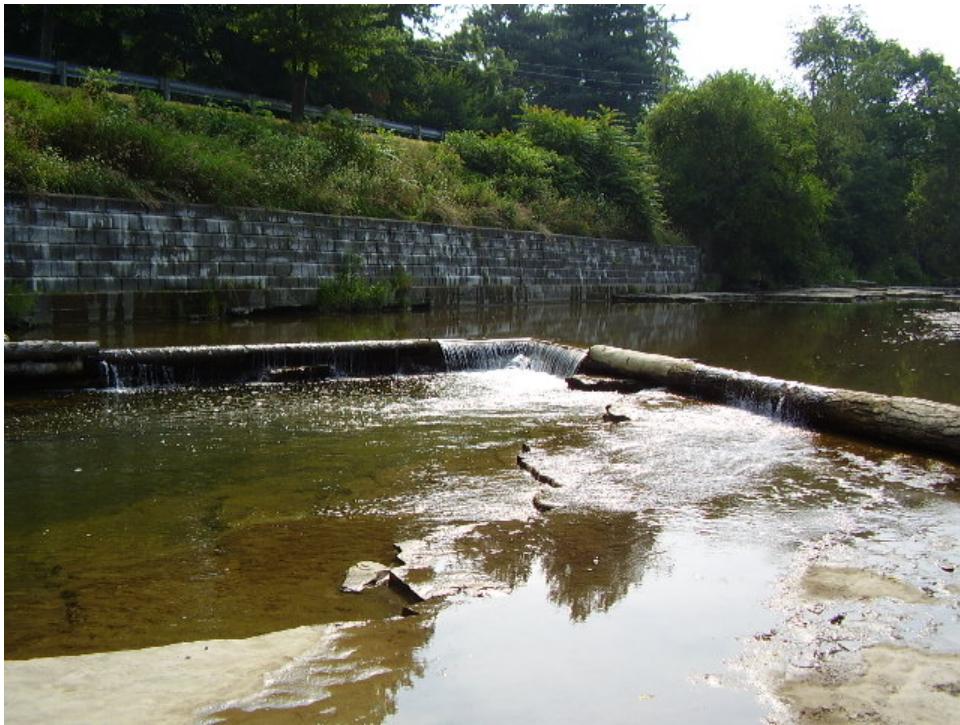
Photo 7 – Channel Alteration, Downstream Manchester Road Bridge

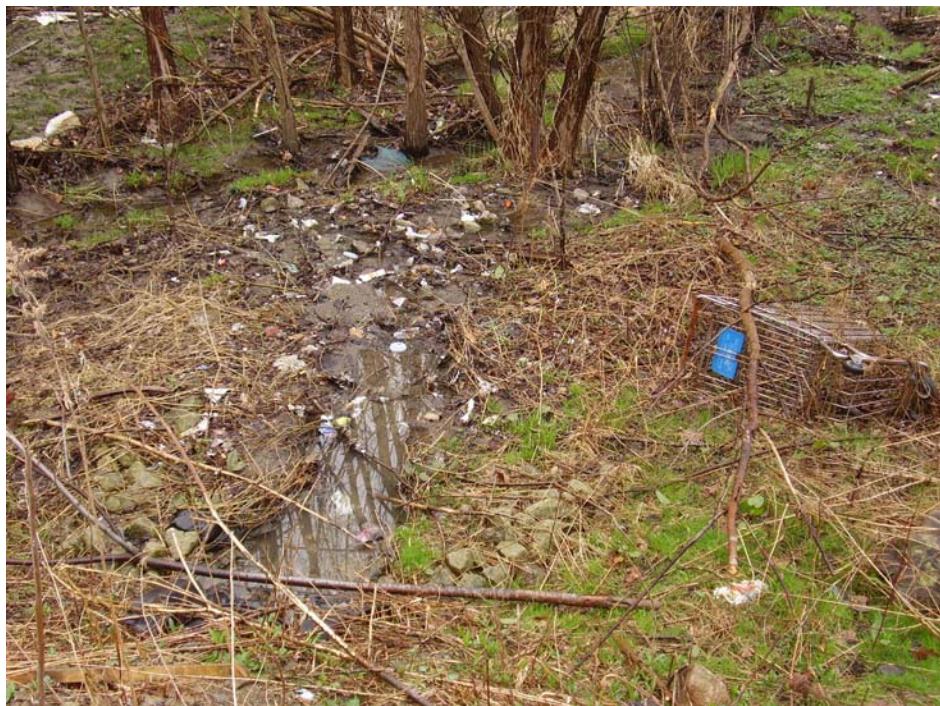
Photo 11 – Water Withdrawals / Encroachments , Upstream Manchester Rd. Bridge

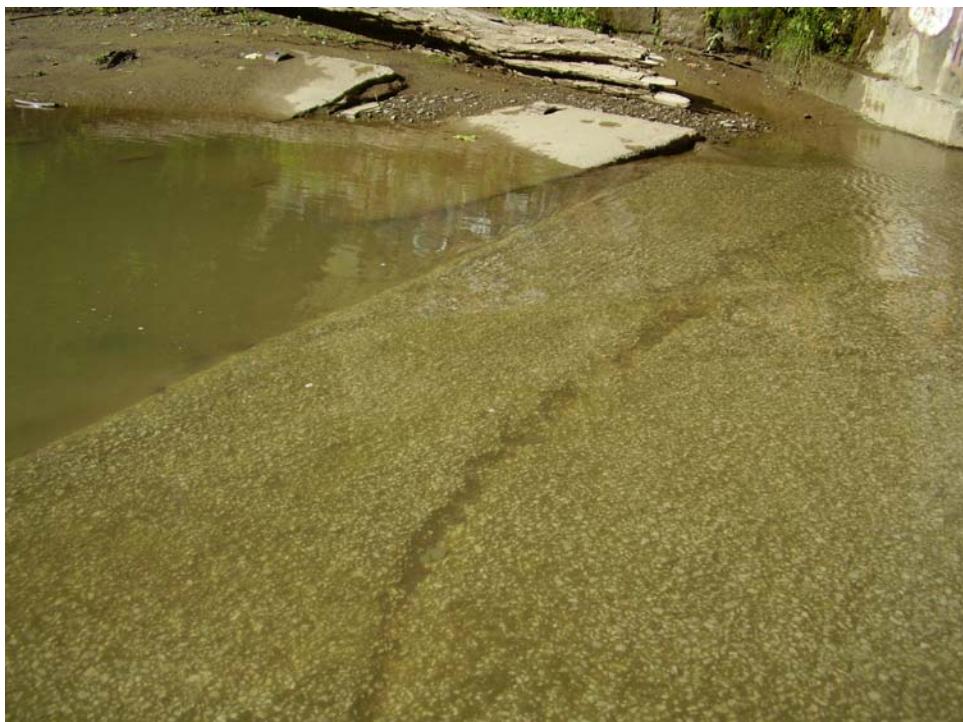
Photo 22 – Sedimentation, Downstream CSXT RR Bridge

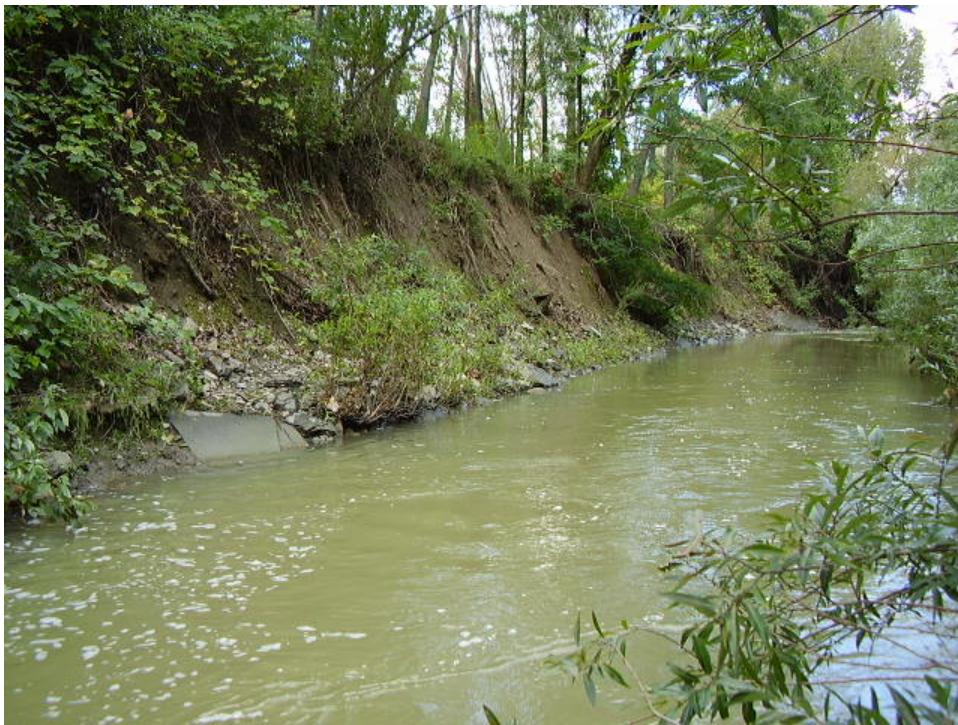
Photo 52 Erosion site 9UNT

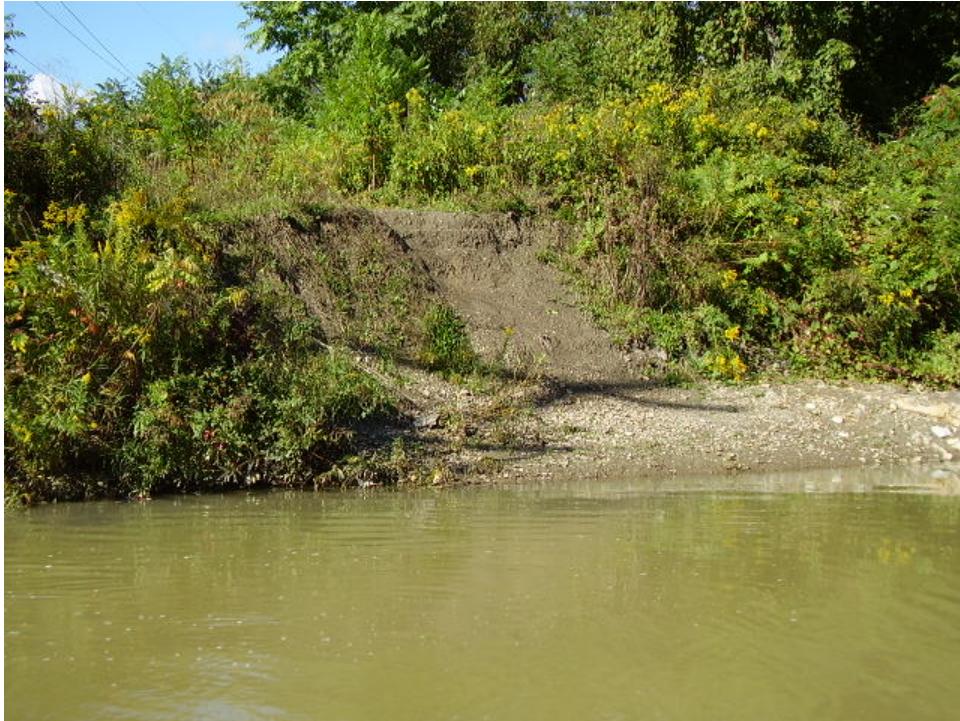
Photo 57 – Erosion Site, Downstream Peach Street Bridge Crossing

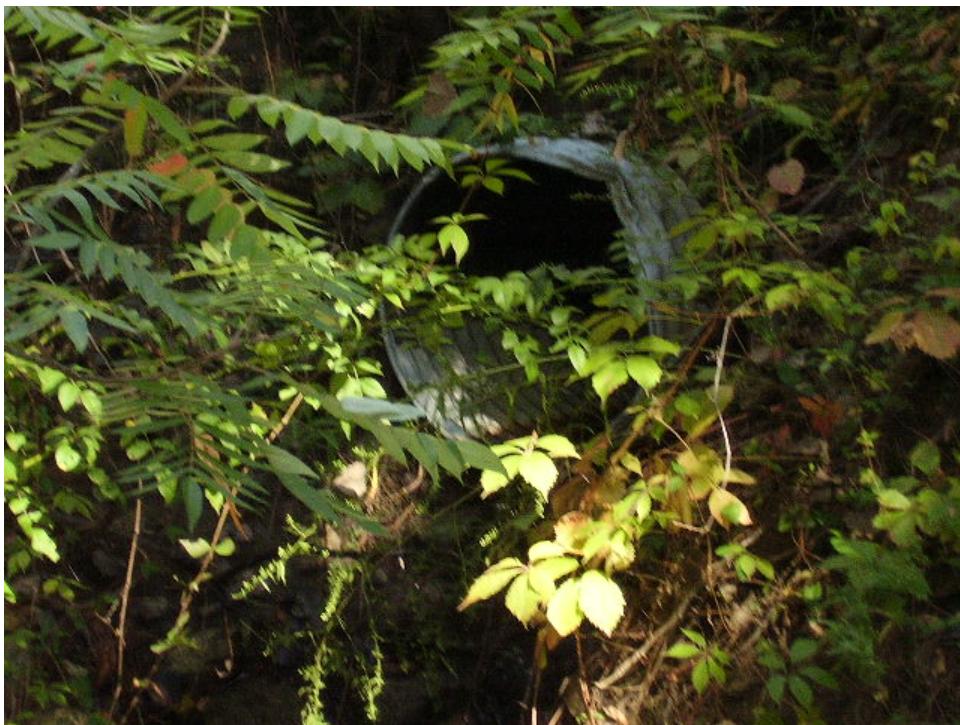
Photo 59 – Pipe Outfall, Downstream Peach Street Bridge Crossing

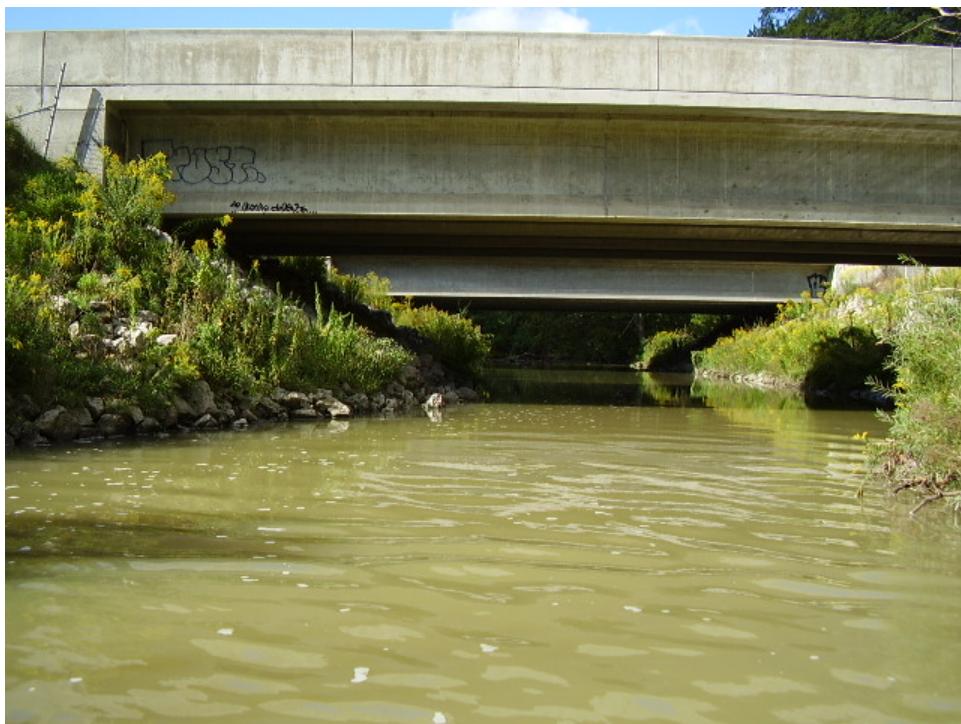
Photo 62 – Pipe Outfall, Interstate 79 Bridge Crossing

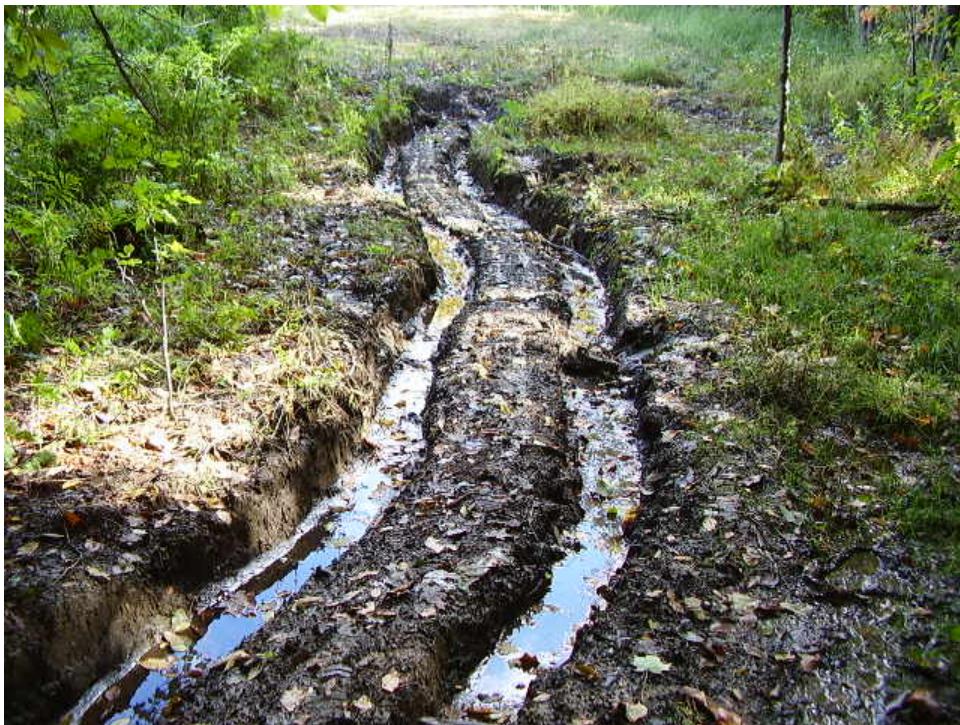
Photo 67 - Loss of Riparian Habitat / Stream Channelization (12UNT)
